East Longmeadow High School

EXISTING CONDITIONS SURVEY

Architects, Engineers & Hazmat Assessment Team visit
June 17, 2022

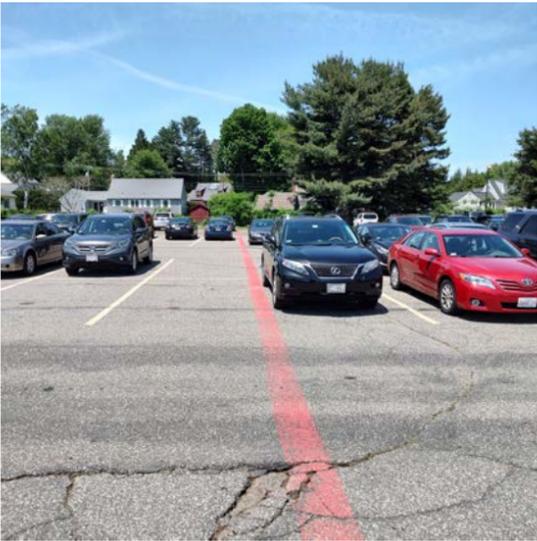
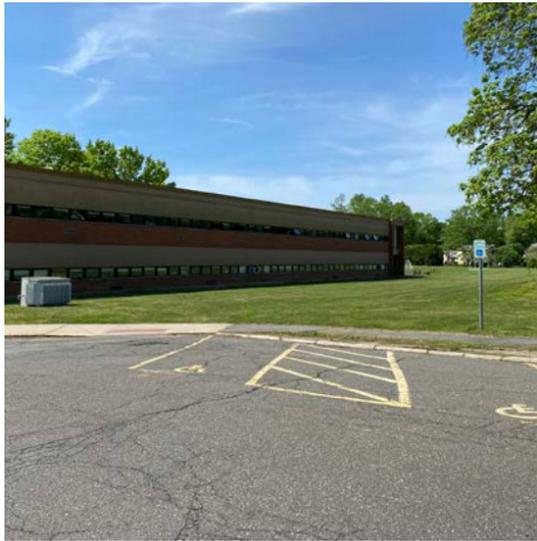
Parking Conditions and Lack of Faculty | Student Parking Separation

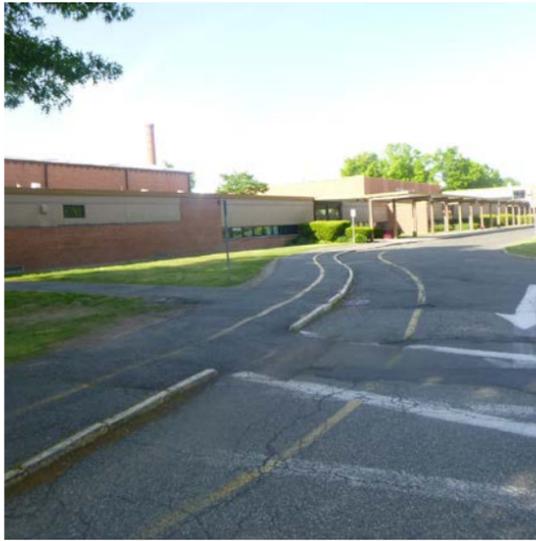
Accessible Parking and Routes Not ADA | AAB Compliant

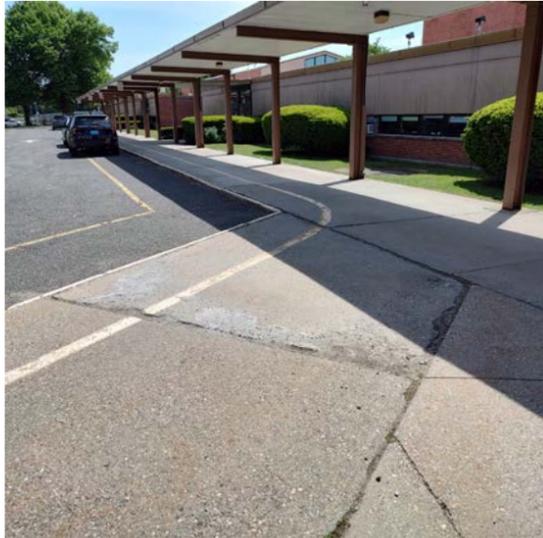
Walkway Conditions

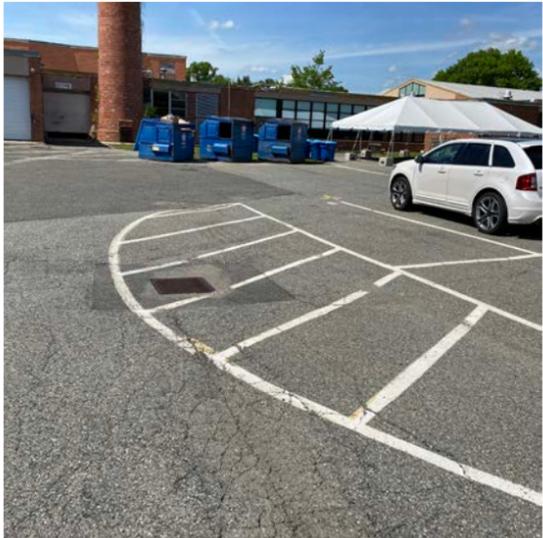
Undersized Loading | Service Area

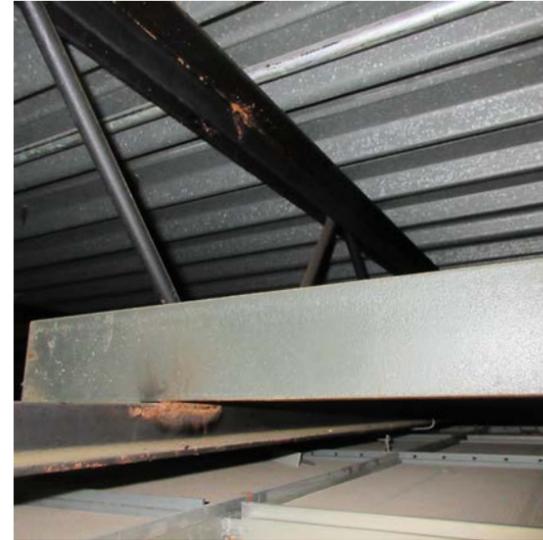
(1) Typical Flat Roof Framing

(1) Flat roof structure consists of open web steel joists, steel girders, and metal roof deck

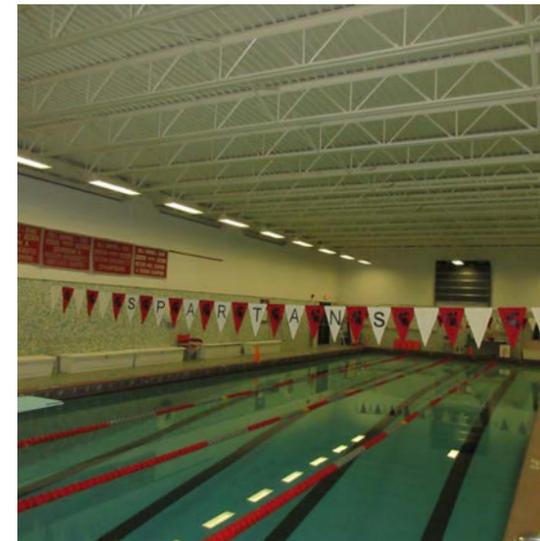
(5) Swimming pool roof consists of long span open web joists and metal roof deck

(5) Swimming Pool Structure

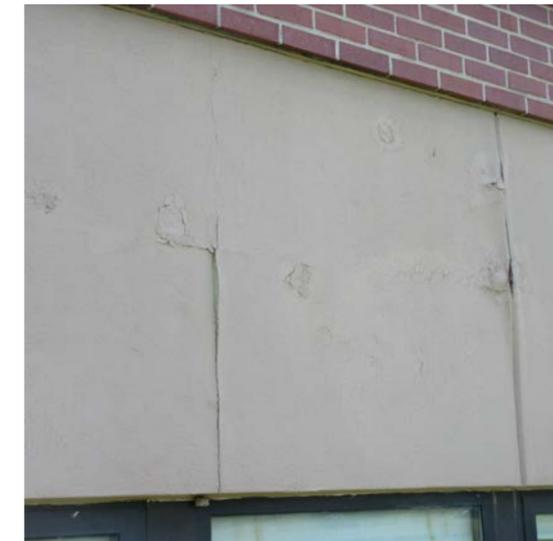
(6) Façade stucco shows cracking/delamination

(6) Typical façade stucco condition

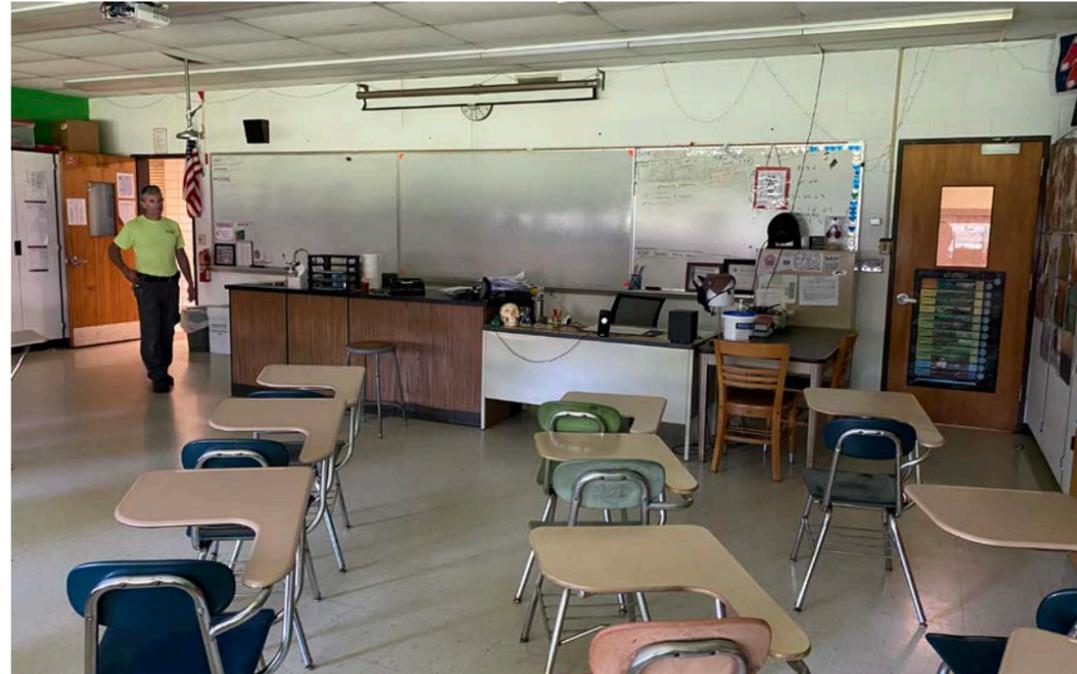
(1) Furnishings are dated, inconsistent, ergonomically inappropriate and discouraging of collaboration and project-based learning

(1) Make-do furniture & casework - Pre K CR

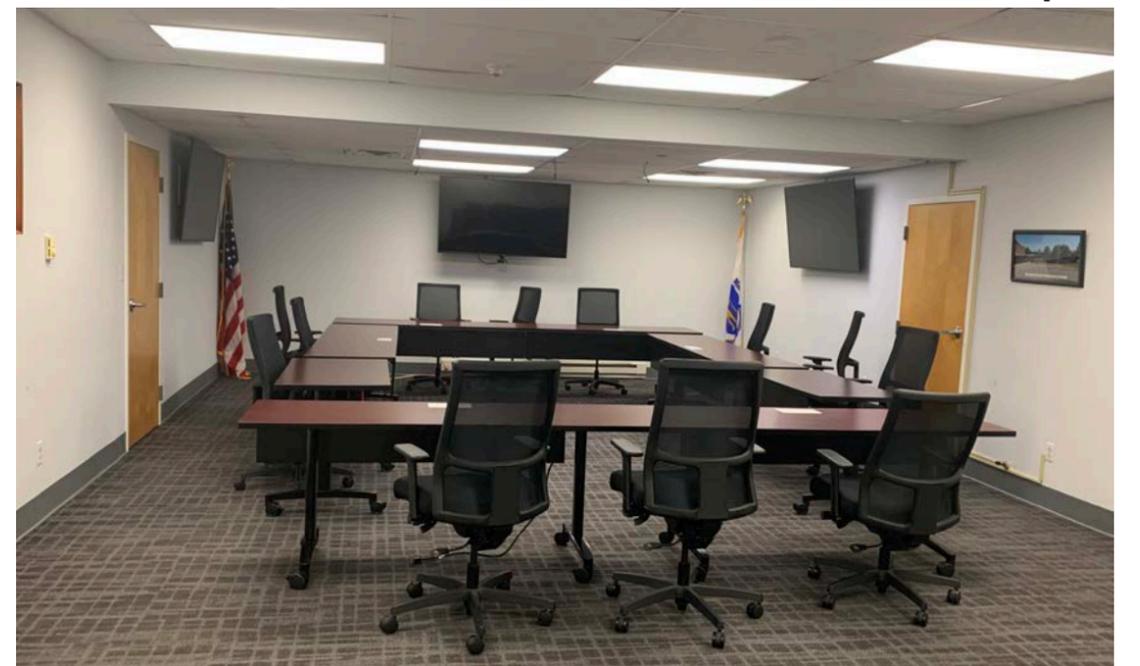
(4) Important civic spaces and classrooms lack natural light or appropriate ventilation or sense of connection.

(4) Non-public/windowless meeting rooms

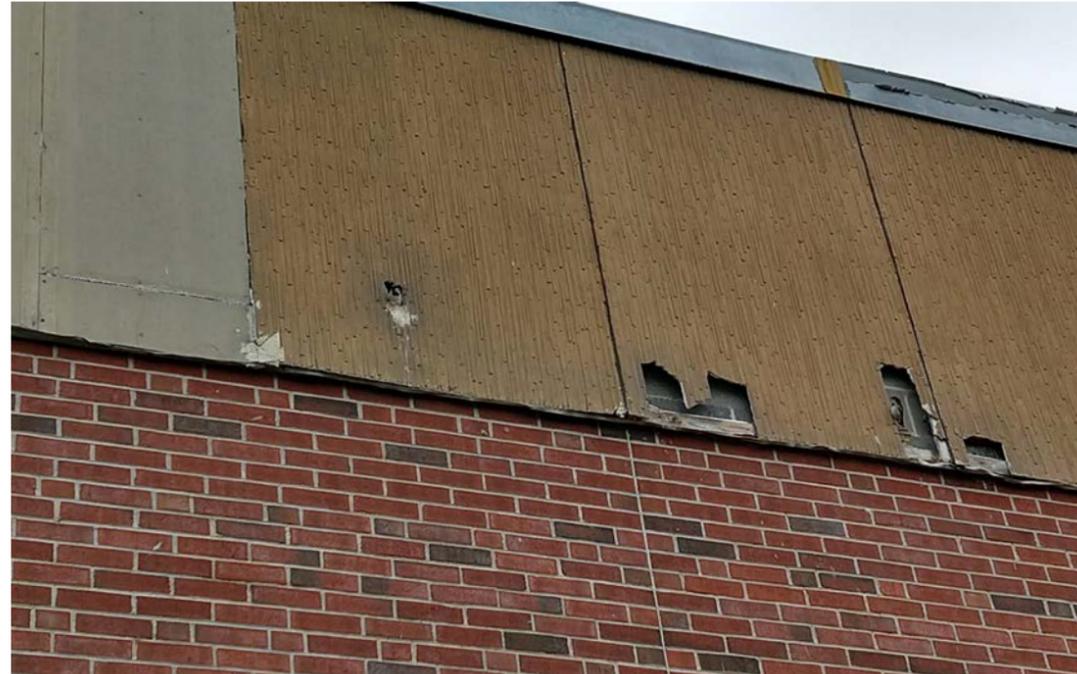
(1) Exterior sheet cladding in very poor condition.

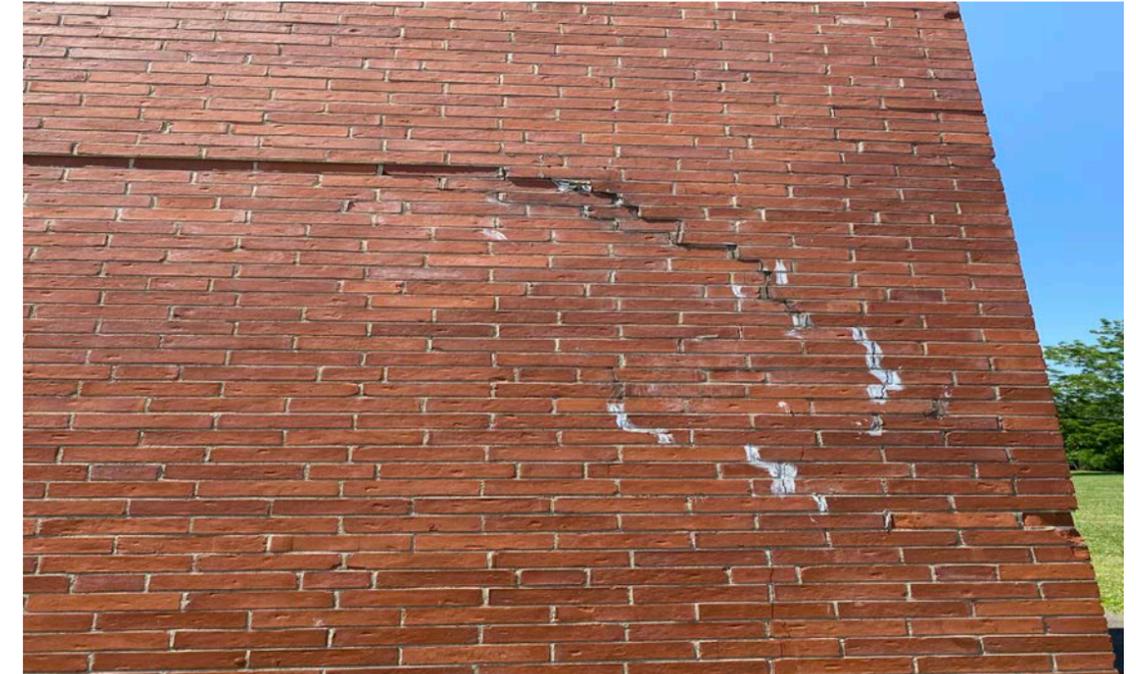
(2) Brick exterior walls in good condition with a small number of areas with brick spalling – and some brick movement.

(2) Select areas of brick spalling and movement

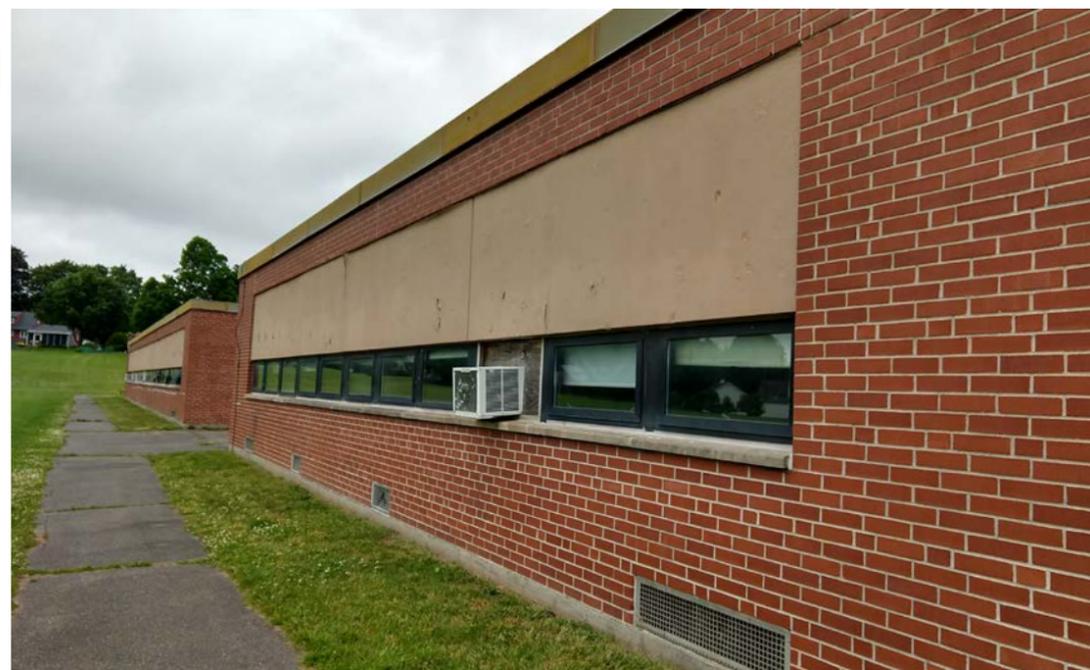
(3) Original exterior window system remains and is located behind EIFS envelope system that is wearing and blocking daylight.

(3) "Updated" windows

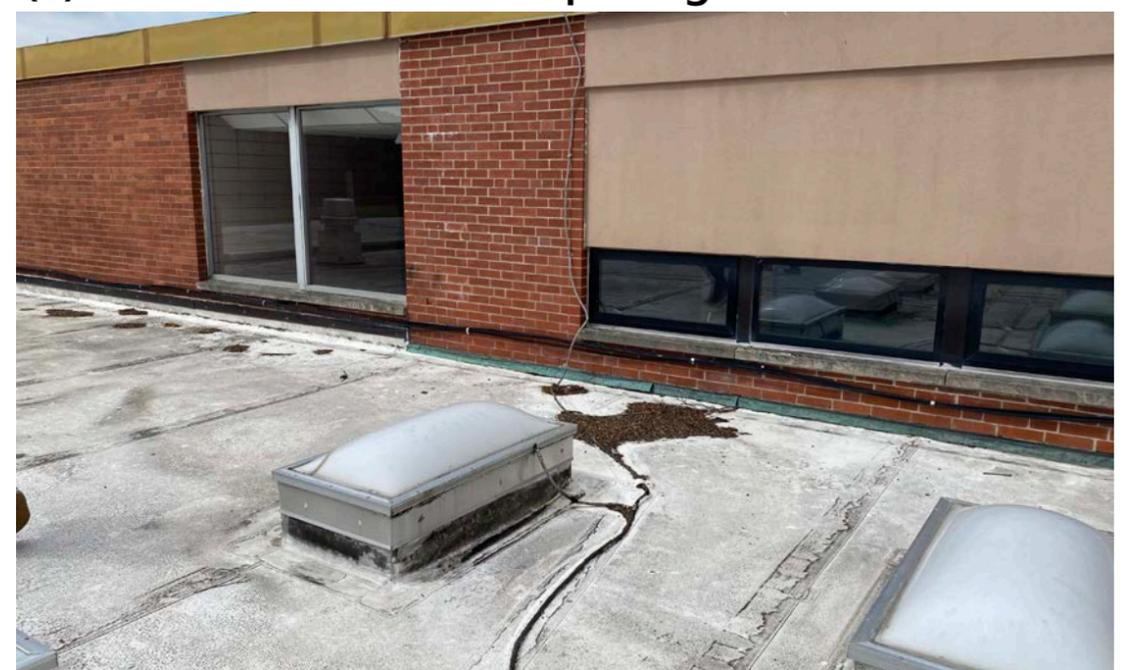
(4) Roof is in poor shape. History of leaks. Minimal slopes. Surprisingly low / minimal flashing at adjacent walls.

(4) Low flashing and evidence of ponding

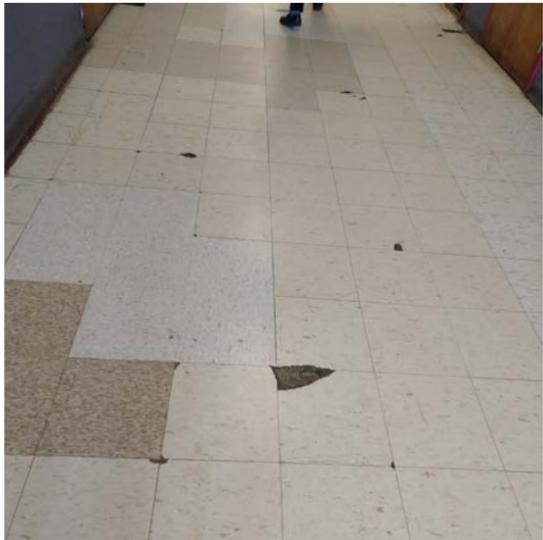
Deteriorating floor finishes

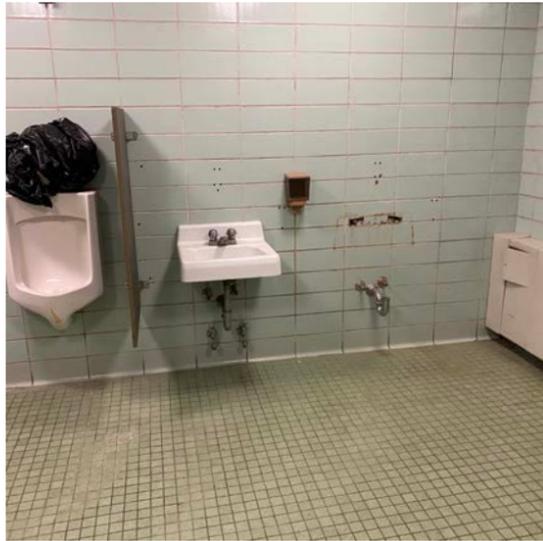
Bathrooms that cannot be monitored have been abandoned

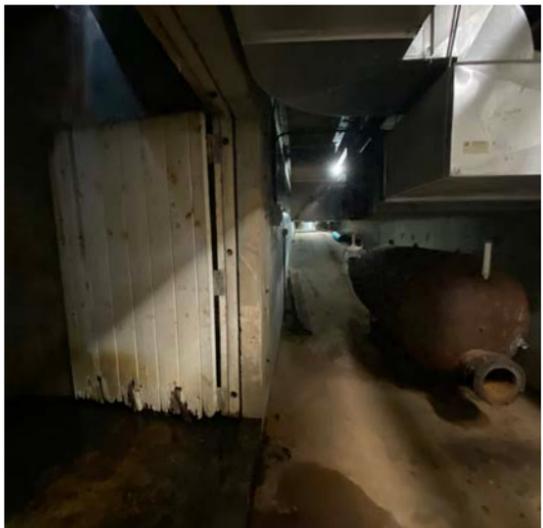
Water infiltration at pool basement

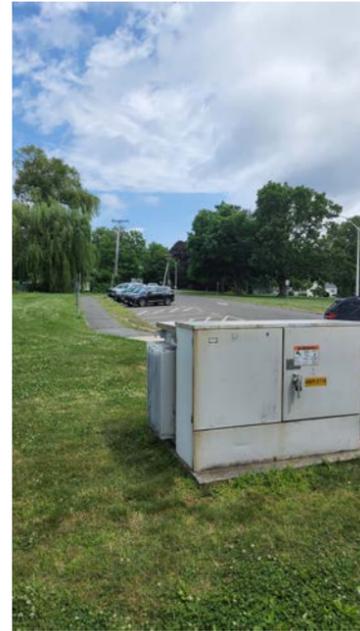
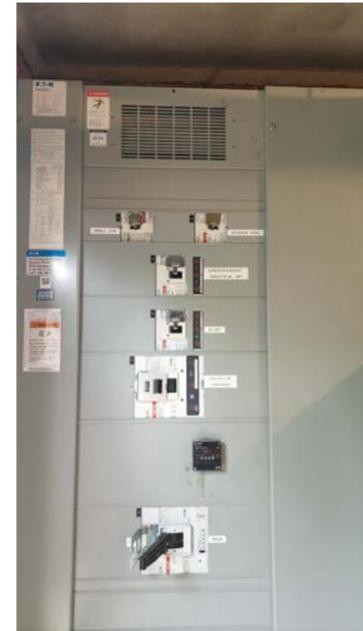
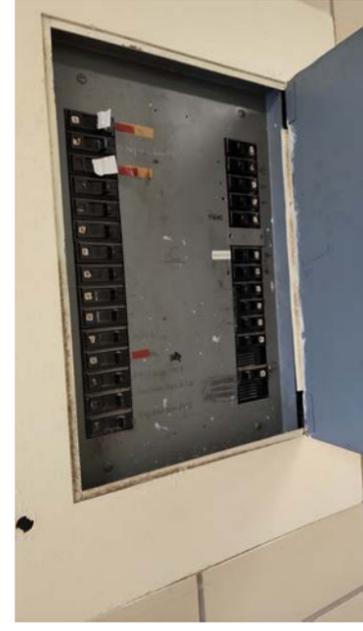
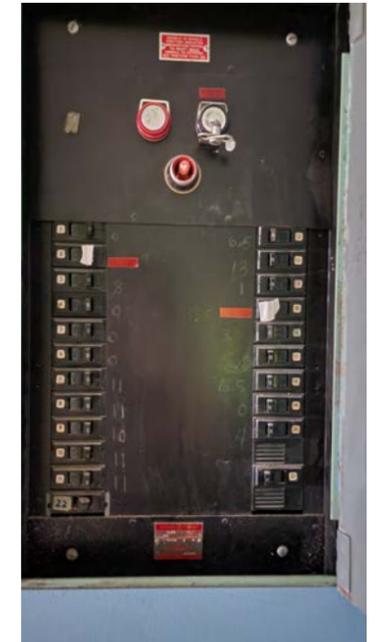
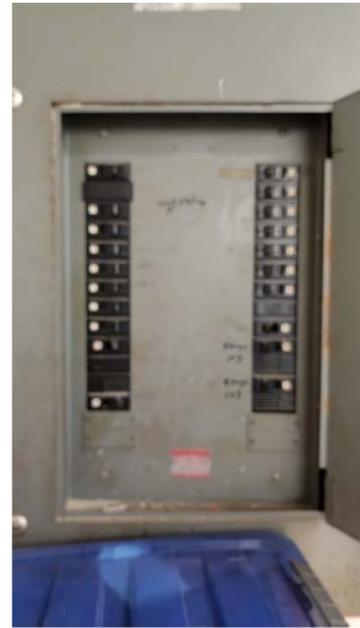
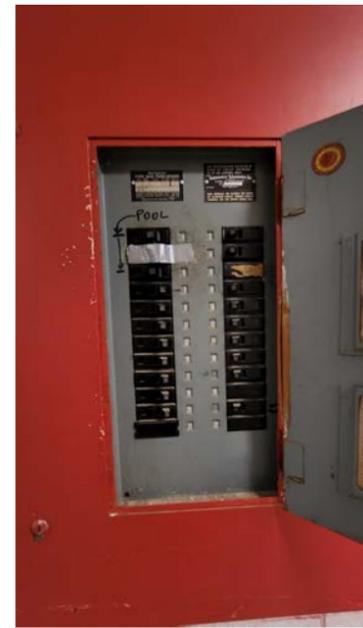
Utility Transformer, Main Distribution Panel, Typical Small Power Panels

- Existing outdoor utility transformer and the Main Distribution Panel, by Eaton, rated 1,200 Amp 277/480v 3ph 4w, were installed during 1975 school building addition. Although the Main Distribution panel is in good operational condition, it's reaching its 50-yr life expectancy.

- The Main Distribution Panel is feeding the Original 1965 Distribution panel, by General Electric, rated 120/208v 3ph 4w, via an indoor 500KVA stepdown transformer. The Original Distribution panel is in poor condition and beyond its life expectancy.

- The Main and Original Distribution Panels feed (37) branch panels, installed throughout the building. Majority of panels are in poor condition and beyond their life expectancy, except for a few "newer" ones, such as Gym panels and Kitchen panels. All downstream power feeders are old, except for a few ones associated with recent upgrades.

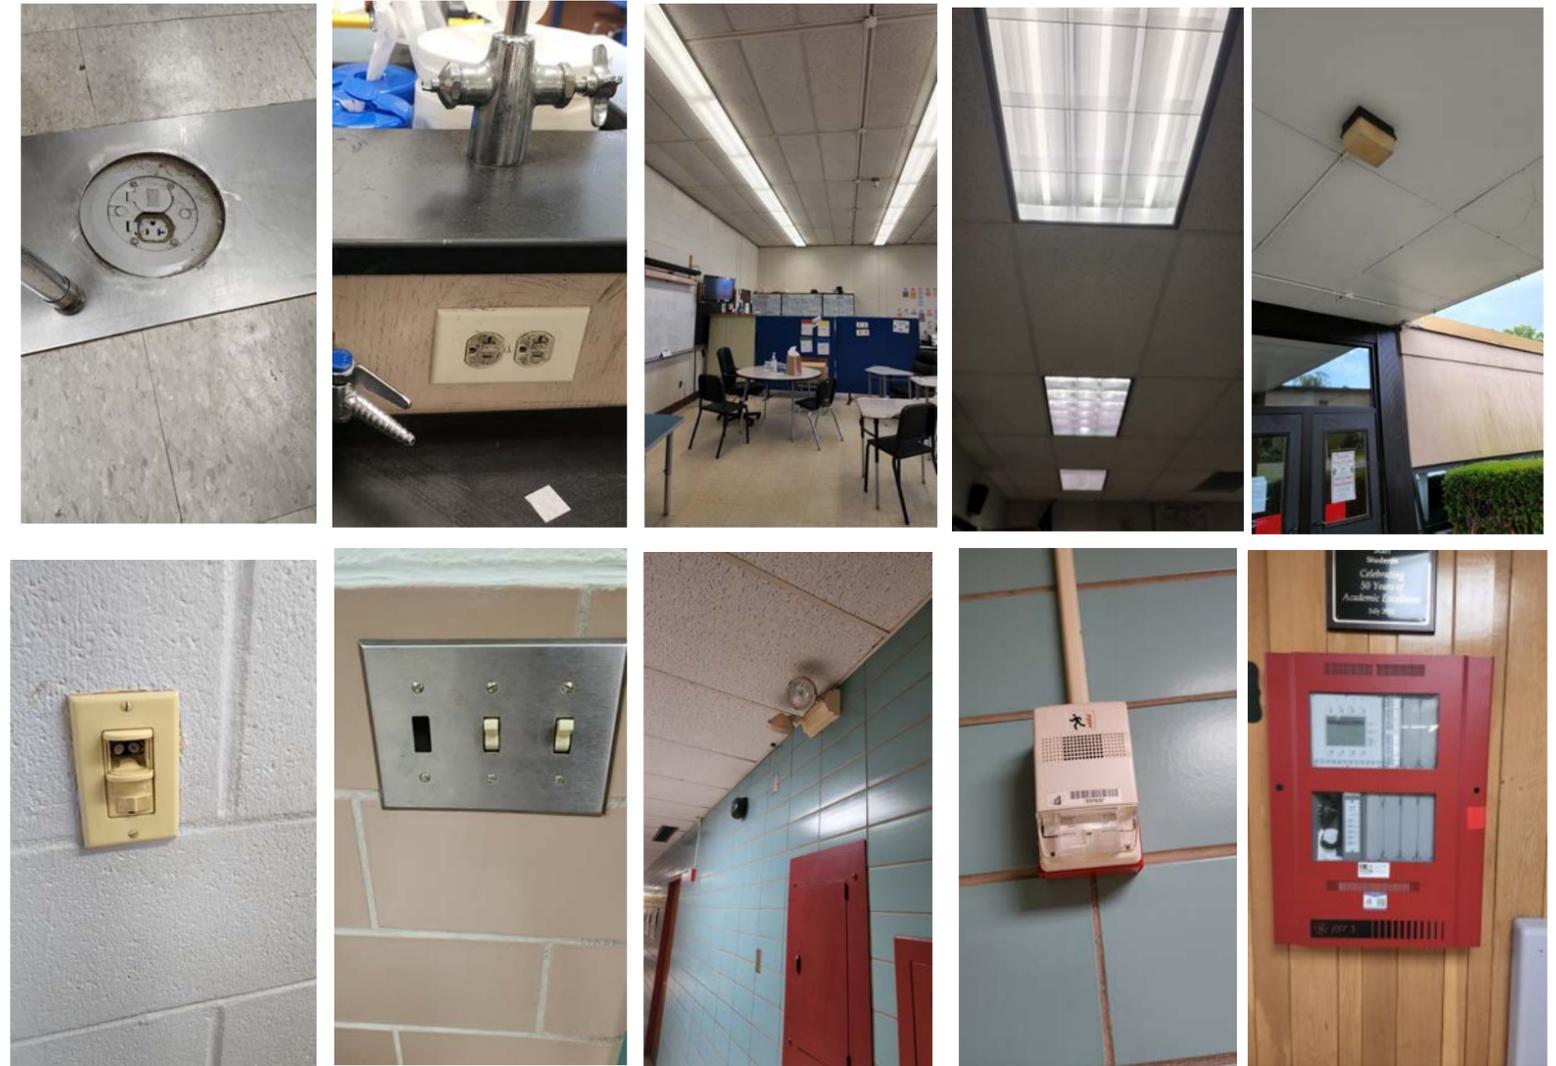
- All building areas have wall- and floor-mounted receptacles, the age and condition vary. Majority of receptacles are beyond their useful life. Typical classrooms have insufficient quantity of receptacles. Science classrooms have non-GFI outlets at counters with sinks (code violation). Some floor-mounted outlets are missing covers. Kitchen receptacles are non-GFI (code violation).

- Lighting system consists of surface-, recessed- and pendant-mounted lights, primarily with non-dimming T8 fluorescent lamps. Both gyms have high output non-dimmable T5 fluorescent lamps. In general, lighting illumination levels are adequate, however lighting fixtures are dated and have no means for adjusting the lighting levels accommodating different tasks. Exit signs with integral emergency light heads and emergency battery units are provided throughout, appear to be in fair condition. Exterior lights are operational, but old.

- Limited lighting controls are present, but not throughout the entire building – occupancy sensors were observed in a few classrooms and small rooms (some sensors are not operational). There are no daylight sensors or time controls. Lights in corridors are manually switched.

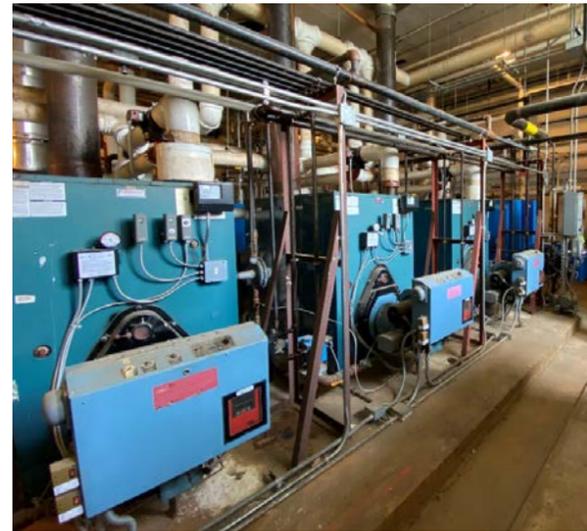
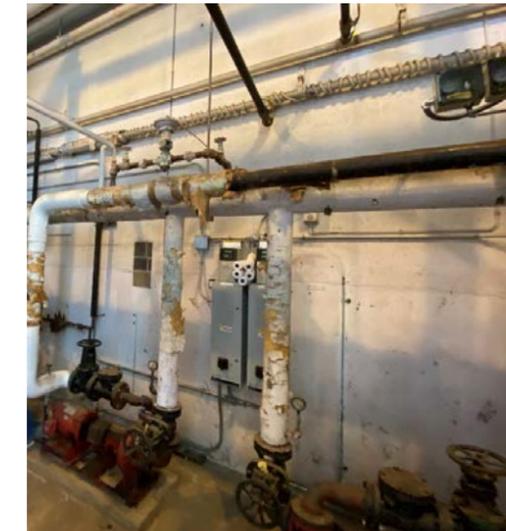
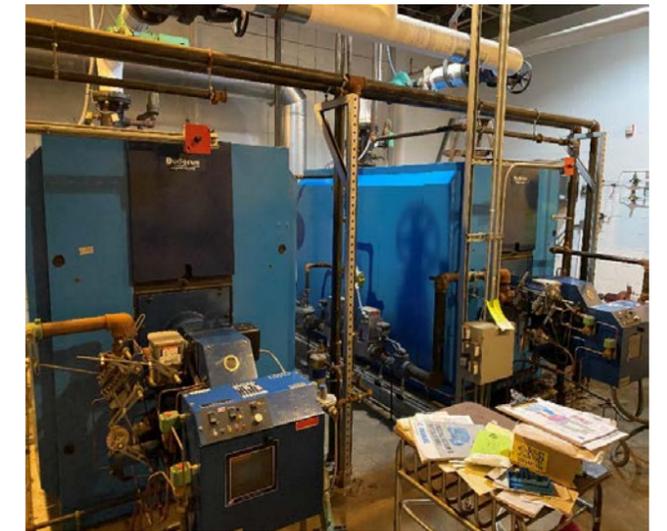
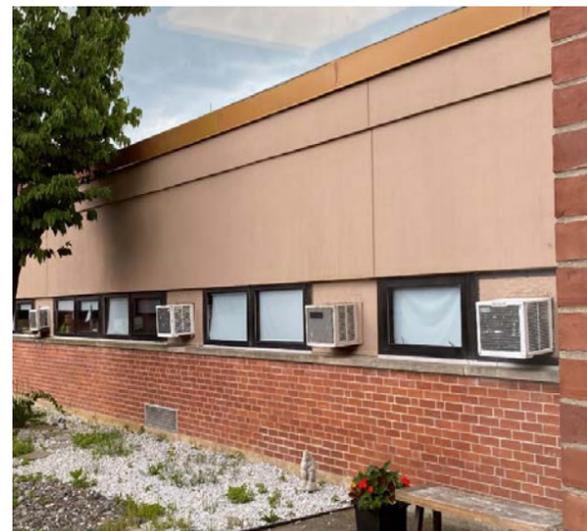
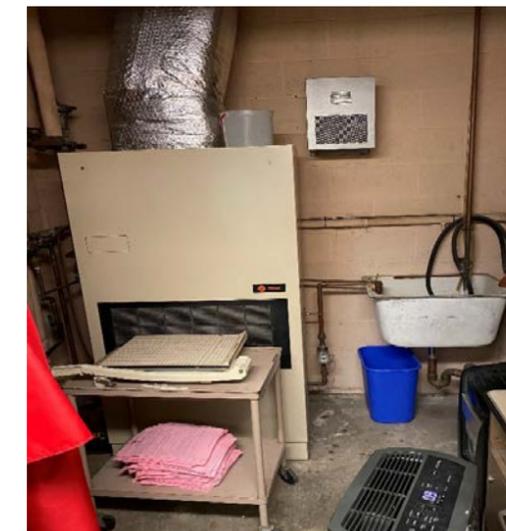
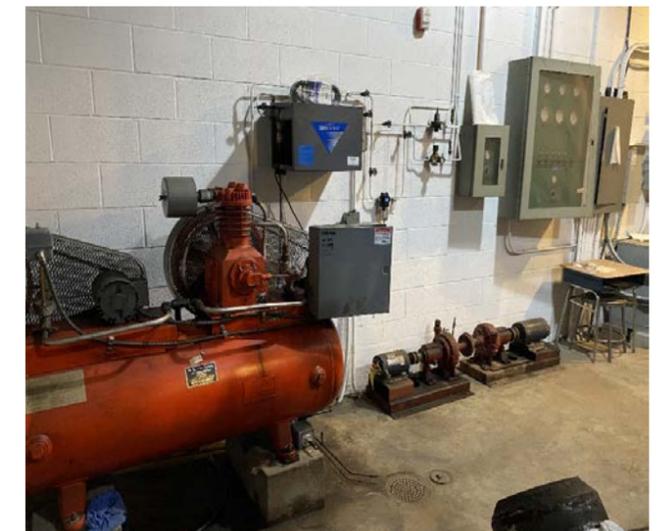
- Most of the HVAC equipment has exceeded its life expectancy.
- Although boilers are 10-14 years old, there is no central boiler plant or centralized heating hot water distribution.
- Hot water pumps and piping require replacement.
- Fuel oil in two underground tanks not used. Underground fuel oil piping and associated pumps – condition unknown.
- Window units, DX and/or water-cooled split systems require replacement.
- Other than select areas noted above, there is no air conditioning in the building.
- Pneumatic HVAC controls require replacement.

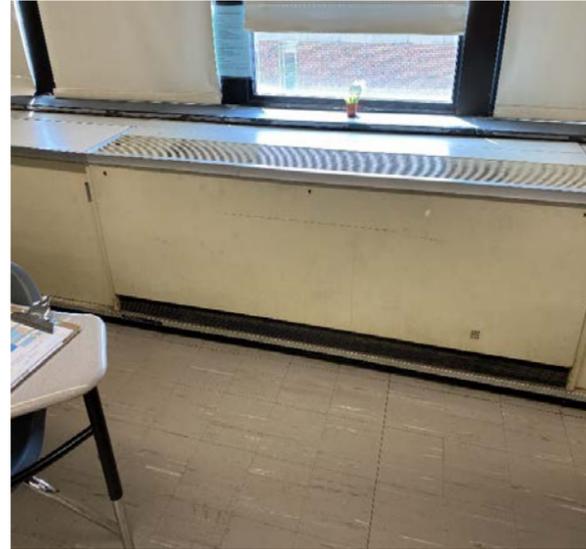
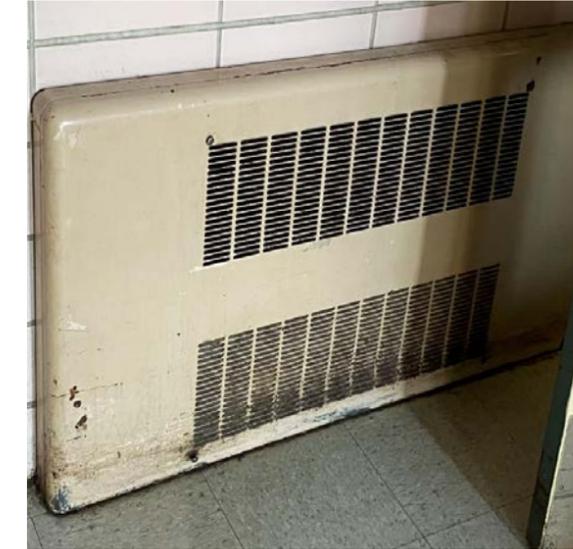
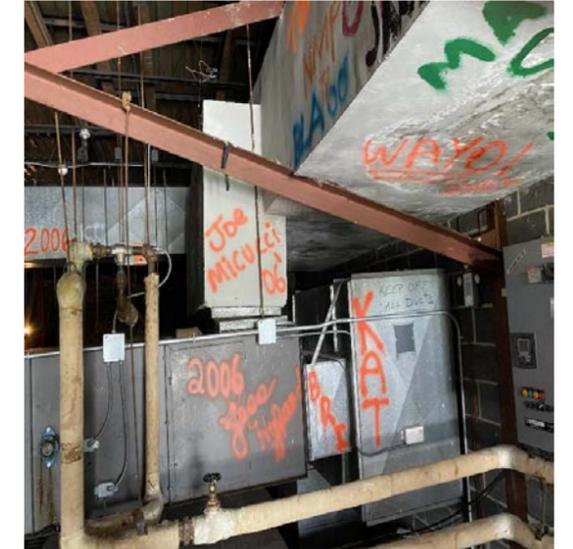
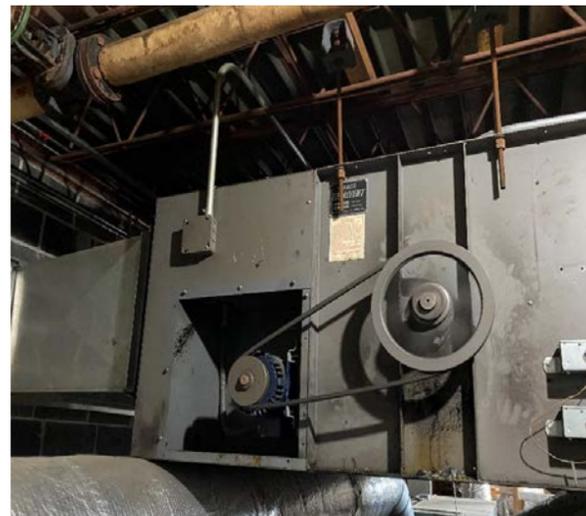
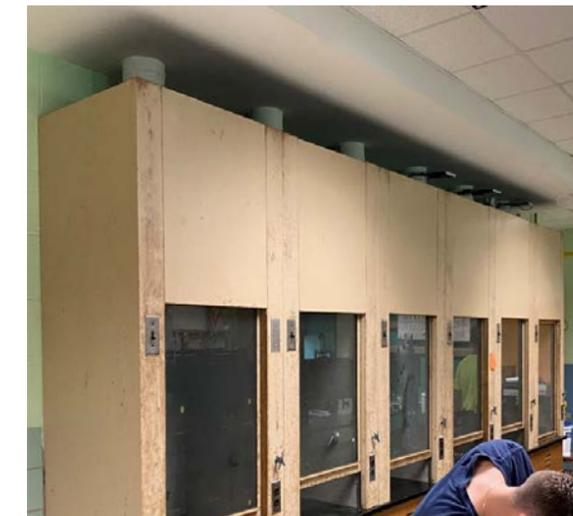
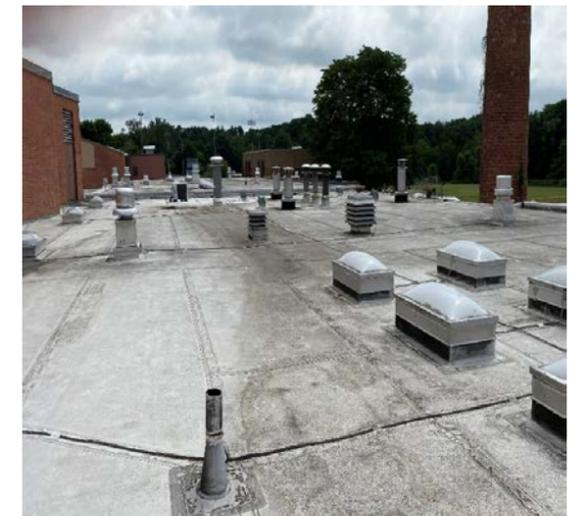
- Unit ventilators, associated hot water piping and accessories serving classrooms require replacement.
- Finned tube radiation, cabinet unit heaters and convectors require replacement.
- Air systems equipment, ductwork and associated components serving Auditorium, Large Gym, Small Gym, Pool, Cafeteria, Kitchen, and Locker Rooms require replacement.
- Fume hood and associated ductwork in Chemistry classroom require replacement.
- All HV units and exhaust fans require replacement.
