EVALUATION OF EXISTING CONDITIONS - SITE

East Longmeadow High School

Location: 180 Maple Street, East Longmeadow

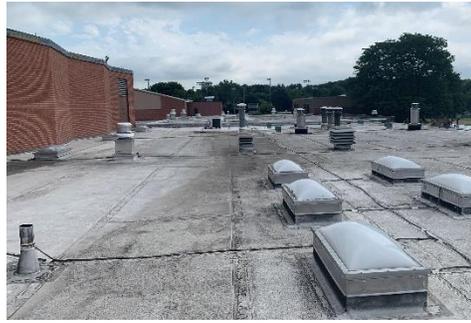
Roof: The roofs are primarily white membrane roofs in poor condition and beyond useful life. The school has a reported history of roof leaks. Insulation is inadequate to meet current requirements. Most roof areas are low slope with no parapet. All membrane roofs are not flashed up against adjacent walls sufficiently.

View of cafeteria roof showing membrane, original skylights, vents and lightning protection. Discoloration from frequent ponding.

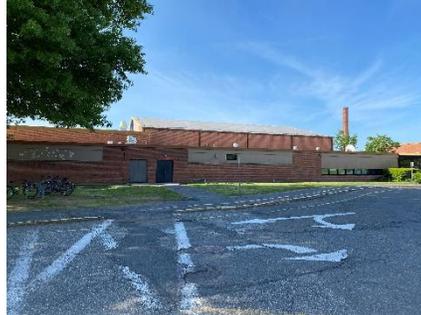
East elevation pool addition. Infilled panelized cement board cladding disintegrating above masonry. Window areas infilled with EIFS.

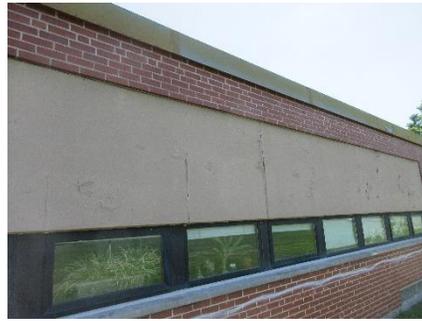
All window replacements date from the early 1980s. During an early 1980s energy upgrade, the window systems were removed and the opening filled with an EIFS (stucco) insulation system to improve energy performance. Smaller ribbon windows were installed. The EIFS is not in good shape. A significant quantity of skylights are also in poor shape and prone to leakage.

Classroom windows from exterior

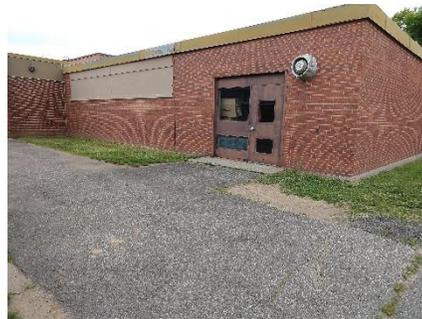
Most doors appear to be original metal and wood doors with no thermal breaks. All of these doors should be replaced.

Utility door at Locker Room

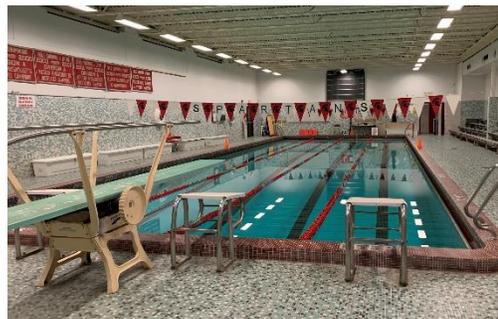
The existing PE wing is extremely worn. ELHS has significant requirements for PE participation and a broad range of athletic options. Additionally, the school contains a 4-lane pool that is accessible to the community after school hours. The complex of locker rooms, staff offices, storage rooms, weight rooms, and equipment rooms is poorly organized and in disrepair in part because of heavy use. The hazmat study notes significant quantities of hazmat material in the flooring and exterior cladding of this wing. The existing pool is in fair shape. The exposed steel open web joist supporting the roof should be more carefully inspected for rust given the high moisture content of the room and age of the pool. The mechanical space below shows persistent moisture leakage from piping systems.

Existing pool

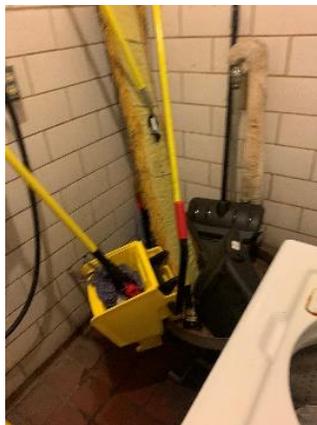
Janitorial Area: This room is congested and undersized. In the laundry area, floors have degraded and exposed piping and electrical conduit is unsanitary as it is difficult to access for cleaning and maintenance.

Limited space for organized housekeeping storage.

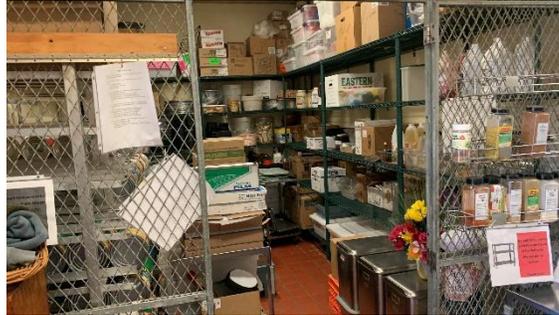
Dry Storage Area: Storage areas are minimal and food storage is shared with pots, pans and office equipment. Metal fencing with a gate separates the storage area. Metal fencing tends to accumulate dust and is unsanitary.

Dry food storage room with metal fencing, which is unsanitary.

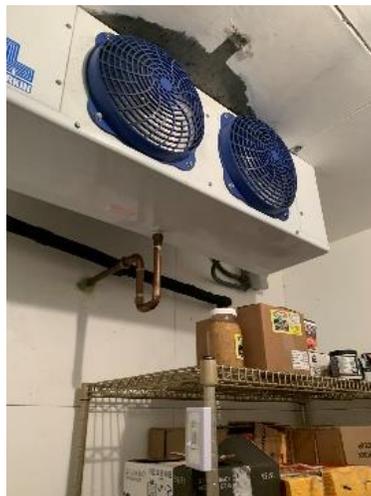
**Refrigerator/
Freezer Storage:** The walk-in refrigerator and freezer compartments are undersized for the current program and at times commodities or goods must be declined. By design, the freezer compartment is accessed through the refrigerated compartment, which extremely limits storage shelving. Some interior ceiling panels appear to be deteriorating.

Interior ceiling panels are degrading.

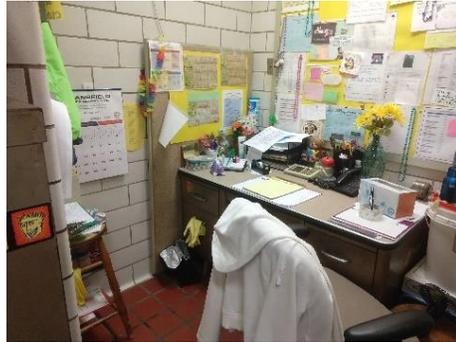
Food Service Office: This area is congested and extremely undersized for a staff of two (2), computer stations and multiples of required work items including file cabinets. This space is not A.D.A. accessible.

Office is congested and not A.D.A. compliant.

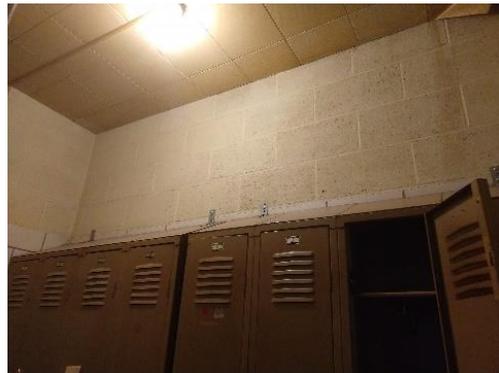
Poor lighting.

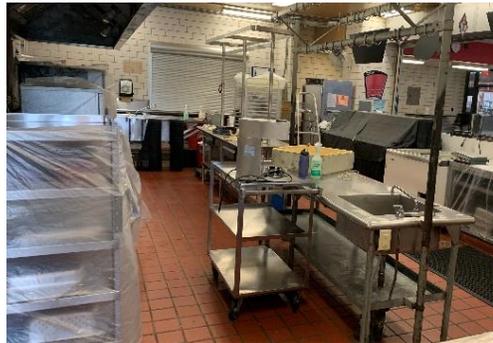
Preparation Areas: Understructures, utensil racks, pot & pan racks, etc. are constructed of inappropriate materials (galvanized steel or painted steel), which have degraded, are peeling and should be considered unsanitary. Wood-top tables are unsanitary because it is not possible to properly sanitize them. Arrangement of equipment is poor and inefficient as it relates to storage and cooking. There is an insufficient quantity of code-mandated hand sinks. There is only one (1) dedicated hand washing sink in the entire facility. There are no A.D.A. accessible work stations.

Understructures and utensil rack are constructed of inappropriate materials, degraded, and peeling. Unsanitary condition.

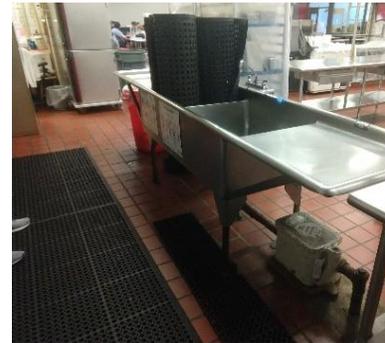
Floor surfaces are extremely slippery when wet or even damp. Rubber mats are used throughout to prevent falls. Unsanitary and hazardous to foot traffic.

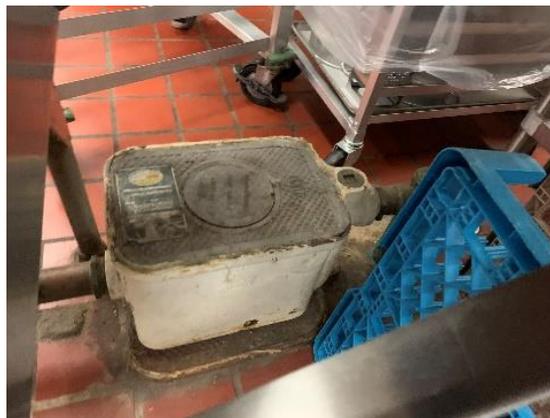
Flooring has degraded and exposed interceptor is unsanitary.

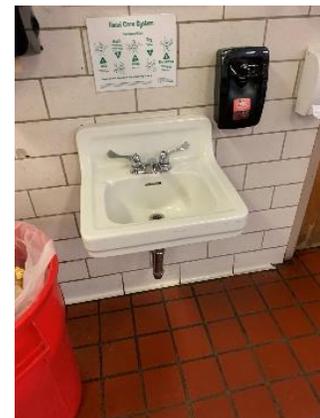
The only hand washing station in the entire facility.

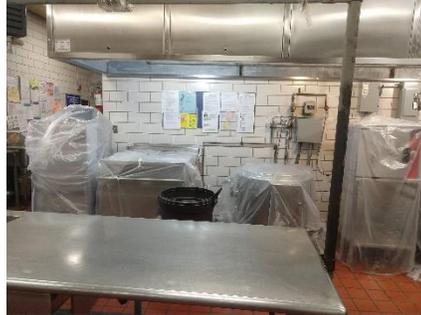
Cooking Equipment: Most equipment appears to be in fair condition; however, equipment is limited. There is no water capture in the floor for the steamer, kettle, and skillet. This situation poses a hazard to foot traffic. There is an inadequate number of floor drains to enhance housekeeping. Exposed piping, between and behind the cooking equipment, is unsanitary and difficult to access for cleaning and maintenance. Exhaust hood appears to be in fair condition.

Equipment is limited for the current program.

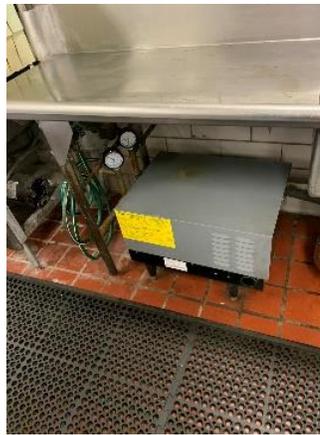
Floor surfaces are extremely slippery when wet or even damp. Rubber mats are used throughout to prevent falls. Unsanitary and hazardous to foot traffic.

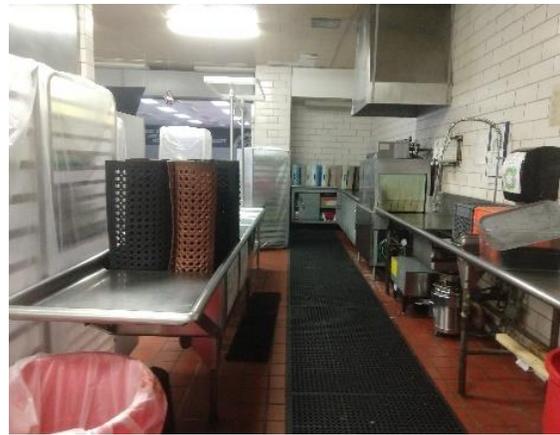
Some understructures are constructed of inappropriate materials. Degraded and peeling. Unsanitary condition.

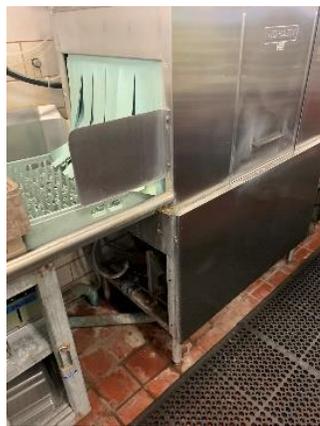
Considerable scale/lime buildup and flooring has degraded. Exposed piping. Unsanitary.

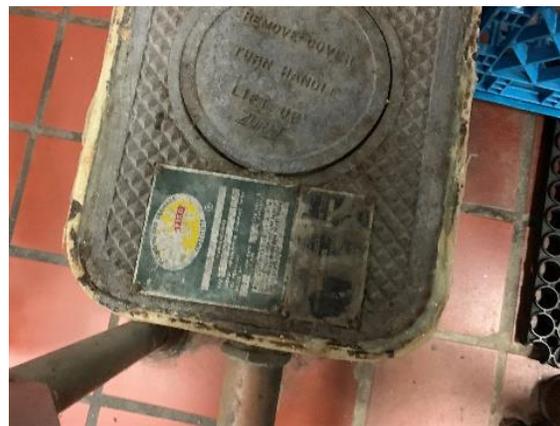
Flooring has degraded, and exposed interceptor is unsanitary.

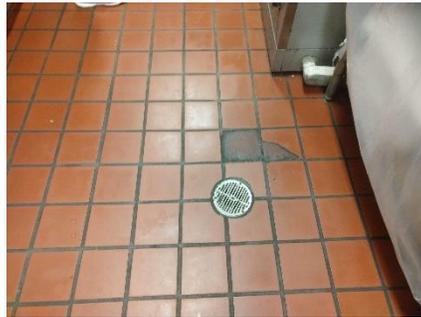
General Conditions: Exposed piping, electric conduit and duct work render some areas almost impossible to maintain as a sanitary environment. In some areas, wall surfaces, ceilings, and flooring have deteriorated and are in unsanitary condition. Fans are used to circulate air in warm weather. These fans tend to spread dust throughout the entire area. There are an inadequate number of floor drains to enhance housekeeping. Perforated ceiling panels are located in some areas. These panels are non-washable and therefore not code compliant. Some portions have degraded. Some light fixtures lack protective covers and therefore are not code compliant. Food service staff toilet is not handicap compliant.

In some areas, flooring is degraded.

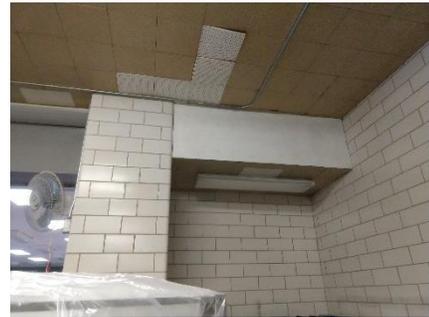
Exposed piping and degraded ceiling tiles are unsanitary.

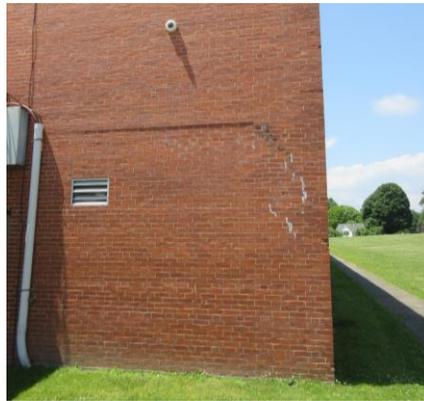
Photo 5 – Vertical crack in brick façade

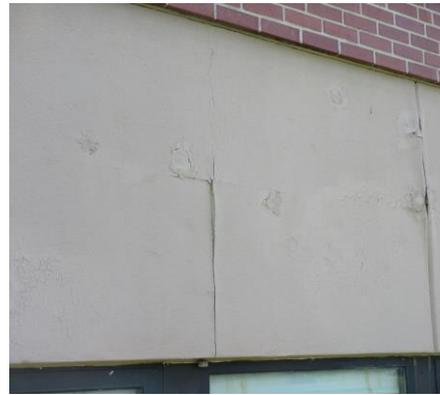
-The exterior side of some façade stucco shows delamination in multiple locations (Photo 6)

Photo 6 - Façade stucco deterioration

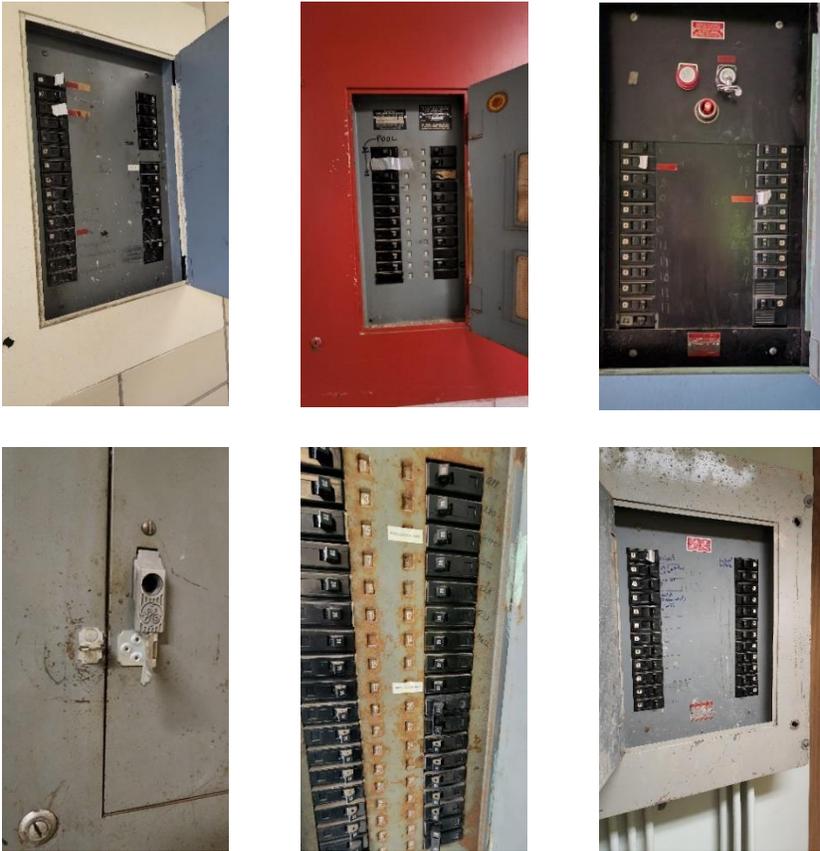
Examples of “older” panels in poor condition.

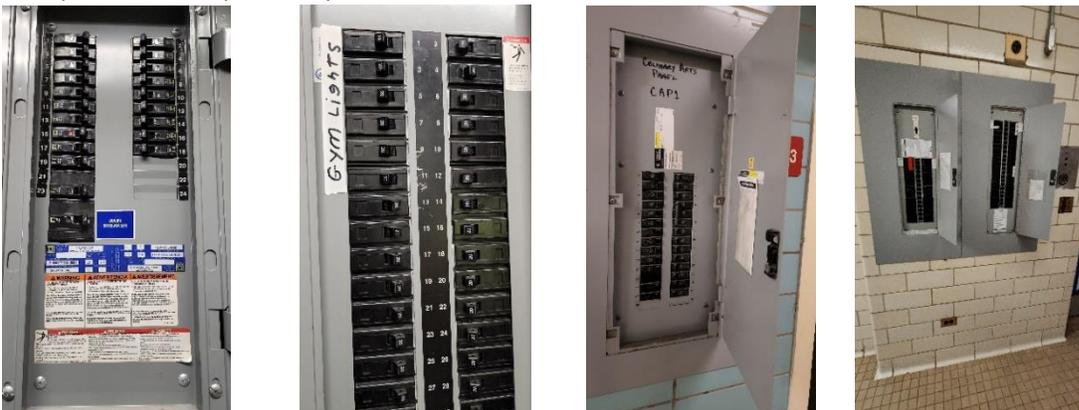
Examples of “older” panels in poor condition.

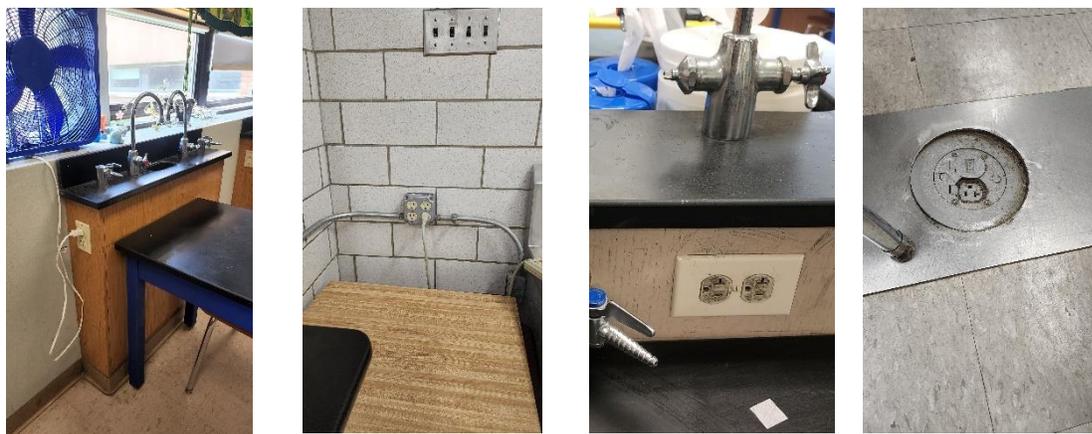
Branch wiring from “old” branch panels to “original” location of receptacles and lights (irrespective of whether the receptacles and lights have been replaced later) is beyond its useful life expectancy (usually about 40-50 years). Assumed that the majority of “old” receptacles would require replacement (if not replaced recently). A few receptacles in kitchen were observed as non-GFCI type (Code violation). A few receptacles in science classrooms near sinks were observed as non-GFCI type (Code violation). In general, the number of receptacles in classrooms and similar educational spaces found inadequate (or in inconvenient locations). A few floor boxes with receptacles were observed missing covers.

Examples of non-GFCI type receptacles and floor boxes with missing covers

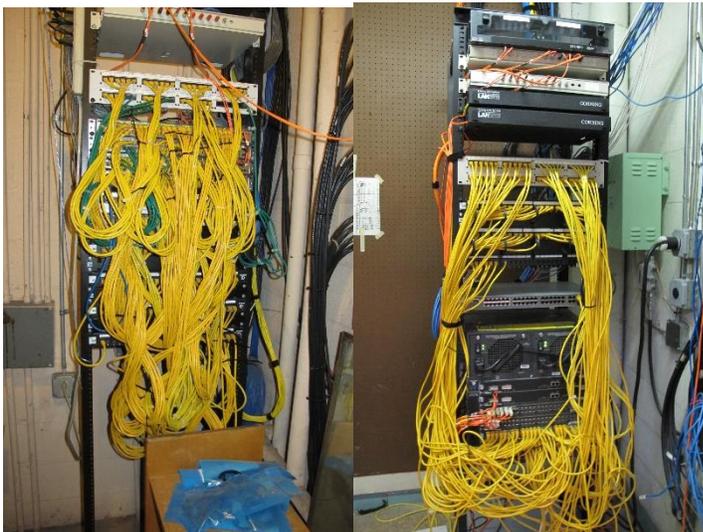
Examples of Network Equipment Racks in unsecured, unairconditioned spaces.

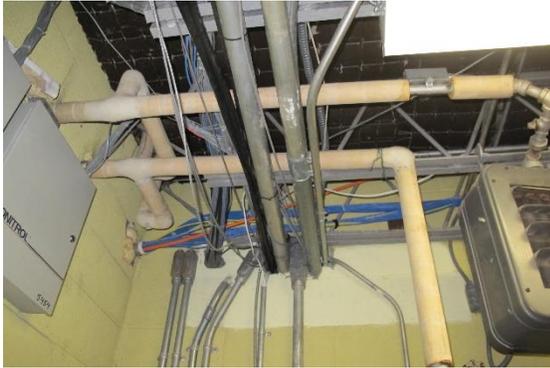
Example of improper telecommunications installation.

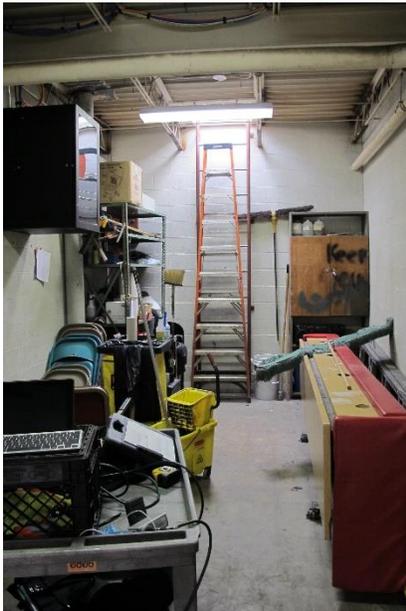
Upper Left: Example of Network Equipment Cabinet in unsecured, unairconditioned space.

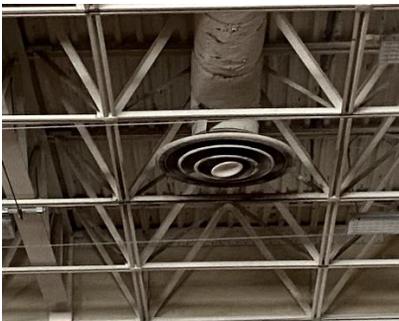
Damaged diffuser in Small Gym

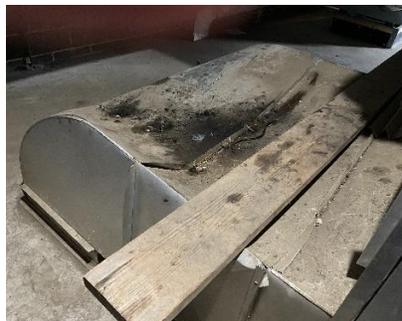
Damaged ductwork in penthouse serving Large Gym

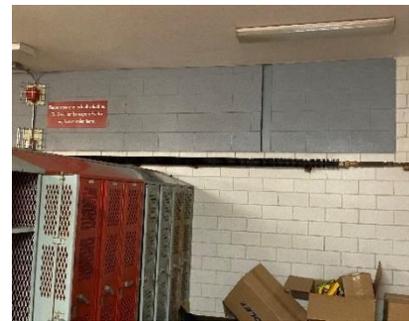
Bare finned tube element in Boys Locker Room

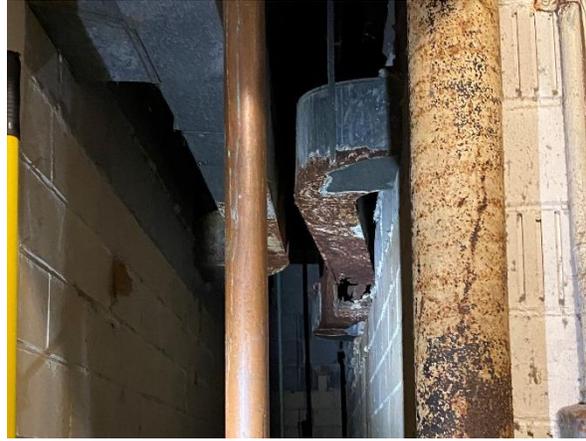
Toilet Room exhaust ducts rusted through

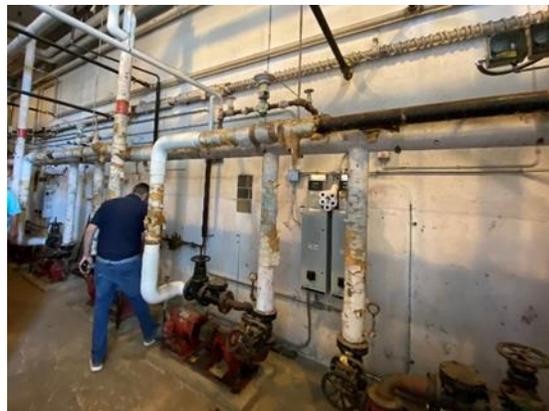
Original pumps, piping and insulation

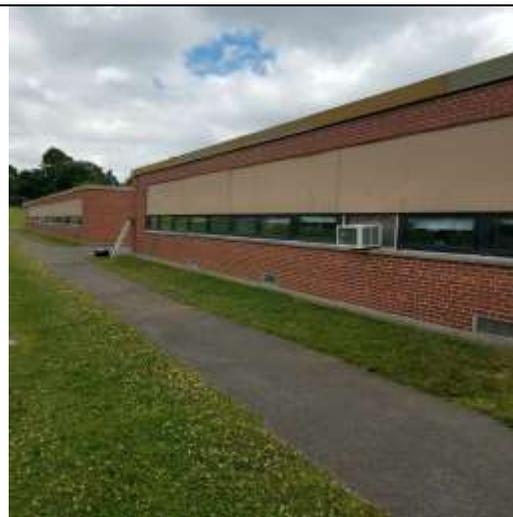
Bldg. E, asbestos black glazing

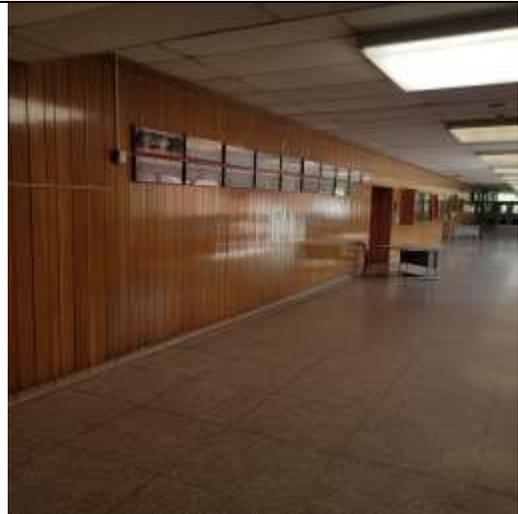
Wall panel glue, assumed asbestos

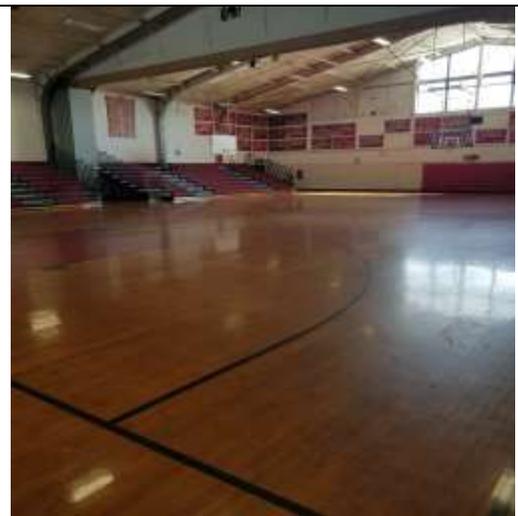
Main gym, older upper windows & assumed VB
