Senior Center

Town of East Longmeadow ADA Transition Plan

September 2025

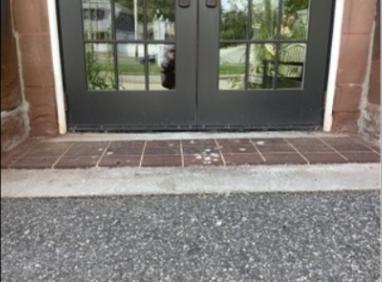
Level changes > 1/4"	.75"	Alter change in level to be 1/4" high max.	1	-	-
2	Gazebo	Ext.		Exterior Access Route	Walkway

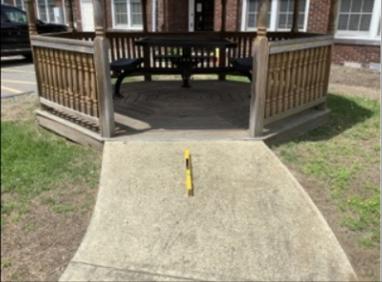
Cross slope > 1:50 (2.00%) Running slope > 1:20 (5.00%)	2.3% 12.6%	Reduce cross slope to be no steeper than 1:50 (2.00%). Reduce running slope to be no steeper than 1:20 (5.00%).	1	-	-
3	Gazebo	Ext.		Exterior Access Route	Exterior

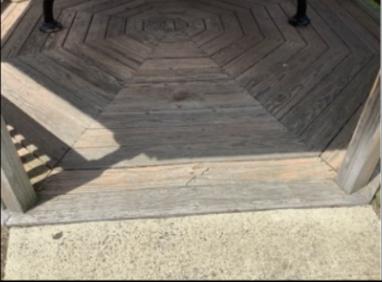
Route not maintained in operable working condition	-	Repair surface to ensure the accessible route is maintained in operable working condition.	1	-	-

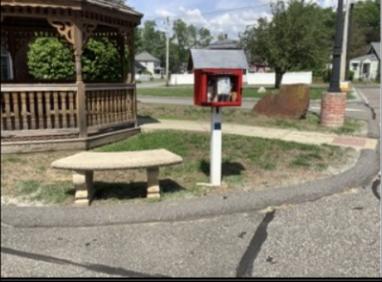
4	Near Check-In Entrance	Ext.		Exterior Access Route	Exterior

Accessible route not provided	-	Ensure an accessible route is provided to the little library or relocate the little library to an accessible route.	1	-	-
5	Picnic Area	Ext.		Exterior Access Route	Exterior

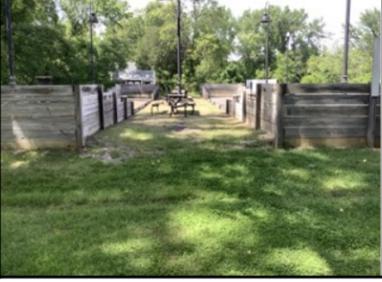
Accessible route not provided	-	Ensure an accessible route is provided to the picnic area.	1	-	-

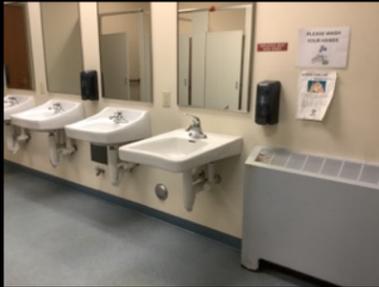
Clear floor space is not provided	-	Relocate the soap dispenser to maintain a 30" min. by 48" min. clear floor space. Recommendation also applies to the women's toilet room.	2	825	\$1K - \$5K
											1650	
26	Near Single-User Toilet Room	1		Operable Parts / Reach Range	Other

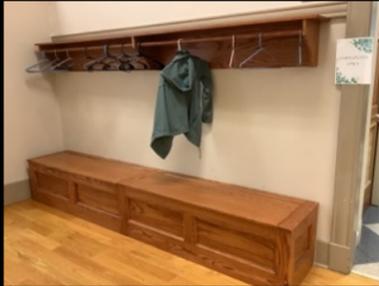
Clear floor space is not provided Reach < 15" or > 48"(forward/side approach)	- 65.5"	Provide an additional coat hook located no higher than 48" max. above the finished floor.	1	124	\$1 - \$500
											124	
27	Entrance Near Check-In	Ext.		Operable Parts / Reach Range	Equipment

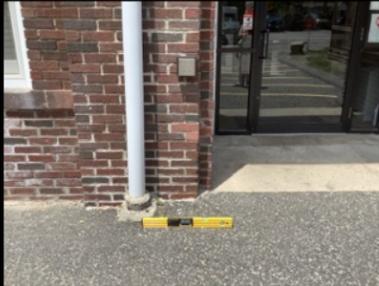
Element not on an accessible route Clear floor space is not provided	2.8% -	Ensure that the automatic door opener is located on an accessible route that is sloped no greater than 1:20 (5.00%). Ensure that the 30" by 48" clear floor space at the automatic the automatic door opener is sloped no more than 1:50 (2.00%) in all directions.	1	-	-

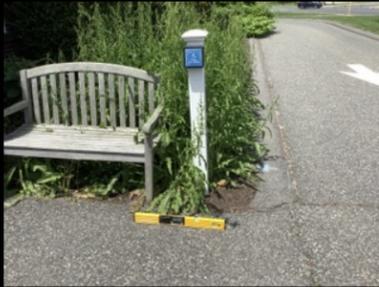
28	Entrance Near North Main Street (East Side)	Ext.		Operable Parts / Reach Range	Equipment

Element not on an accessible route Clear floor space is not provided Not compliant	6% - -	Ensure that the automatic door opener is located on an accessible route that is sloped no greater than 1:20 (5.00%). Ensure that the 30" by 48" clear floor space at the automatic the automatic door opener is sloped no more than 1:50 (2.00%) in all directions. Repair automatic door opener to ensure it is maintained in operable working condition.	1	-	-
29	Entrance Near Recreation Department	Ext.		Operable Parts / Reach Range	Equipment

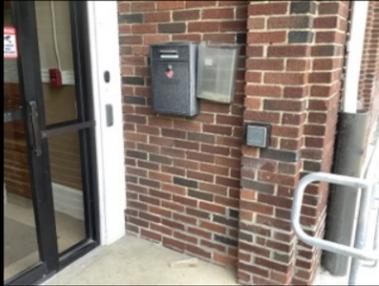
Reach < 15" or > 48"(forward/side approach)	55.75"	Relocate drop-box so that controls are no higher than 48" above the ground.	1	-	-

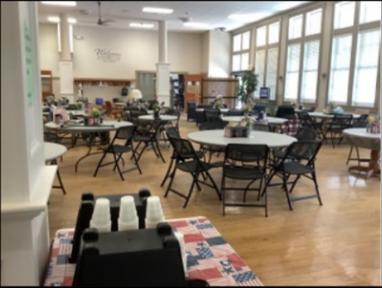
ID	Location	Floor	Room	Element	Type	Photo	Issues	Current Measure	Recommendations	Quantity	Price	Cost Estimation
Assembly Area												
30	Auditorium	1		Assembly Area	N/A

Assistive listening devices not provided	-	If audible communication is integral to the use of the space, provide an assistive listening system. Note: Cost provided is for a transmitter, receiver, ear speaker, neck loop and USB charger with a capacity of 100.	1	3621	\$1K - \$5K
											3621	
Picnic Tables												
31	Entrance Near Kitchen	Ext.		Picnic Tables	N/A

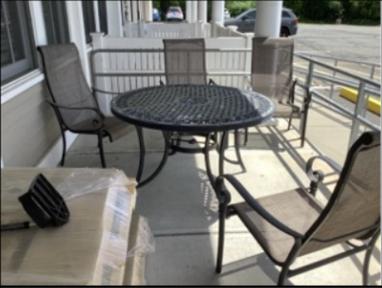
Picnic table not on an accessible route Knee clearance less than 19" deep	- -	Ensure that the picnic table is connected to an accessible route. Provide at least one picnic table with knee clearance that is 19" deep min.	1	2310	\$1K - \$5K
											2310	
32	Picnic Area	Ext.		Picnic Tables	N/A

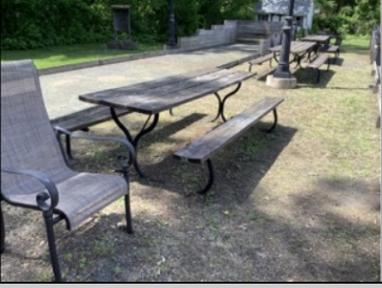
At least 5% accessible spaces not provided Picnic table not on an accessible route Knee clearance less than 19" deep	- - 9"	Ensure that at least 5% (minimum one) of picnic tables are accessible. Ensure that the picnic table is connected to an accessible route. Provide at least one picnic table with knee clearance that is 19" deep min.	1	2310	\$1K - \$5K

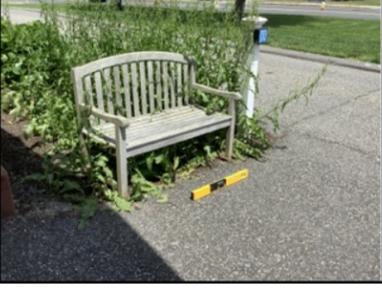
No accessible route to one bench in area	6.9%	Relocate one bench to an accessible route.	1	-	-

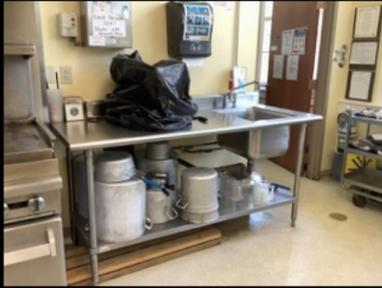
Knee/toe clearance not provided at sink Sink > 34" high Knee/toe clearance not provided at countertop	- -	Provide a sink with knee and toe clearance positioned for a forward approach. Lower sink to be no higher than 34" positioned for a forward approach. Ensure knee and toe clearance are provided for 15" wide min. at the countertop next to the cooktop.	1	5106	\$5K - \$10K
											5106	
35	Kitchen	1		Kitchens and Kitchenettes	N/A

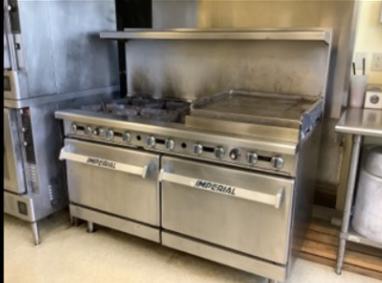
Knee/toe clearance not provided at cooktop	-	Provide a cooktop with knee and toe clearance positioned for a forward approach.	1	1650	\$1K - \$5K
											1650	
Toilet & Bathing Rooms												
Overall Access												
36	Women's Multi-User Toilet Room	1		Overall Access	Toilet Room

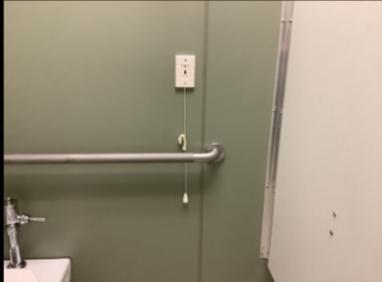
Element is not maintained in operable condition	-	Ensure the emergency pull cord is not tied so that it extends to within 12" of the floor. Recommendation also applies to the men's toilet room.	2	Labor	Labor

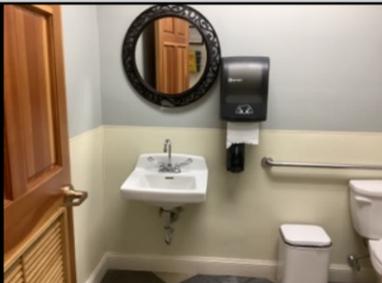
Plumbing underneath is exposed Mirror above lavatory w/reflective surface > 40"	- 52.25"	Insulate or otherwise configure pipes to prevent contact for at least one lavatory. Lower mirror so that the bottom surface is at 40" max. above the finished floor.	1	248 825	\$1K - \$5K
											1073

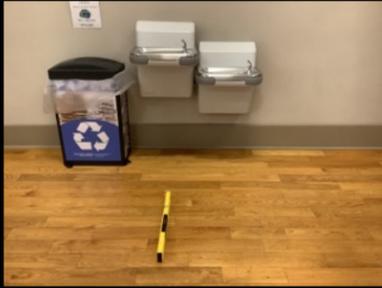
Fountain not on accessible route Clear floor space not provided	3% -	Ensure that the drinking fountain is located on an accessible route with a running slope that is no greater than 1:20 (5.00%). Ensure that the 30" by 48" clear floor space at the drinking fountain is sloped no more than 1:50 (2.00%) in all directions. .	1	6957	\$5K - \$10K
											6957	
Recreation Facilities												
Field												
43	Horseshoe	Ext.		Field	Other. . .

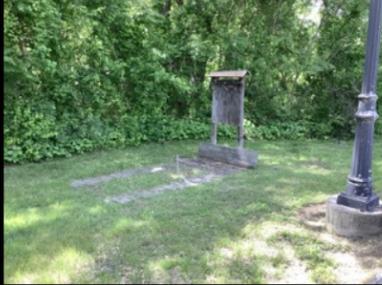
Field not connected to an accessible route	-	Provide a stable, firm and slip resistant accessible route to the horseshoe section.	1	-	-
Court												
44	Picnic Area	Ext.		Court	Other

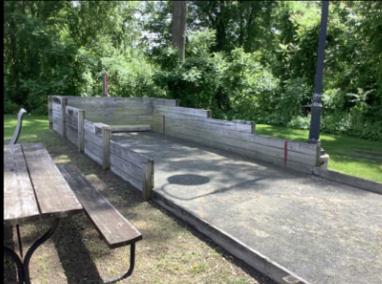
Court is not connected to an accessible route No accessible route between all areas of sport activity		Provide an accessible route to the boundary of sport activity at the court. Install an accessible route between all areas of sport activity.	1	-	-

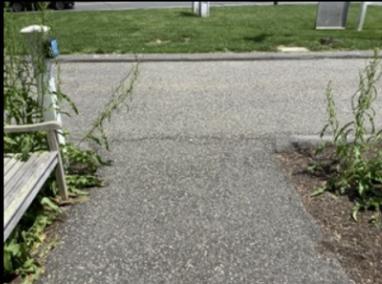
-	Recommend providing a detectable warning, to alert pedestrians that they are entering a vehicle entry/exit way.	1	-	-

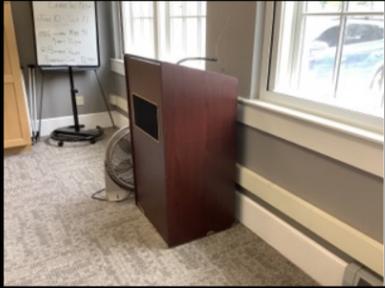
-	Recommend providing an adjustable height lectern with knee and toe clearance.	1	-	-
Operable Parts / Reach Range												
47	Entrance Near Check-In	Ext.		Operable Parts / Reach Range	Equipment

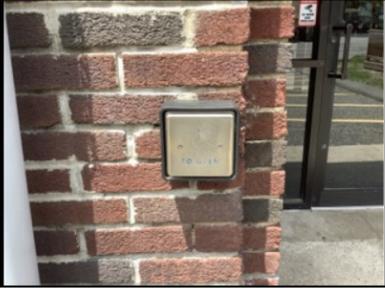
-	Recommend repainting the faded International Symbol of Accessibility (ISA) image on the automatic door opener control.	1	-	-
Visual Contrast												
48	Stairs to Auditorium Entrance Near Kitchen	Ext.		Visual Contrast	N/A

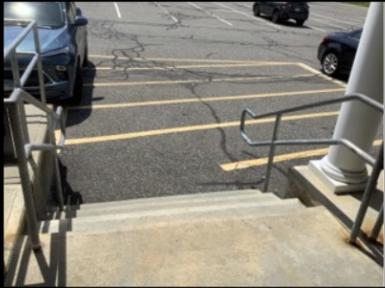
-	Recommend providing a contrasting color strip at each stair tread on the stair so that each tread is readily apparent when viewed in descent or ascent. Recommendation applies to all stairs that do not already have a contrasting color strip on each stair tread.	1	-	-
