Birchland Park Middle School

Town of East Longmeadow ADA Transition Plan

October 2025

Institute for Human Centered Design

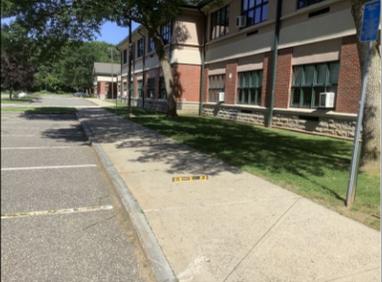
Cross slope > 1:50 (2.00%)	2.8%	Reduce cross slope to be no steeper than 1:50 (2.00%).	1	-	-
2	Along East Softball Field	Ext.	-	Exterior Access Route	Walkway

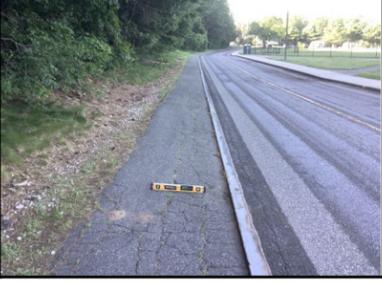
Cross slope > 1:50 (2.00%) Route not maintained in operable working condition	8%	Reduce cross slope to be no steeper than 1:50 (2.00%). Repair cracked openings in the surface to ensure the accessible route is maintained in operable working condition.	1	-	-

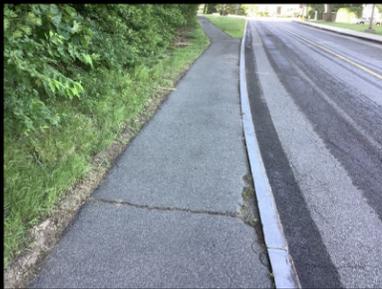
ID	Location	Floor	Room	Element	Type	Photo	Issues	Current Measure	Recommendations	Quantity	Price	Cost Estimation
6	Along Elmcrest Street/By Hanward Hill	Ext.	-	Exterior Access Route	Sidewalk

Surface openings > 1/2"	1"	Ensure that the surface opening is no greater than 1/2" max.	1	-	-
7	Along Elmcrest Street/By Hanward Hill	Ext.	-	Exterior Access Route	Sidewalk

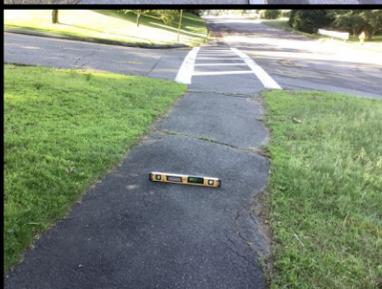
Cross slope > 1:50 (2.00%) Route not maintained in operable working condition	4.5%	Reduce cross slope to be no steeper than 1:50 (2.00%). Repair cracked openings in the surface to ensure the accessible route is maintained in operable working condition.	1	-	-

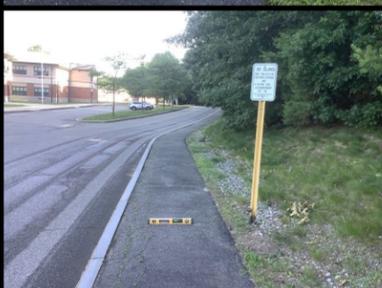
Cross slope > 1:50 (2.00%) Route not maintained in operable working condition	5.1%	Reduce cross slope to be no steeper than 1:50 (2.00%). Repair cracked openings in the surface to ensure the accessible route is maintained in operable working condition.	1	-	-

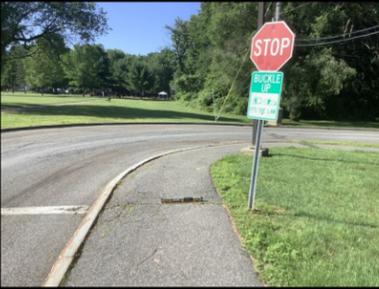
ID	Location	Floor	Room	Element	Type	Photo	Issues	Current Measure	Recommendations	Quantity	Price	Cost Estimation
16	Along Elmcrest Street/To Elm Street	Ext.	-	Exterior Access Route	Sidewalk

Cross slope > 1:50 (2.00%) Route not maintained in operable working condition	3.1%	Reduce cross slope to be no steeper than 1:50 (2.00%). Repair cracked openings in the surface to ensure the accessible route is maintained in operable working condition.	1	-	-
17	Along Elmcrest Street/To Elm Street/By East Softball Field	Ext.	-	Exterior Access Route	Sidewalk

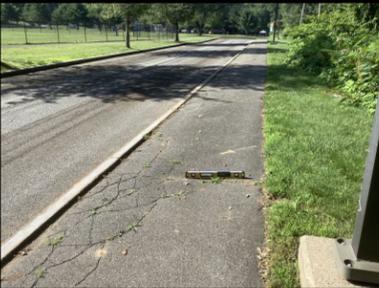
Cross slope > 1:50 (2.00%) Route not maintained in operable working condition	6.2% -	Reduce cross slope to be no steeper than 1:50 (2.00%). Repair cracked openings in the surface to ensure the accessible route is maintained in operable working condition.	1	-	-
18	Along Elmcrest Street/To Elm Street/By East Softball Field	Ext.	-	Exterior Access Route	Sidewalk

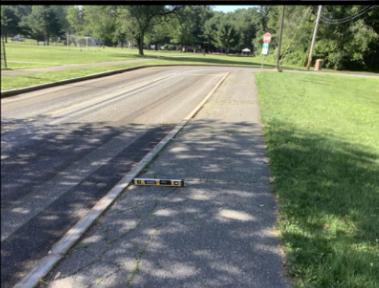
Cross slope > 1:50 (2.00%) Route not maintained in operable working condition	7.9%	Reduce cross slope to be no steeper than 1:50 (2.00%). Repair cracked openings in the surface to ensure the accessible route is maintained in operable working condition.	1	-	-

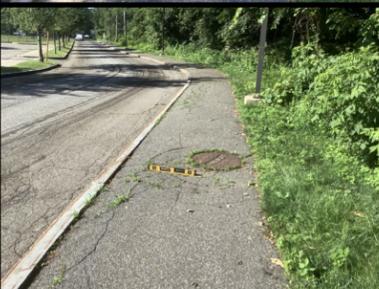
Cross slope > 1:50 (2.00%) Level changes > 1/4" Vertical clearance < 80" above ground	4.7% 0.5" 62"	Reduce cross slope to be no steeper than 1:50 (2.00%). Alter change in level to be 1/4" high max. Trim and maintain low hanging tree branches so they are 80" min. above the ground.	1	-	-
20	Along Elmcrest Street/To Elm Street/By Parking Lot South of Building	Ext.	-	Exterior Access Route	Sidewalk

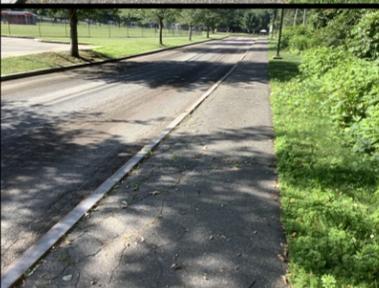
Route not maintained in operable working condition	-	Repair cracked openings in the surface to ensure the accessible route is maintained in operable working condition.	1	-	-

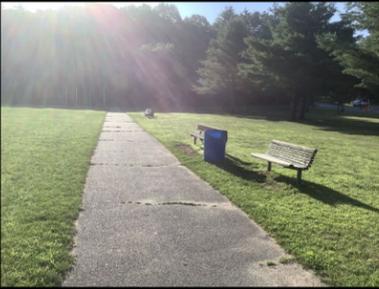
ID	Location	Floor	Room	Element	Type	Photo	Issues	Current Measure	Recommendations	Quantity	Price	Cost Estimation
21	Along South Side of Soccer Field	Ext.	-	Exterior Access Route	Walkway

Route not maintained in operable working condition Accessible route not provided	- -	Repair cracked openings in the surface to ensure the accessible route is maintained in operable working condition. Ensure an accessible route is provided to the trash barrel.	1	-	-
22	Along Southwest Corner of Soccer Field	Ext.	-	Exterior Access Route	Walkway

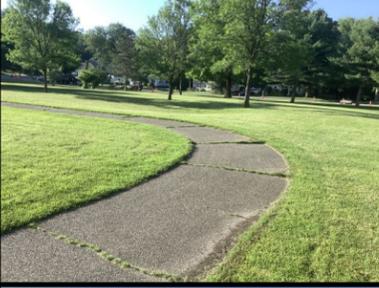
Route not maintained in operable working condition	-	Repair cracked openings in the surface to ensure the accessible route is maintained in operable working condition.	1	-	-
23	Along West Softball Field	Ext.	-	Exterior Access Route	Walkway

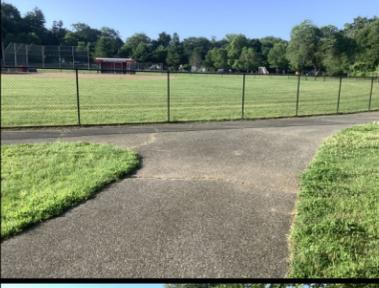
Surface openings > 1/2"	2"	Ensure that the surface opening is no greater than 1/2" max.	1	-	-
24	Along West Softball Field	Ext.	-	Exterior Access Route	Walkway

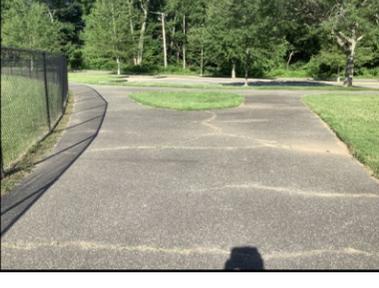
Surface is not stable, firm, and slip-resistant Route not maintained in operable working condition	- -	Remove all loose dirt and gravel surface. Repair cracked openings in the surface to ensure the accessible route is maintained in operable working condition.	1	-	-

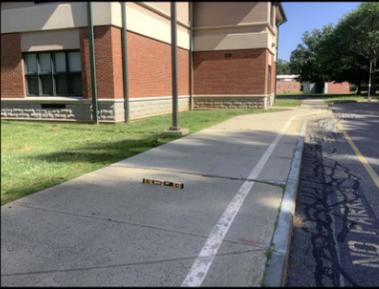
ID	Location	Floor	Room	Element	Type	Photo	Issues	Current Measure	Recommendations	Quantity	Price	Cost Estimation
26	By Main Entrance - East Side/ Parent Drop-Off	Ext.	-	Exterior Access Route	Sidewalk

Surface openings > 1/2" Cross slope > 1:50 (2.00%)	1" 3.2%	Ensure that the surface opening is no greater than 1/2" max. Reduce cross slope to be no steeper than 1:50 (2.00%).	1	-	-
27	By Northeast Corner of Building	Ext.	-	Exterior Access Route	Walkway

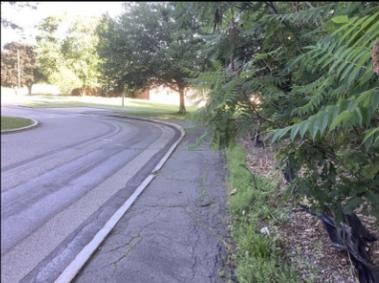
Obstructed by protruding objects Route not maintained in operable working condition		Trim and maintain low hanging tree branches so they are 80" min. above the ground. Repair cracked openings in the surface to ensure the accessible route is maintained in operable working condition.	1	-	-

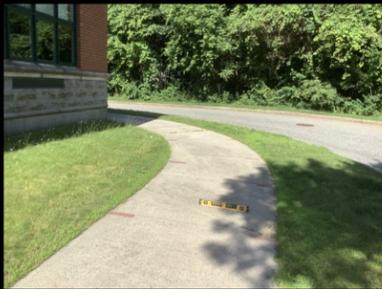
ID	Location	Floor	Room	Element	Type	Photo	Issues	Current Measure	Recommendations	Quantity	Price	Cost Estimation
31	By Northwest Corner of Building	Ext.	-	Exterior Access Route	Sidewalk

Cross slope > 1:50 (2.00%)	2.7%	Reduce cross slope to be no steeper than 1:50 (2.00%).	1	-	-
32	By Parking Lot East of Building	Ext.	-	Exterior Access Route	Sidewalk

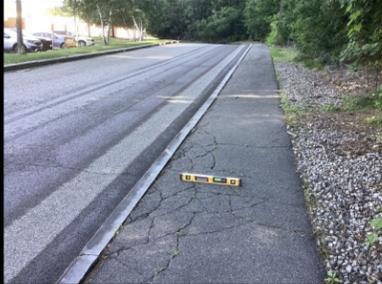
Cross slope > 1:50 (2.00%) Route not maintained in operable working condition	5.7%	Reduce cross slope to be no steeper than 1:50 (2.00%). Repair cracked openings in the surface to ensure the accessible route is maintained in operable working condition.	1	-	-
33	By Parking Lot North of Building	Ext.	-	Exterior Access Route	Sidewalk

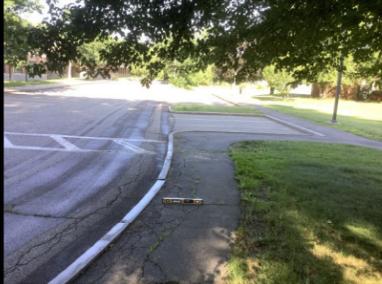
Cross slope > 1:50 (2.00%) Vertical clearance < 80" above ground	6.8% 73"	Reduce cross slope to be no steeper than 1:50 (2.00%). Trim and maintain low hanging tree branches so they are 80" min. above the ground.	1	-	-

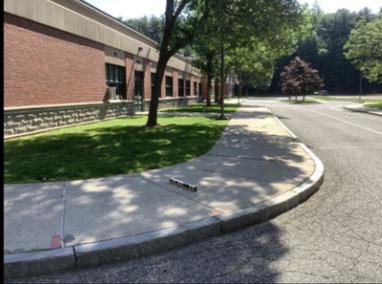
Cross slope > 1:50 (2.00%)	3%	Reduce cross slope to be no steeper than 1:50 (2.00%).	1	-	-

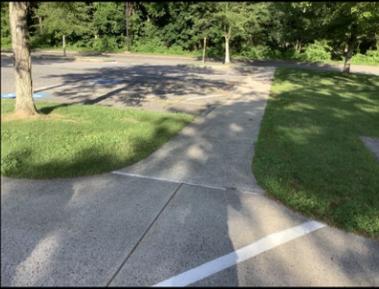
ID	Location	Floor	Room	Element	Type	Photo	Issues	Current Measure	Recommendations	Quantity	Price	Cost Estimation
46	Parking Lot South of Building/By Northwest Corner of Parking Lot	Ext.	-	Exterior Access Route	Walkway

Level changes > 1/4"	1"	Alter change in level to be 1/4" high max.	1	-	-
47	Portable Toilet by Northeast Corner of Soccer Field	Ext.	-	Exterior Access Route	Walkway

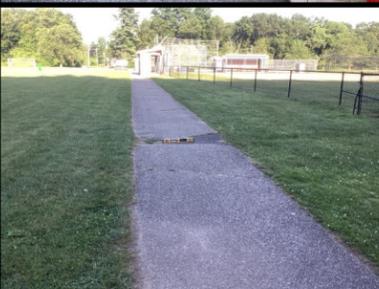
Cross slope > 1:50 (2.00%) Route not maintained in operable working condition	5.1% -	Reduce cross slope to be no steeper than 1:50 (2.00%). Repair cracked openings in the surface to ensure the accessible route is maintained in operable working condition.	1	-	-

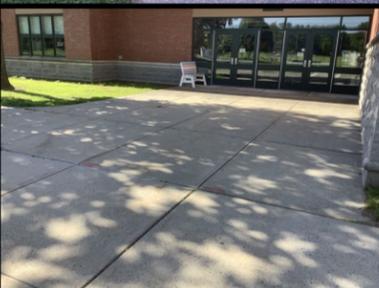
Surface openings > 1/2"	1"	Ensure that the surface opening is no greater than 1/2" max.	1	-	-

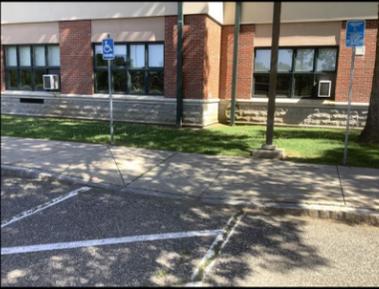
ID	Location	Floor	Room	Element	Type	Photo	Issues	Current Measure	Recommendations	Quantity	Price	Cost Estimation
56	Accessible Parking by Secondary Entrance - South Side/ Bus Drop-Off	Ext.	-	Curb Ramp	Blended Transition

Running slope is > 1:12 (8.33%) Transition from curb ramp to street not flush Curb ramp flares > 1:12 (8.33%) (if no landing)	8.7% 1" 8.7%	Reduce running slope to be no steeper than 1:12 (8.33%). Ensure transition from curb ramp to street is flush or free of changes in level. Reduce slope at curb ramp flares to be no steeper than 1:12 (8.33%).	1	-	-
57	Along Elmcrest Street/By Southwest Corner of Building	Ext.	-	Curb Ramp	Blended Transition

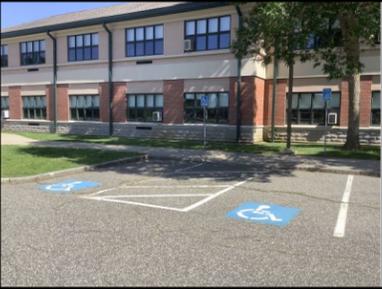
ID	Location	Floor	Room	Element	Type	Photo	Issues	Current Measure	Recommendations	Quantity	Price	Cost Estimation
76	Accessible Parking by Secondary Entrance - South Side/ Bus Drop-Off	Ext.	-	Off-Street Parking Lot or Garage	Visitor

Sign bottom < 60" above finished grade	84"	Locate sign with the bottom of the sign 60" above the ground. Locate sign with the top of the sign 96" above the ground. Recommendation applies to all accessible parking designation signage with a similar issue.	1	Labor	Labor
77	By Main Entrance - East Side/ Parent Drop-Off	Ext.	-	Off-Street Parking Lot or Garage	Visitor

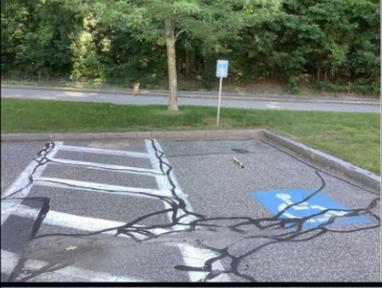
Running or cross slope at space > 1:50 (2.00%) Running or cross slope at access aisle > 1:50 (2.00%) Sign bottom < 60" above finished grade	5.2% 4.4% 63"	Reduce running or cross slope to be no steeper than 1:50 (2.00%). Reduce running or cross slope to be no steeper than 1:50 (2.00%). Locate sign with the bottom of the sign 60" above the ground.	1	-	-

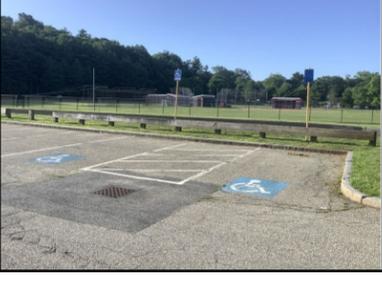
Running or cross slope at space > 1:50 (2.00%) Sign top > 96" above finished grade	3% 98"	Reduce running or cross slope to be no steeper than 1:50 (2.00%). Locate sign with the top of the sign 96" above the ground.	1	Labor	Labor

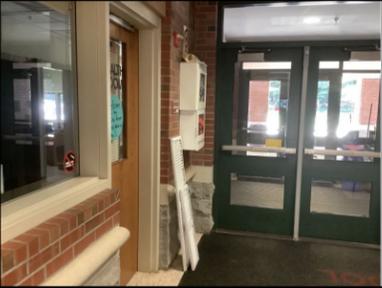
ID	Location	Floor	Room	Element	Type	Photo	Issues	Current Measure	Recommendations	Quantity	Price	Cost Estimation
Interior Access Route												
86	By Main Exit - East Side/ Parent Drop-Off	1	-	Interior Access Route	N/A

Obstructed by protruding objects	7.5"	Provide a cane-detectable barrier such as a railing underneath the defibrillator located 27" max. above the finished floor. Recommendation applies to all defibrillators with a similar issue. Note: Unit cost is provided for one instance of this repetitive item.	1	657	\$500 - \$1K
87	By Main Exit - East Side/ Parent Drop-Off	1	-	Interior Access Route	N/A

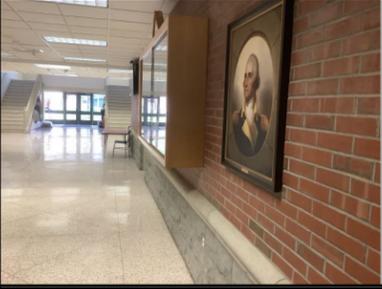
Obstructed by protruding objects	13"	Provide a cane-detectable barrier such as a railing underneath the display box located 27" max. above the finished floor.	1	657	\$500 - \$1K
88	Cafetorium	1	-	Interior Access Route	N/A

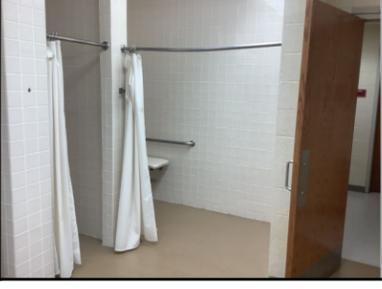
Vertical clearance < 80" above finished floor	75.25"	Relocate the curtain rod so that the bottom edge of the rod is located 80" min. above the finished floor.	1	1320	\$1K - \$5K
											1320

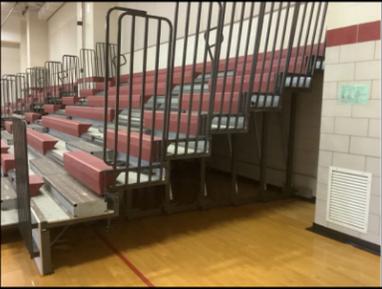
ID	Location	Floor	Room	Element	Type	Photo	Issues	Current Measure	Recommendations	Quantity	Price	Cost Estimation
91	Gymnasium	1	-	Interior Access Route	N/A

Vertical clearance < 80" above finished floor		Provide a cane-detectable barrier underneath bleachers.	1	1584	\$1K - \$5K
											1584	
92	Main Office	1	-	Interior Access Route	N/A

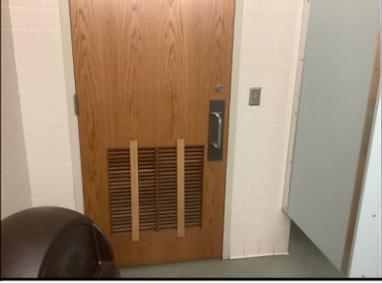
Maneuvering clearance(s) not provided	16.5"	Provide an automatic door opener.	1	9900	\$5K - \$10K
											9900

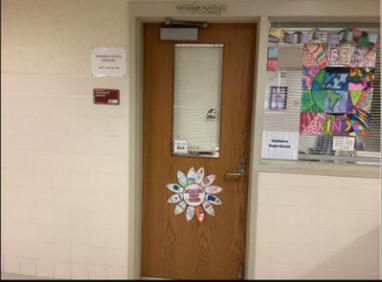
ID	Location	Floor	Room	Element	Type	Photo	Issues	Current Measure	Recommendations	Quantity	Price	Cost Estimation
96	Guidance Office	1	137	Doors, Doorways, & Gates	Meeting Room

Door requires > 5 lbs. of force to open	10 lbs.	Ensure that door opening pressure is monitored and kept in compliance at all doors by maintenance staff every 6 months. Recommendation applies to all interior doors with a similar issue.	1	Labor	Labor
97	Secondary Exit - North Side/ Accessible Drop-Off	1	-	Doors, Doorways, & Gates	Emergency Egress

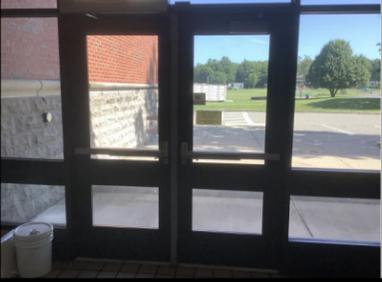
Exterior door requires > 15 lbs. of force to open	30 lbs.	Adjust closers so doors do not require more than 15 pounds of force to open. Recommendation applies to all exterior doors with a similar issue.	1	Labor	Labor
98	Television Classroom	1	126	Doors, Doorways, & Gates	Classroom

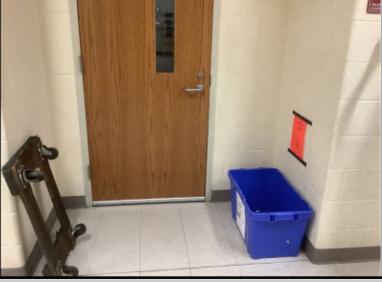
Maneuvering clearance(s) not maintained	-	Relocate the recycling bin to maintain the required maneuvering clearance on the latch side of the door. Ensure that maintenance staff is aware that the maneuvering clearance at doors should be kept clear at all times. Recommendation applies to all doors with a similar issue.	1	Labor	Labor

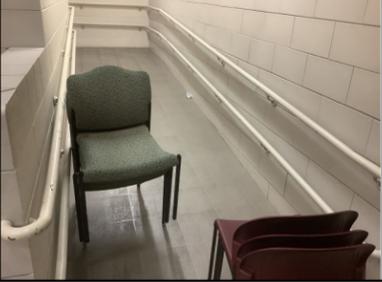
Not maintained in operable working condition	-	Relocate stored items to ensure the ramp is kept clear at all times and maintained in operable working condition.	1	Labor	Labor
Stairways												
100	Cafetorium - to Stage	1	-	Stairways	Egress

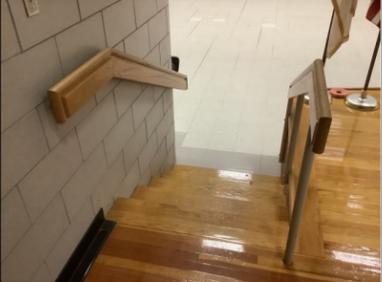
Handrails lack a compliant cross section	5.5"	Provide handrails with 1 1/4" - 2" circular cross sections.	1	-	-

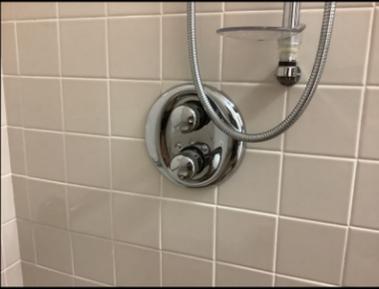
Not compliant	-	Provide shower controls that can be operable with one hand and not require tight grasping, pinching, or twisting of the wrist. Recommendation also applies to the girls' locker room transfer shower.	2	-	-
117	Boys' Locker Room - Transfer Shower	1	-	Operable Parts / Reach Range	Shower Hose Height-Adjustor

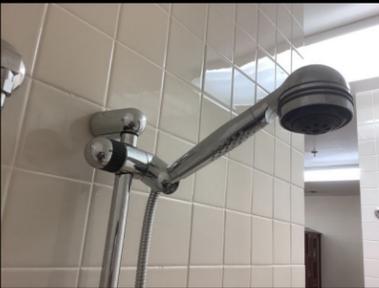
Not compliant	-	Provide a shower hose height-adjustor that can be operable with one hand and not require tight grasping, pinching, or twisting of the wrist. Recommendation also applies to the girls' locker room transfer shower.	2	-	-
118	By Main Exit - East Side/ Parent Drop-Off	1	-	Operable Parts / Reach Range	Defibrillator

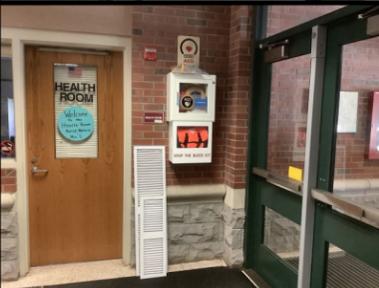
Reach < 15" or > 48"(forward/side approach)	66"	Relocate the defibrillator so that controls are located 48" above the finished floor. Recommendation applies to all defibrillators with a similar issue. Note: Unit cost is provided for one instance of this repetitive item.	1	825	\$500 - \$1K

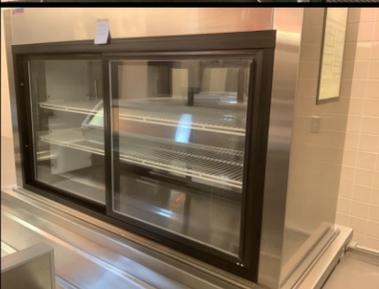
Not compliant	-	Provide hardware on the refrigerator that can be operable with one hand and not require tight grasping, pinching, or twisting of the wrist. Note: Unit cost is provided for one instance of this repetitive item.	1	116	\$1 - \$500
											116	
120	Library Media Center	2	-	Operable Parts / Reach Range	Book Shelves

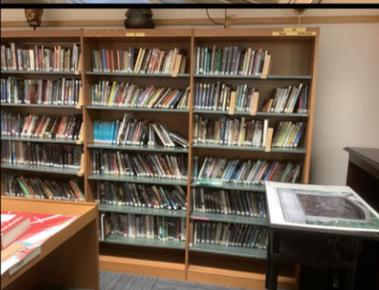
Reach < 15" or > 48"(forward/side approach)	67"	Ensure that staff is available to assist visitors who may need assistance reaching materials that are out of reach range.	1	Labor	Labor

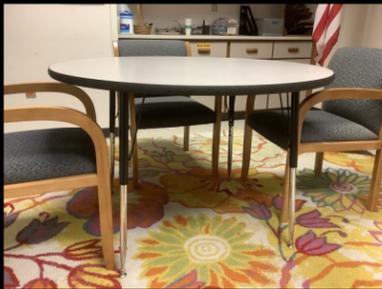
Knee or toe clearance not provided	26.5"	Provide at least one work surface with 30" min. wide knee and toe clearance.	1	1155	\$1K - \$5K
											1155	
127	Television Studio	1	127	Dining or Work Surfaces	Work Surface

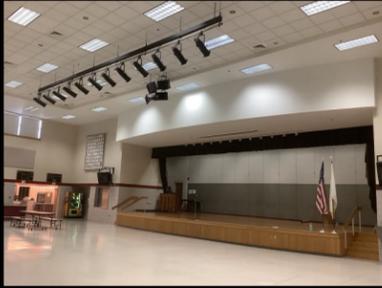
Number of seats Assistive listening devices not provided	300 -	If audible communication is integral to the use of the space, provide an assistive listening system. If an assistive listening system is provided, also provide a sign with the International Symbol of Access for Hearing Loss. Note: Cost is based on a room capacity of 600.	1	8125	\$5K - \$10K
											8125

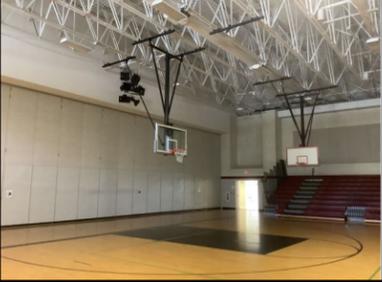
Number of seats Assistive listening devices not provided	563 -	If audible communication is integral to the use of the space, provide an assistive listening system. If an assistive listening system is provided, also provide a sign with the International Symbol of Access for Hearing Loss. Note: Cost is based on a room capacity of 600.	1	8125	\$5K - \$10K
132	East Softball Field/First Base Dugout	Ext.	-	Assembly Area	N/A

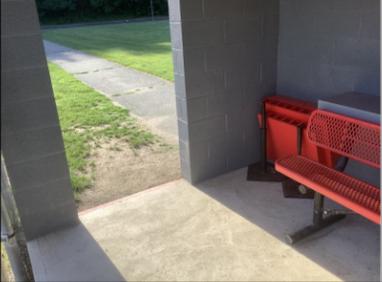
Wheelchair spaces overlap circulation paths Wheelchair spaces < 36" x 48" (if front entrance)	- 32"	Relocate seating area so that wheelchair spaces do not overlap circulation paths. Provide a 36" by 48" clear floor space at the wheelchair space. Recommendation applies to all dugouts with a similar issue.	1	-	-
Locker Room

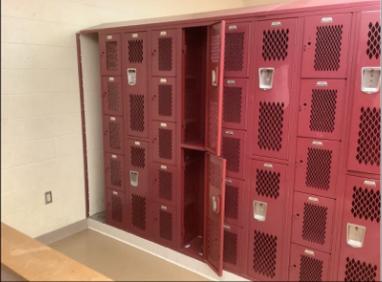
5% of lockers are not accessible	-	Provide at least one accessible locker (or ensure 5% of all lockers are accessible), with coat hooks and storage shelves located between 15" min. and 48" max. above the finished floor. Recommendation also applies to the girls' locker room. Note: Unit cost is provided for one instance of this repetitive item.	1	1416	\$1K - \$5K
134	Boys' Locker Room	1	-	Locker Room	Boys'

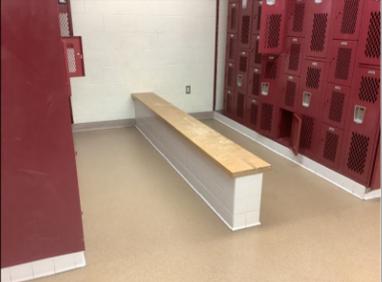
Back support not provided at bench Bench < 24" deep Bench lacks 12" clear underneath	- 11.5" -	Provide at least one bench with back support or that is affixed to a wall with room on the side to transfer. Provide a bench that is 24" deep. Provide a bench that has 12" clear underneath. Recommendation also applies to the girls' locker room.	2	990	\$1K - \$5K
135	Fine Arts Hallway	1	-	Locker Room	N/A

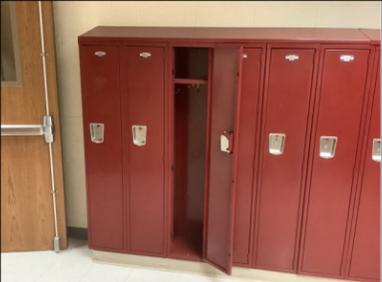
5% of lockers are not accessible	-	Provide at least one accessible locker (or ensure 5% of all lockers are accessible), with coat hooks and storage shelves located between 15" min. and 48" max. above the finished floor (Note: Unit cost is provided for one instance of this repetitive item).	1	1416	\$1K - \$5K

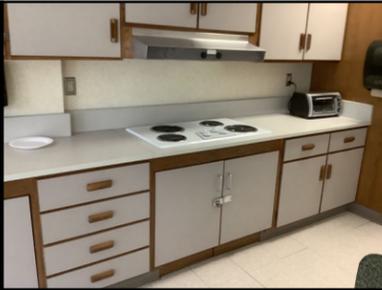
Knee/toe clearance not provided at cooktop Countertop next to cooktop < 15" wide Reach < 15" or > 48"(forward/side approach)	- - 55.5"	If the stove is used by students or members of the public, provide a cooktop with knee and toe clearance positioned for a forward approach, ensure a countertop that is at least 15" wide is provided next to the cooktop, and provide a second set of controls for the range hood mounted 48" max. above the finished floor.	1	1650 1518 825	\$1K - \$5K
											3993	
142	Family and Consumer Science	1	114	Kitchens and Kitchenettes	N/A

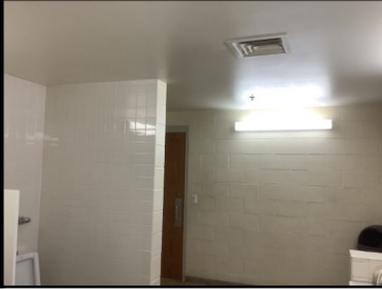
Audible and visible alarm not provided		When fire system is updated, ensure that a visible and audible fire alarm is installed. Recommendation applies to all toilet rooms with a similar issue.	1	Labor	Labor

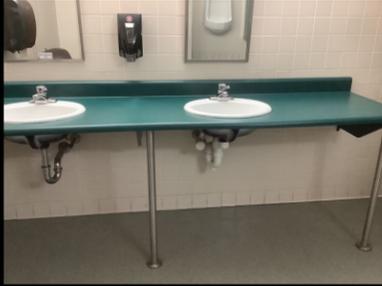
Toe or knee clearances not provided	26"	Provide at least one lavatory with knee and toe clearance positioned for a forward approach. Recommendation applies to all lavatories with a similar issue. Note: Unit cost is provided for one instance of this repetitive item.	1	1155	\$1K - \$5K
											1155	
Single-User Toilet												
146	All-Gender Single-User Toilet Room by Science Lab 103	1	-	Single-User Toilet	N/A

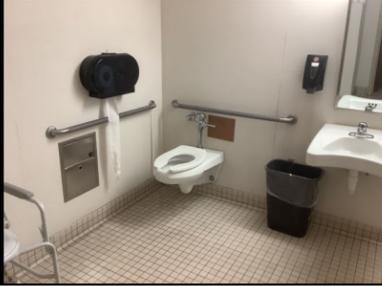
Side grab bar < 54" from back wall Item mounted over grab bar (MAAB) Dispenser/item located < 1½" below the grab bar	48" - -	Relocate the side wall grab bar to ensure it is located 12" max. from the rear wall. Relocate the toilet paper dispenser so that it is not mounted over the grab bar. Ensure the flush control is mounted 1 1/2" min. below the grab bar. Recommendation also applies to all toilet rooms with a similar issue. Note: Unit cost is provided for one instance of this repetitive item.	1	1320 825 -	\$1K - \$5K

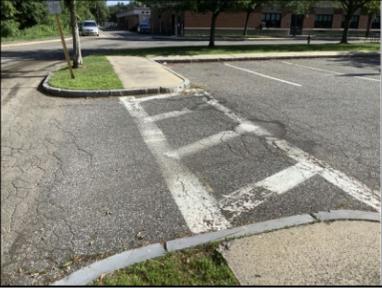
Recommend repainting the crosswalk.	1	-	-
Egress Maps												
168	Television Classroom	1	126	Egress Maps	N/A
