# Brown Farm

## Town of East Longmeadow ADA Transition Plan

July 2025

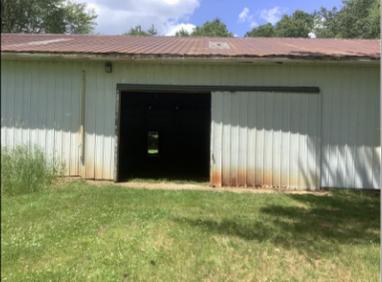
Accessible route not provided		If the Town provides events in this building, ensure that an accessible route is provided from the parking lot into this structure.	1	-	-
2	Community Garden	Ext.		Exterior Access Route	Exterior

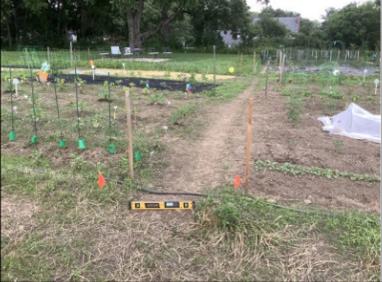
Exterior route < 48" wide Cross slope > 1:50 (2.00%) Surface is not stable, firm, and slip-resistant	23" 5.6%	Ensure that a clear width of 48" min. is maintained at the accessible route. Reduce cross slope to be no steeper than 1:50 (2.00%). Provide a surface that is stable, firm and slip-resistant such as stone dust, asphalt or concrete.	1	-	-

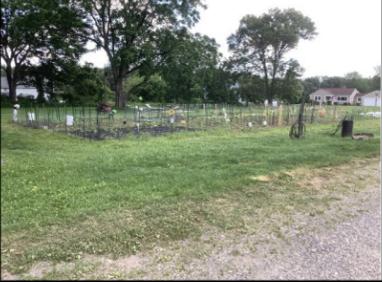
3	Community Garden	Ext.		Exterior Access Route	Exterior

Accessible route not provided		Ensure an accessible route is provided from the parking lot to the community garden.	1	-	-
4	Community Garden	Ext.		Exterior Access Route	Exterior

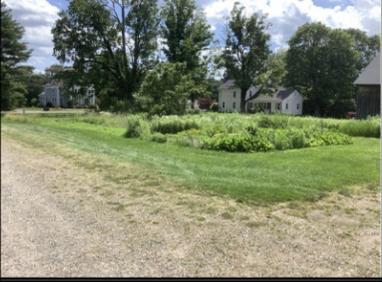
Accessible route not provided		If this community garden is used by members of the public, ensure an accessible route is provided from the parking lot to the community garden.	1	-	-
5	Patio by Community Garden	Ext.		Exterior Access Route	Exterior

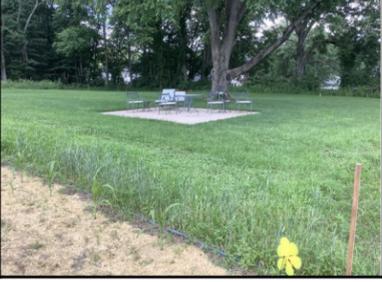
Accessible route not provided		Ensure an accessible route is provided to the patio.	1	-	-

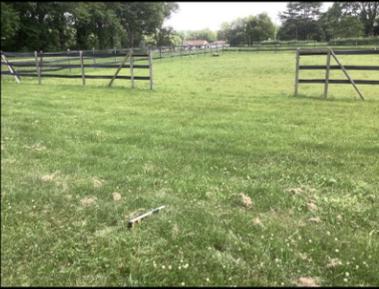
Running slope > 1:20 (5.00%) Surface is not stable, firm, and slip-resistant	22.5% -	Reduce running slope to be no steeper than 1:20 (5.00%). Provide a surface that is stable, firm and slip-resistant such as stone dust, asphalt or concrete.	1	-	-
7	To Outdoor Arena	Ext.		Exterior Access Route	Exterior

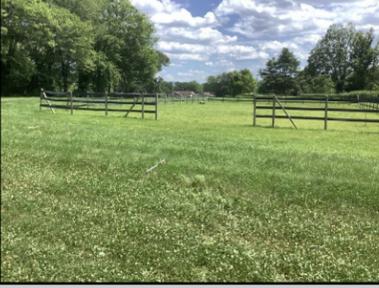
Running slope > 1:20 (5.00%) Surface is not stable, firm, and slip-resistant Accessible route not provided	11.7%	Ensure an accessible route is provided to the outdoor arena from the parking lot. Reduce running slope to be no steeper than 1:20 (5.00%). Provide a surface that is stable, firm and slip-resistant such as stone dust, asphalt or concrete.	1	-	-
Off-Street Parking Lot or Garage												
8	Parking Lot	Ext.		Off-Street Parking Lot or Garage	Visitor

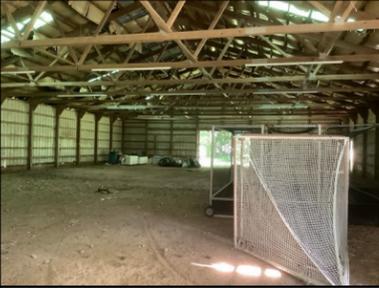
Surface not stable, firm, and slip-resistant	-	If the Town provides events in this building, repair the surface.	1	-	-
10	Barn	1		Interior Access Route	N/A

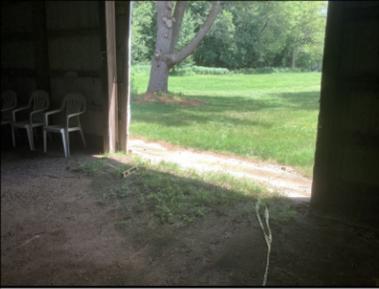
Running slope > 1:20 (5.00%)	10.9%	If the Town provides events in this building, provide compliant handrails with 1 1/4"- 2" circular cross sections and reduce the running slope to be no higher than 1:12 (8.33%) with compliant platforms and edge protection.	1	-	-

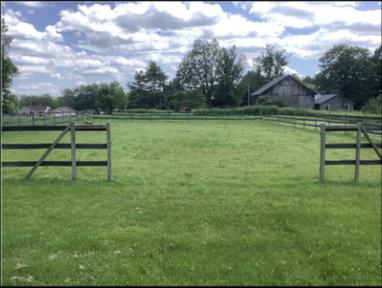
Recommend providing toilet facilities on the site. Portable toilets should have 72" clear depth and 60" clear width at the toilet and should be located on an accessible route.	1	-	-
