# East Longmeadow Fire Station

## Town of East Longmeadow ADA Transition Plan

July 2025

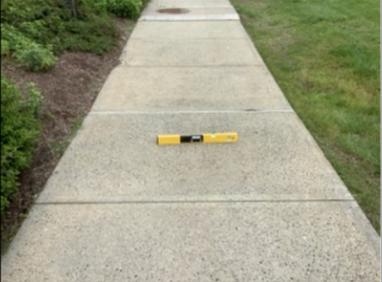
ID	Location	Floor	Room	Element	Type	Photo	Issues	Current Measure	Recommendations	Quantity	Price	Cost Estimation
<div style="border: 1px solid gray; padding: 2px;">Approach and Entrance</div> <div style="border: 1px solid gray; padding: 2px; margin-top: 5px;">Exterior Access Route</div>												
1	From Main Entrance Towards Parking	Ext.		Exterior Access Route	Walkway

Cross slope > 1:50 (2.00%)	2.7%	Reduce cross slope to be no steeper than 1:50 (2.00%).	1	-	-
2	Near Accessible Parking	Ext.		Exterior Access Route

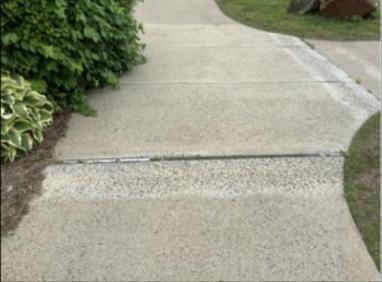
Surface openings > 1/2"	1.25"	Ensure that the surface opening is no greater than 1/2" max.	1	-	-
3	Parking Lot	Ext.		Exterior Access Route	Parking Lot

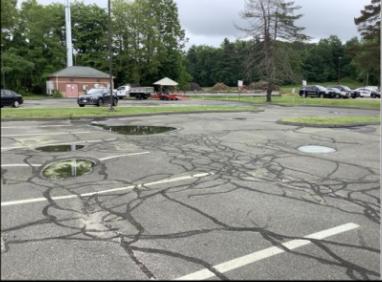
Does not prevent accumulation of water Route not maintained in operable working condition		Repair surface. Ensure the accessible route is maintained in operable working condition.	1	-	-
4	Towards Parking	Ext.		Exterior Access Route	Walkway

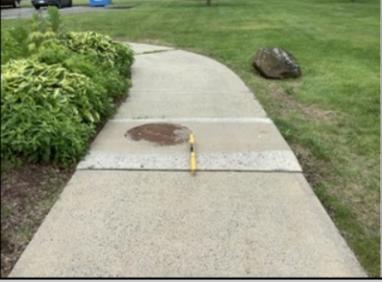
Running slope > 1:20 (5.00%)	10.3%	Reduce running slope to be no steeper than 1:20 (5.00%).	1	-	-

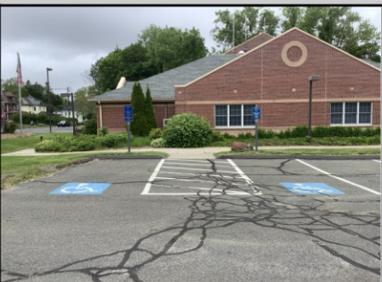
<div style="border: 1px solid gray; padding: 2px;">Off-Street Parking Lot or Garage</div>												
5	Accessible Parking Spaces	Ext.		Off-Street Parking Lot or Garage	Visitor

Total # of parking Total # of designated car accessible parking spaces Total # of designated van accessible spaces Sign bottom < 60" above finished grade	15 1 1 51.75"	Locate sign with the bottom of the sign 60" above the ground.	2	Labor	Labor

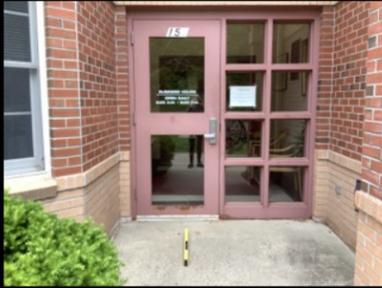
ID	Location	Floor	Room	Element	Type	Photo	Issues	Current Measure	Recommendations	Quantity	Price	Cost Estimation
<b>Entrance</b>												
6	Main Entrance	Ext.		Entrance	Main Entrance

Accessibility issues at the main entrance include maneuvering clearance that has a steeper slope than is allowed.

Maneuvering clearance at door > 1:50 (2.00%)	5.8%	Provide an automatic door opener in a level area where the slope and cross slope are no greater than 1:50 (2%) for a wheelchair user (30" x 48" area).	1	9900	\$5K - \$10K
											<b>9900</b>	
<b>Access to Goods and Services</b>												
<b>Means of Egress</b>												
7	Apparatus Bay Egress	1		Means of Egress	N/A

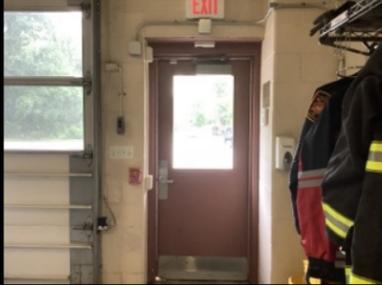
Tactile exit sign not provided Directional sign to accessible emergency exit not provided	- -	Ensure that a tactile exit sign with raised characters and braille is provided at the exit door. Mount the sign between 48"- 60" above the finished floor located on the latch side of the door. Provide a directional sign indicating the location of the nearest accessible emergency exit.	1	413 413	\$500 - \$1K

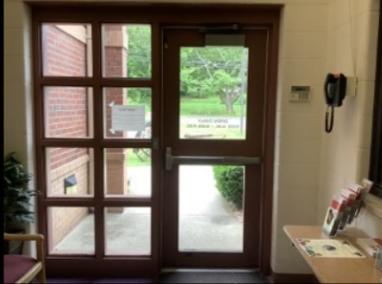
<b>826</b>	
8	Lobby	1		Means of Egress	N/A

Tactile exit sign not provided Illuminated ISA symbol not provided (MAAB)	- -	Ensure that a tactile exit sign with raised characters and braille is provided at the exit door. Mount the sign between 48"- 60" above the finished floor located on the latch side of the door. When the illuminated exit sign is repaired or replaced, provide an illuminated sign with the International Symbol of Accessibility (ISA).	1	413	\$1 - \$500
											<b>413</b>	
<b>Interior Access Route</b>												
9	Corridor by Administrative Office	1		Interior Access Route	N/A

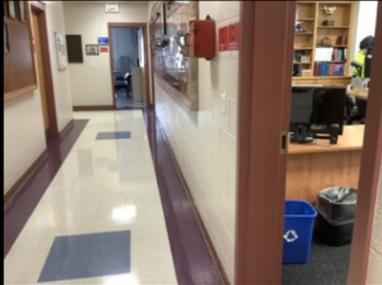
Obstructed by protruding objects	6.5"	Provide a cane detectable barrier such as a fixed trash can or railing located 27" max. above the finished floor or relocate the red box. Ensure that maintenance staff is aware every object that they mount in the circulation path that is greater than 4" deep, located between 27" and 80" above the finished floor is considered a protruding object. Cost estimate is for relocating the red box.	1	825	\$500 - \$1K

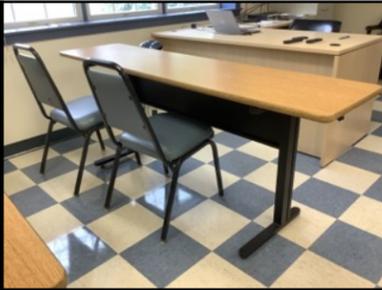
ID	Location	Floor	Room	Element	Type	Photo	Issues	Current Measure	Recommendations	Quantity	Price	Cost Estimation
<b>Dining or Work Surfaces</b>												
15	Training Room	1		Dining or Work Surfaces	Work Surface

Knee clearance less than 19" deep	14.5"	Provide at least one work surface with knee clearance that is 19" deep min.	1	700	\$500 - \$1K
											<b>700</b>	
<b>Assembly Area</b>												
16	Training Room	1		Assembly Area	N/A

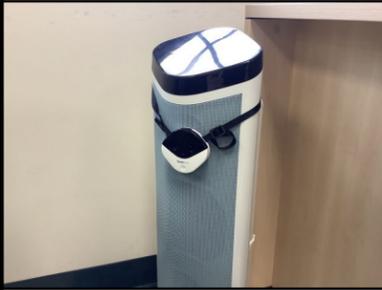
Accessibility issues include a possible lack of an adequate assistive listening system in the training room. Based on the

seating capacity of 75, three (3) receivers must be provided, two (2) of which must be hearing-aid compatible.

Number of seats Assistive listening devices not provided	75 -	If audible communication is integral to the use of the space, provide an assistive listening system. IHCD team was shown this device, however under the ADA, based on the seating capacity of 75 people, 3 receivers must be provided, two of which must be hearing-aid compatible. Assistive listening systems should be identified by signage that contains that contains the International Symbol of Access for Hearing Loss.	1	2716	2716

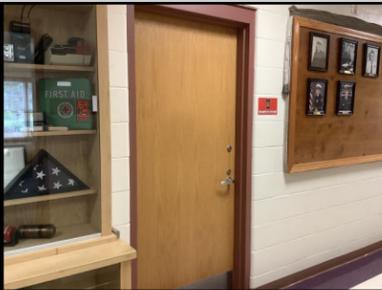
<b>Toilet &amp; Bathing Rooms</b>												
<b>Overall Access</b>												
17	Women's and Men's Single-User Toilet Rooms	1		Overall Access	Toilet Room

Sign to accessible toilet not provided International Symbol of Acc. not provided	- -	Change the signs at each single-user toilet room to read "All-Gender" and recommend bringing the current men's toilet room into compliance. At the current women's room, provide a directional sign indicating the location of the nearest accessible toilet room. At the current men's room, provide a sign with the International Symbol of Accessibility (ISA). Cost estimate is for 2 designation and 1 directional signs.	1	413 413 413	\$1K - \$5K
											<b>1239</b>	
18	Women's and Men's Toilet Rooms	1		Overall Access	Toilet Room

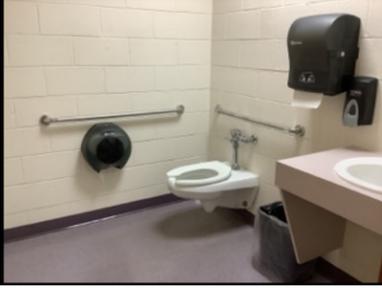
Audible and visible alarm not provided	-	When fire system is updated, ensure that a visible and audible fire alarm is installed.	2	-	-

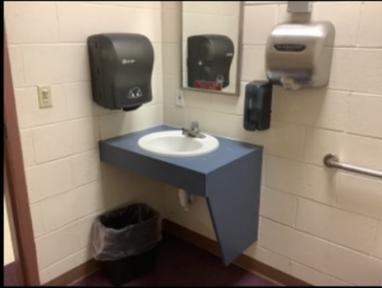
ID	Location	Floor	Room	Element	Type	Photo	Issues	Current Measure	Recommendations	Quantity	Price	Cost Estimation
<b>Lavatory</b>												
19	Men's Toilet Room	1		Lavatory	N/A

Clear floor space not provided at lavatory Faucet requires > 5 lbs. of force	- 7 lbs	Provide at least one lavatory with a 30" min. by 48" min. clear floor space positioned for a forward approach. Relocate the trash container. Ensure that the faucet is adjusted so that it requires no more than 5 lbs. of force to operate.	1	Labor	Labor
<b>Single-User Toilet</b>												
20	Men's Toilet Room	1		Single-User Toilet	N/A

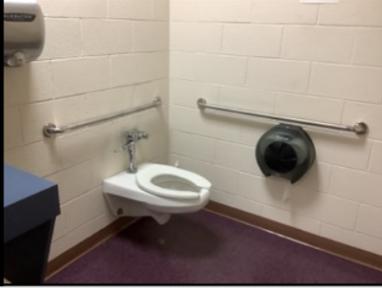
Centerline < or > 18" (MAAB) Rear grab bar < 42" long (MAAB) Clearance at toilet < 60" clear width	20.5 37.25" 57"	Relocate toilet so that the centerline is 18" from the side wall. Provide a rear wall grab bar that is 42" long min. and extends from the toilet 12" min. on one side and 24" min. on the other side (open side). Relocate the trash bin and rebuild lavatory counter so that there is 60" clear wide at the toilet.	1	6066 1238 3094	\$10K - \$50K

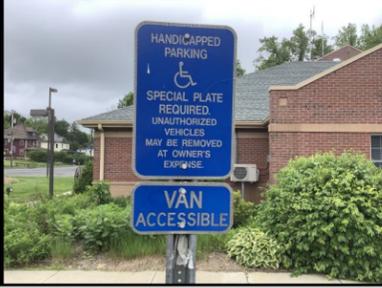
<b>10398</b>	
<b>Best Practice</b>												
<b>Accessible Parking</b>												
21	Accessible Parking Spaces	Ext.		Accessible Parking	N/A

At all accessible parking spaces, recommend replacing the identification sign with one that includes the text "Accessible" parking instead of "Handicapped" parking.	1	-	-
<b>Curb Ramp</b>												
22	Route to Accessible Parking	Ext.		Curb Ramp	N/A

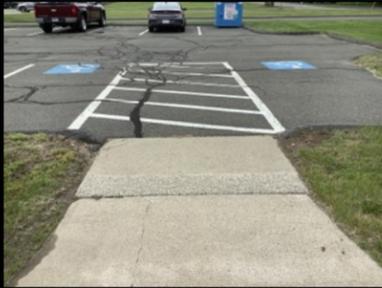
Recommend providing a detectable warning on the curb ramp.	1	-	-

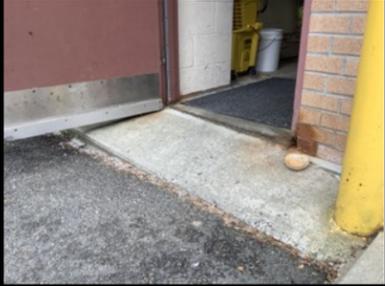
ID	Location	Floor	Room	Element	Type	Photo	Issues	Current Measure	Recommendations	Quantity	Price	Cost Estimation
<b>Inaccessible Egress</b>												
23	Apparatus Bay Egress	1		Inaccessible Egress	N/A

2.5"	Recommend altering the change in level at this inaccessible exit to be 1/4" high max. so that the level change does not act as a tripping hazard. Alternately, provide a contrasting color strip on the edge of the step, so that people are more easily able to recognize the change in level.	1	-	-
<b>Lectern</b>												
24	Training Room	1		Lectern	N/A

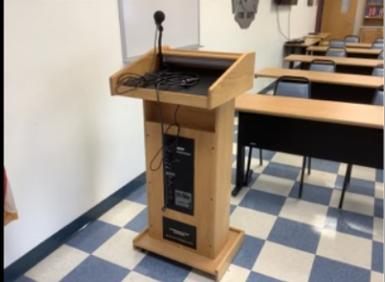
Recommend providing an adjustable height lectern with knee and toe clearance.	1	-	-
