East Longmeadow Public Library

Town of East Longmeadow ADA Transition Plan

June 2025

Institute for Human Centered Design

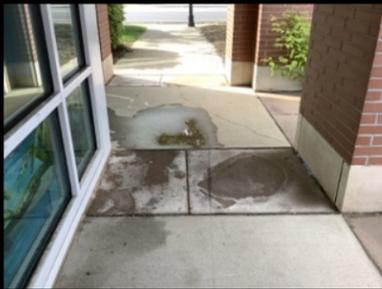
ID	Location	Floor	Room	Element	Type	Photo	Issues	Current Measure	Recommendations	Quantity	Price	Cost Estimation
11	Towards Maple Street	Ext.		Exterior Access Route	Walkway

Does not prevent accumulation of water	-	Repair surface to ensure water does not accumulate within the accessible route.	1	-	-
12	Near Main Entrance	Ext.		Exterior Access Route	Walkway

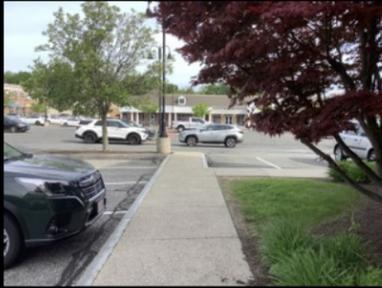
Vertical clearance < 80" above ground	73"	Trim low hanging tree branches above the accessible route so they are at least 80" above the ground.	1	-	-
Curb Ramp												
13	From Parking	Ext.		Curb Ramp	Perpendicular

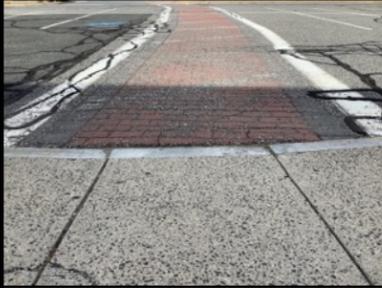
Transition from curb ramp to street not flush	-	Ensure transition from curb ramp to street is flush or free of changes in level.	1	-	-
14	Parking Near Shopping Center	Ext.		Curb Ramp	Perpendicular

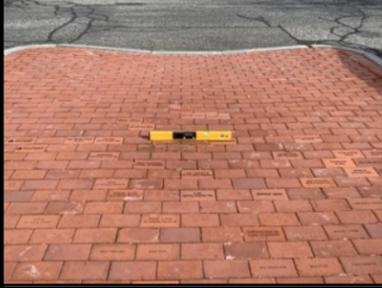
Landing not provided at top of curb ramp	2.5%	Provide landing at top of curb ramp with a slope that is no greater than 1:50 (2.00%) in all directions or reconfigure ramp.	1	-	-

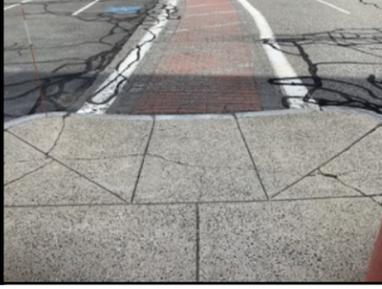
15	From Parking	Ext.		Curb Ramp	Perpendicular

Curb ramp not maintained in operable working condition	-	Repair surface to ensure curb ramp is maintained in operable working condition.	1	-	-

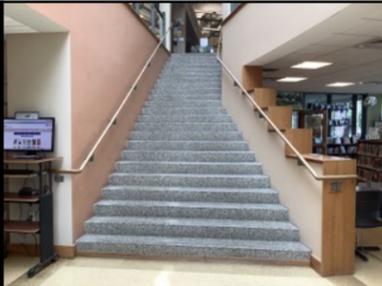
Handrail height < 34" or > 38"	41"	Alter so the handrails are 34"- 38" high above the floor.	1	-	-
26	Emergency Stairs Near Staff Room	2		Stairways	Interior

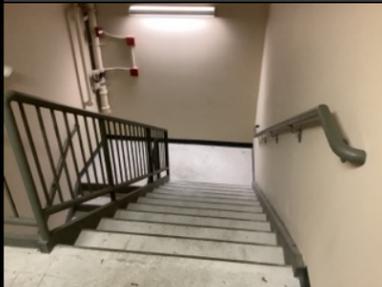
Handrails not continuous where required	-	Ensure gripping surface is continuous along the length of the staircase and is not obstructed along the top and bottom. The gripping surface of the handrail shall not be obstructed for more than 20% of the length.	1	-	-
27	Emergency Stairs Near Toilet Rooms	2		Stairways	Egress

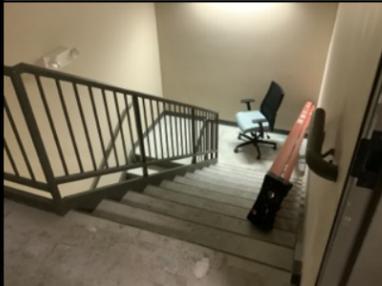
Not maintained in operable working condition Gripping surface has obstructions	- -	Relocate stored items to ensure stairs are maintained in operable working condition. Currently, the posts are obstructing the central handrail, ensure gripping surface is continuous along the length of the staircase and is not obstructed along the top and bottom.	1	-	-

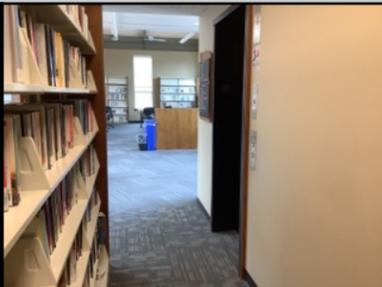
Elevator												
28	Near Elevator	2		Elevator	Interior

Clear floor space not provided	41"	Relocate book shelves to provide a 30" min. by 48" min. clear floor space positioned for a forward approach at the elevator call button. Note; IHCD team was told that this is a difficult passage for some visitors to navigate as presently constituted.	1	Labor	Labor
Signage												
29	Community Room	1		Signage	Designation

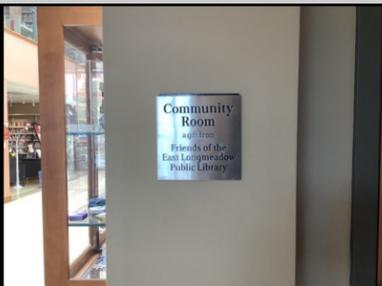
Raised characters not provided on sign Braille not provided on sign Location of tactile sign not compliant Non-glare finish and contrast not provided on sign Character style not compliant	- - - -	Provide text with raised characters duplicated in braille on the sign. Where a tactile sign is provided at double door with two active leafs, locate the sign to the right of the right-hand door. Install a sign with a non-glare finish with characters that have a high contrast to the background. Provide a sign with compliant characters. Characters should be sans serif.	1	413	\$1 - \$500

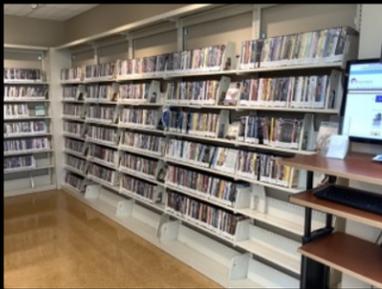
Reach < 15" or > 48"(forward/side approach)	64.5"	Ensure that staff is available to assist visitors who need assistance reaching available materials. Recommendation applies to all shelves with a similar issue.	1	Labor	Labor
36	Conference Room	1		Operable Parts / Reach Range	Clothes Rod/Hooks

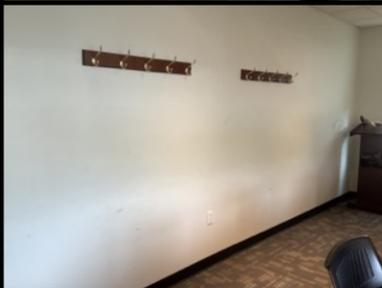
Reach < 15" or > 48"(forward/side approach)	67"	Provide an additional coat hook located no higher than 48" above the finished floor.	1	124	\$1 - \$500
124												
Dining or Work Surfaces												
37	Library Catalog Computer	1		Dining or Work Surfaces	Work Surface

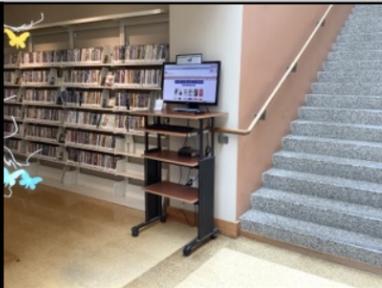
Top of dining/work surface < 28" or > 34"	46.25"	Provide a work surface with the top between 28"- 34" above the floor, 27" min. clear height and 30" min. clear width underneath. Recommendation also applies to the print release on Floor 2.	2	1155	\$1K - \$5K

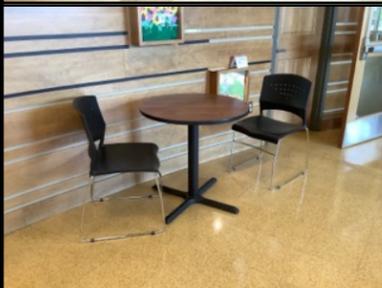
Knee clearance less than 19" deep	-	Provide a work surface with knee clearance that is 19" deep min. Note: Most pedestal tables are not accessible.	1	751	\$500 - \$1K
751												
Assembly Area												
39	Community Room	1		Assembly Area	N/A

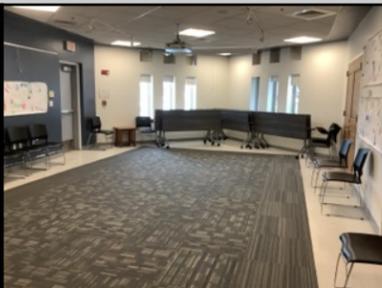
Assistive listening devices not provided	-	If audible communication is integral to the use of the space, provide an assistive listening system. Note: Cost provided is for a transmitter, receiver, ear speaker, neck loop and USB charger with a capacity of 50.	1	2604	\$1K - \$5K
2604

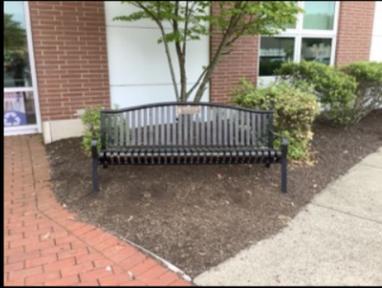
No accessible route to one bench in area	-	Relocate one bench to an accessible route or provide an accessible route to the bench.	1	Labor	Labor
Kitchens and Kitchenettes												
41	Community Room Kitchen	1		Kitchens and Kitchenettes	N/A

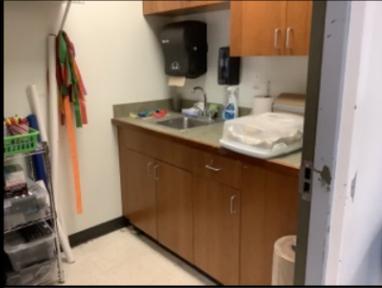
Knee/toe clearance not provided at sink Sink > 34" high	- 36"	Provide a sink with knee and toe clearance positioned for a forward approach. Lower sink to be no higher than 34" positioned for a forward approach.	1	5106	\$5K - \$10K
42	Community Room Kitchen	1		Kitchens and Kitchenettes	N/A

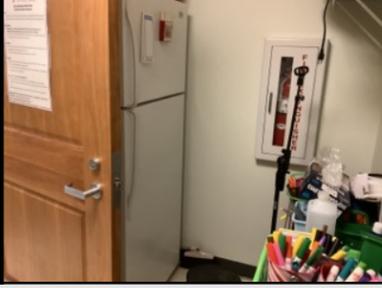
Clear floor space at refrigerator not provided	-	Relocate stored items to provide a 30" x 48" clear floor space that is centered to the refrigerator.	1	Labor	Labor
Toilet & Bathing Rooms

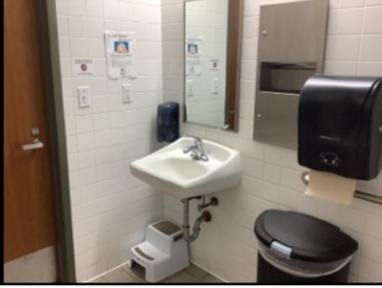
Lavatory												
43	Children's Room Family Toilet Room	1		Lavatory	N/A

Clear floor space not provided at lavatory Plumbing underneath is exposed	- -	Relocate step stool to maintain a 30" min. by 48" min. clear floor space positioned for a forward approach and knee and toe clearance at the lavatory. Insulate or otherwise configure pipes to prevent contact for at least one lavatory.	1	248	\$1 - \$500

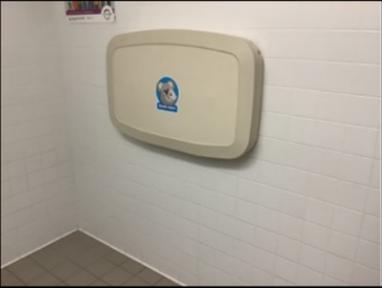
Changing table surface > 34" high Operable part > 48" high	37.5" 56.5"	Ensure that the changing surface is located between 28" - 34" above the finished floor with knee and toe clearance positioned for a forward approach. Lower the baby changing table so that the table pull control is located no higher than 48" above the finished floor.	1	1320	\$1K - \$5K
											1320	
Additional Access												
Drinking Fountains												
55	Between Community and Conference Rooms	1		Drinking Fountains	Hi-Lo

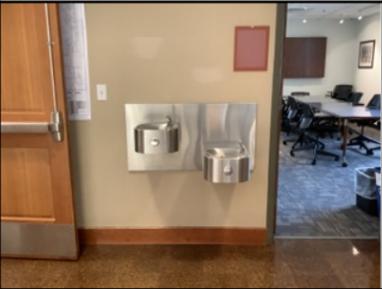
Standing height fountain does not have cane protection	-	Provide a cane-detectable barrier skirt under the high unit.	1	1469	\$1K - \$5K
											1469	
Best Practice												
Detectable Warning

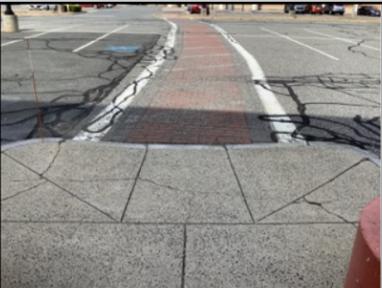
56	From Parking	Ext.		Detectable Warning	N/A

-	Recommend providing a detectable warning at the entrance to the parking lot, to alert pedestrians they are entering vehicular traffic.	1	-	-
57	Parking Near Shopping Center	Ext.		Detectable Warning	N/A

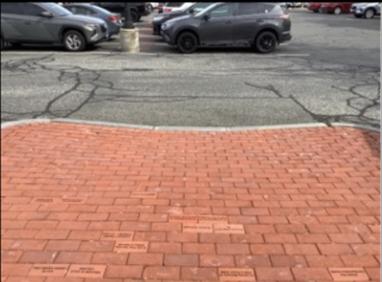
-	Recommend providing a detectable warning at the entrance to the parking lot, to alert pedestrians they are entering vehicular traffic.	1	-	-

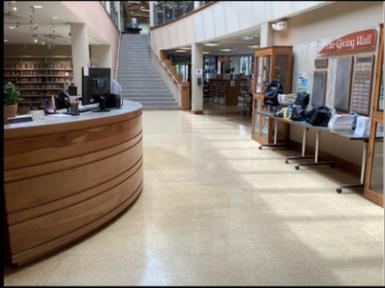
-	Recommend switching to a matte flooring finish. The floor is so highly polished that it creates a glare problem. Many people with low vision and some with perceptual disabilities may have difficulty navigating the floor surface.	1	-	-
Lectern												
59	Conference Room	1		Lectern	N/A

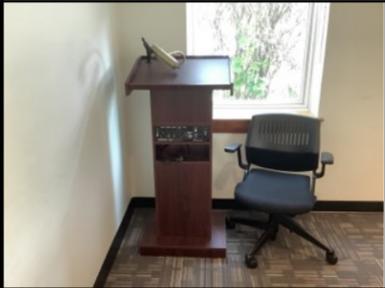
-	Recommend providing an adjustable height lectern with knee and toe clearance positioned for a forward approach.	1	-	-
Off-Street Parking Lot or Garage												
60	Parking Near Main Entrance	Ext.		Off-Street Parking Lot or Garage	N/A

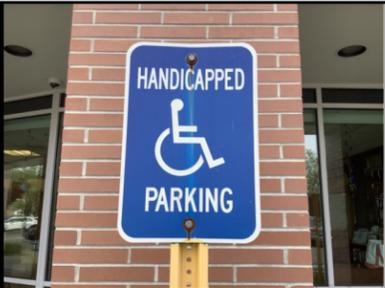
-	Recommend replacing the accessible parking identification sign with one that includes the text "Accessible" parking instead of "Handicapped" parking. Recommendation applies to all accessible parking spaces.	1	-	-

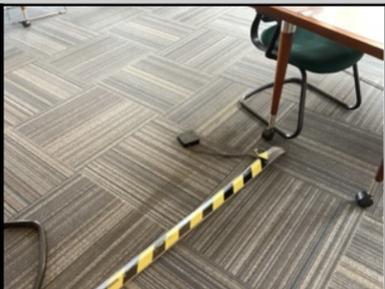
Power Cord												
61	Newspapers and Magazines	2		Power Cord	N/A

-	Recommend replacing the cord strip with outlets no lower than 15" min. above the finished floor, as people may trip on the electric cord.	1	-	-

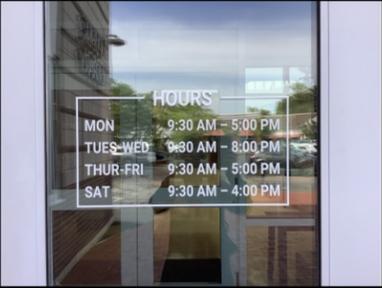
-	<p>Recommend providing a solid background behind the text that is in a color that provides a high contrasts with the text, and providing printing in the correct standard readable direction when the sign is viewed from both sides of the glass.</p> <p>Recommendation also applies to the main entrance.</p>	1	-	-
Visual Contrast												
63	Lobby Stairs	2		Visual Contrast	N/A

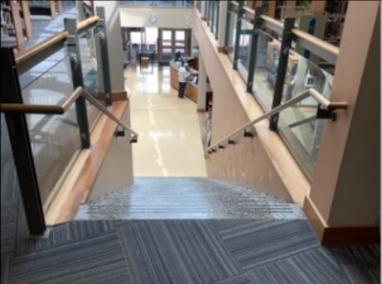
-	<p>Recommend providing a contrasting color strip at each stair tread on the stair so that each tread is readily apparent when viewed in descent or ascent.</p> <p>Recommendation applies to all interior stairs.</p>	1	-	-
