# Service Building

## Town of East Longmeadow ADA Transition Plan

July 2025

Institute for Human Centered Design

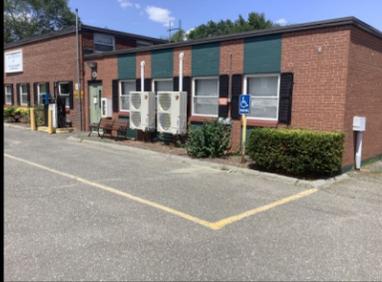
Accessibility issues include lack of a marked access aisle, and parking identification signage that lacks the designation “Van Accessible”.

Access aisle not provided Sign does not have the designation "Van Accessible"	- -	Provide a marked access aisle that is at least 96" wide. Add the designation "Van Accessible" to the sign located at the van accessible space. (Cost estimate is for the sign.)	1	825	\$500 - \$1K
											<b>825</b>	
<b>Access to Goods and Services</b>												
<b>Means of Egress</b>												
2	Northeast Egress	1		Means of Egress	N/A

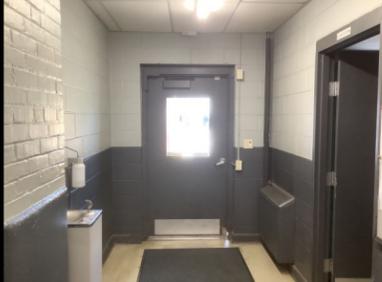
Tactile exit sign not provided	-	Ensure that a tactile exit sign with raised characters and braille is provided at the exit door. Mount the sign between 48" - 60" above the finished floor located on the latch side of the door.	1	413	\$1 - \$500

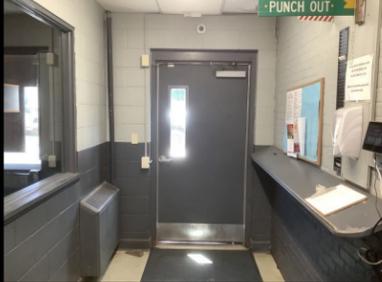
Tactile exit sign not provided	-	Ensure that a tactile exit sign with raised characters and braille is provided at the exit door. Mount the sign between 48" - 60" above the finished floor located on the latch side of the door.	1	413	\$1 - \$500
											<b>413</b>	
<b>Interior Access Route</b>												
4	By Southwest Main Entrance/Exit	1		Interior Access Route	N/A

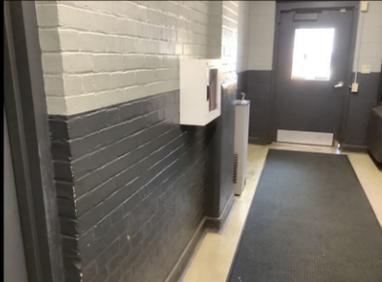
Obstructed by protruding objects	6"	Provide a cane-detectable barrier such as a fixed trash can or railing located 27" max. above the finished floor or relocate the defibrillator. Ensure that maintenance staff is aware every object that they mount in the circulation path that is greater than 4" deep and located between 27" and 80" above the finished floor is considered a protruding object.	1	825	\$500 - \$1K
											<b>825</b>

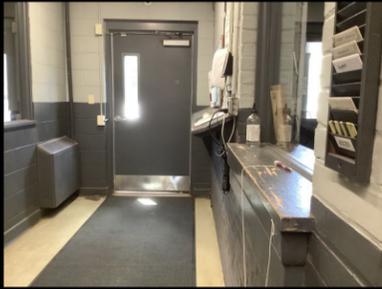
Obstructed by protruding objects	10"	Provide a cane-detectable barrier such as a fixed trash can or railing located 27" max. above the finished floor. Ensure that maintenance staff is aware every object that they mount in the circulation path that is greater than 4" deep and located between 27" and 80" above the finished floor is considered a protruding object. <b>Note:</b> service counter is not used by the public.	1	825	\$500 - \$1K
<div style="background-color: #f0f0f0; padding: 5px; border: 1px solid #ccc;"> <b>Dining or Work Surfaces</b> </div>												
6	Lounge	1		Dining or Work Surfaces	Dining Surface

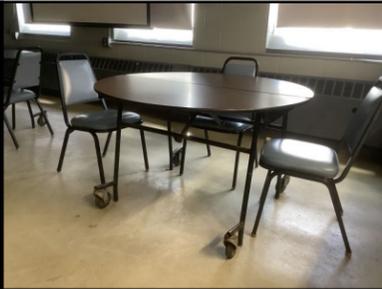
Knee clearance less than 19" deep	15"	Provide at least one dining surface with knee clearance that is 19" deep min. and, 27" high min. measured to the bottom of the dining surface. Ensure the dining surface is also 30" wide min., with the top no higher than 34" above the finished floor.	1	751	\$500 - \$1K

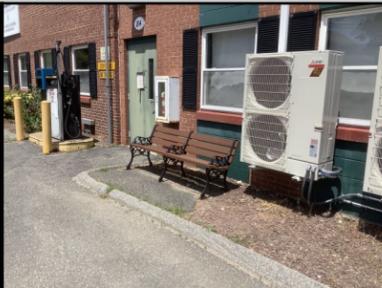
No accessible route to one bench in area		Relocate at least one bench to an accessible route or provide at least one additional bench located on an accessible route at the Service Building.	1	Labor	Labor
<div style="background-color: #f0f0f0; padding: 5px; border: 1px solid #ccc;"> <b>Additional Access</b> </div>												
<div style="background-color: #f0f0f0; padding: 5px; border: 1px solid #ccc;"> <b>Drinking Fountains</b> </div>												
8	Main Hallway	1		Drinking Fountains	High

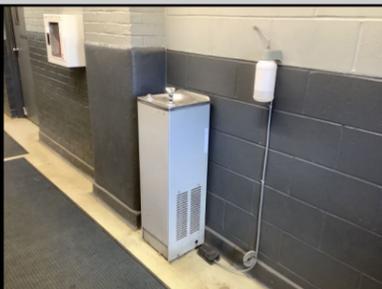
No drinking fountain provided for seated users		Provide an additional drinking fountain for seated users,.	1	6647	\$5K - \$10K
<div style="background-color: #f0f0f0; padding: 5px; border: 1px solid #ccc;"> <b>Best Practice</b> </div>
