Town Hall

Town of East Longmeadow ADA Transition Plan

July 2025

Institute for Human Centered Design

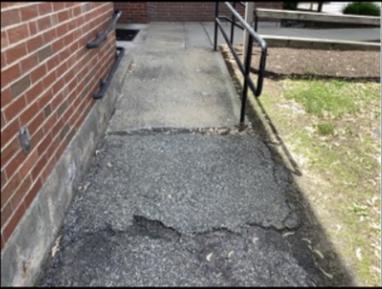
ID	Location	Floor	Room	Element	Type	Photo	Issues	Current Measure	Recommendations	Quantity	Price	Cost Estimation
6	Route by the Parking Lot	Ext.		Exterior Access Route	Walkway

Route not maintained in operable working condition	-	Ensure the accessible route is maintained in operable working condition.	1	-	-
7	Route From Northeast Parking Lot	Ext.		Exterior Access Route	Walkway

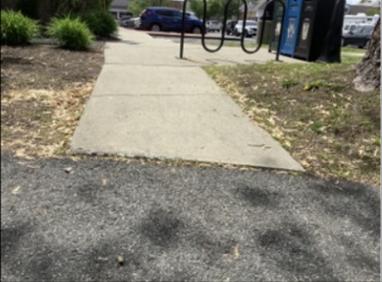
Level changes > 1/4"	.5%	Alter change in level to be 1/4" high max.	1	-	-
8	Route From Stepped Entrance	Ext.		Exterior Access Route	Walkway

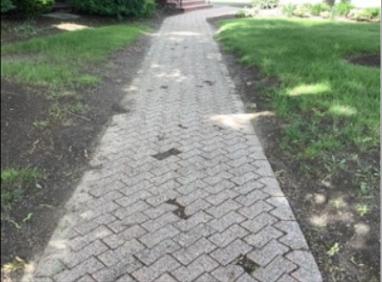
Route not maintained in operable working condition	-	Ensure the accessible route is maintained in operable working condition.	1	-	-
9	Route Towards Locked Door	Ext.		Exterior Access Route	Walkway

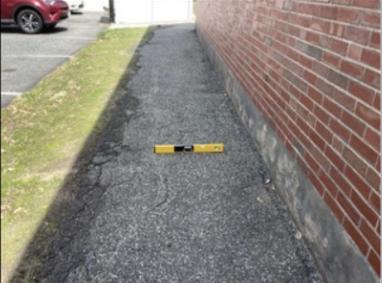
Cross slope > 1:50 (2.00%)	4.5%	Reduce cross slope to be no steeper than 1:50 (2.00%).	1	-	-
10	Towards Entrance Near Building Department	Ext.		Exterior Access Route	Walkway

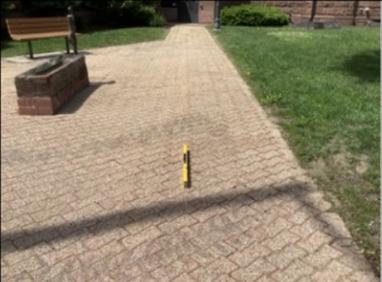
Running slope > 1:20 (5.00%)	8.2%	Reduce running slope to be no steeper than 1:20 (5.00%).	1	-	-

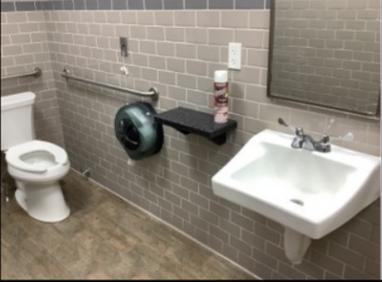
ID	Location	Floor	Room	Element	Type	Photo	Issues	Current Measure	Recommendations	Quantity	Price	Cost Estimation
31	Men's Toilet Room	1		Interior Access Route	N/A

Obstructed by protruding objects	8.5"	Remove the shelf out of the clear floor space required at the toilet. It can be relocated to another part of the room, however if it is located higher than 27" it would most likely be considered a protruding object and need a cane-detectable barrier underneath, such as a fixed trash can or railing located 27" max. above the finished floor.	1	1320	\$1K - \$5K
											1320	
32	Stairs to Department of Public Works	1		Interior Access Route	N/A

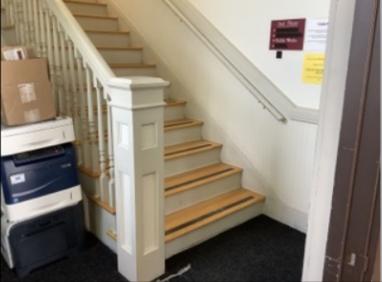
Accessible vertical route not provided	-	The Town could either install a Limited Use Limited Application (LULA) elevators or have staff members from the upstairs offices meet with the public in an accessible location.	1	-	-
33	Towards Town Clerk	1		Interior Access Route	N/A

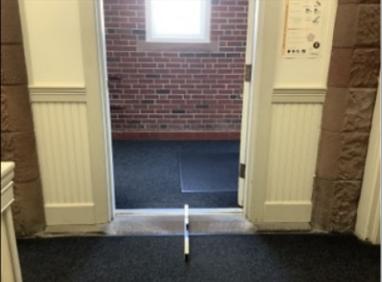
Level changes > 1/4" Running slope > 1:20 (5.00%)	2" 6.3%	Alter change in level to be 1/4" high max. Further study will be needed to determine whether it is technically feasible to bring the route into full compliance with the ADA Standards.	1	-	-

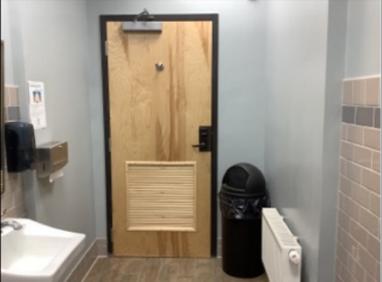
Doors, Doorways, & Gates												
34	Men's Toilet Room	1		Doors, Doorways, & Gates	Toilet Room

Maneuvering clearance(s) not provided	-	Relocate the trash container to ensure that 18" min. clear is provided on the latch side of the door.	1	-	-
35	Town Clerk/ Collector/ Treasurer	1		Doors, Doorways, & Gates	Office

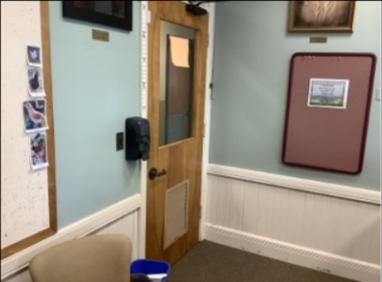
Maneuvering clearance(s) not provided		Relocate the trash and recycling bins that are located in the door maneuvering clearance. Ensure that there is 18" clear on the latch side of the door.	1	Labor	Labor

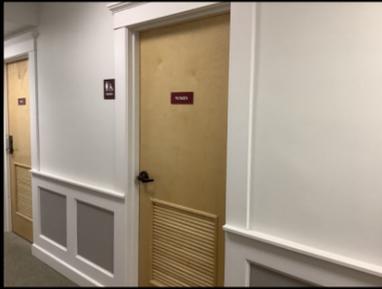
ID	Location	Floor	Room	Element	Type	Photo	Issues	Current Measure	Recommendations	Quantity	Price	Cost Estimation
46	Women's Toilet Room and Men's Toilet Room	1		Signage	Designation

Raised characters < 48" or > 60" above ground	65.5"	Mount the sign so that the baseline of the lowest tactile character is 48" min. above finished floor and the baseline of the highest tactile character is 60" max. above the finished floor.	2	Labor	Labor
Service Counter												
47	Planning Department Counter	1		Service Counter	N/A

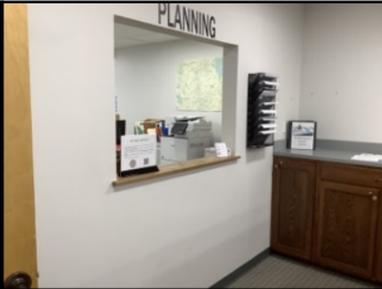
Counter > 36" high	44"	Provide a counter that is 36" max. above the ground or finished floor.	1	1888	\$1K - \$5K
											1888	
48	Town Manager and Health Department	1		Service Counter	N/A

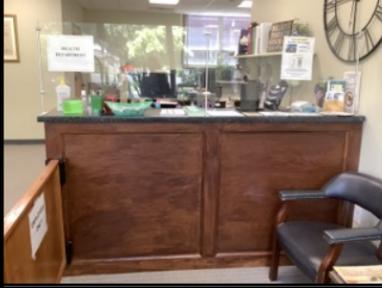
Counter > 36" high	43.5"	Provide a counter that is 36" max. above the ground or finished floor.	1	1888	\$1K - \$5K
											1888	
49	Department of Public Works Counter	2		Service Counter	N/A

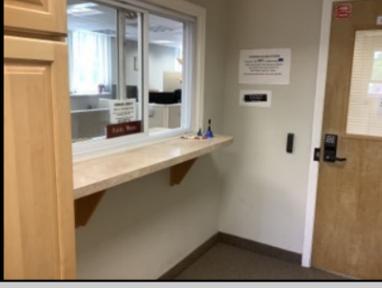
Counter > 36" high	41.75"	Provide a counter that is 36" max. above the ground or finished floor.	1	1888	\$1K - \$5K

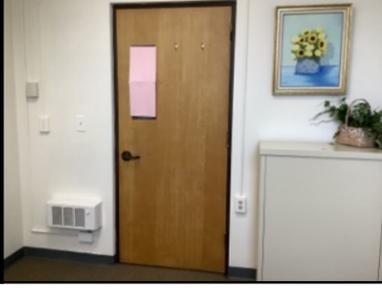
1888	
Operable Parts / Reach Range												
50	Mother's Room	1		Operable Parts / Reach Range	Clothes Rod/Hooks

Reach < 15" or > 48"(forward/side approach)	73"	Provide a hook no higher than 48" above the finished floor.	1	124	\$1 - \$500
											124

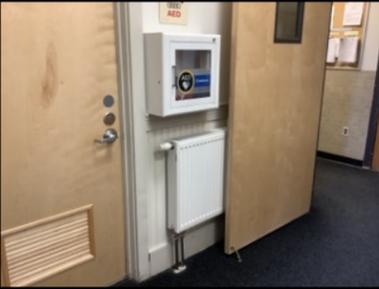
ID	Location	Floor	Room	Element	Type	Photo	Issues	Current Measure	Recommendations	Quantity	Price	Cost Estimation
51	Near Employee Toilet Room	1		Operable Parts / Reach Range	Defibrillator

Reach < 15" or > 48"(forward/side approach)	49"	Relocate the defibrillator so that controls are between 15"- 48" above the finished floor. /Ensure that staff is available to assist visitors who need assistance.	1	825	\$500 - \$1K
52	Planning Department Counter	1		Operable Parts / Reach Range	Bell

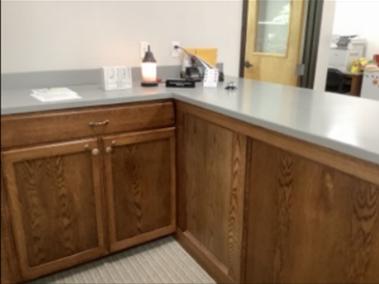
Side reach over an obstruction > 34" high	43"	Relocate the bell to the accessible lower counter and ensure that staff understand that the bell should stay in this location so that it is located within reach range.	1	Labor	Labor
53	Town Hall to Egress	1		Operable Parts / Reach Range	Equipment

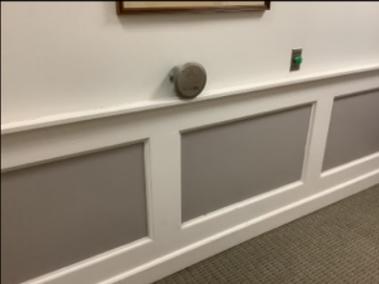
Not compliant	Not maintained	The automatic door opener button has to be held down, and it is loose. Ensure that it is maintained in operable working condition.	1	-	-

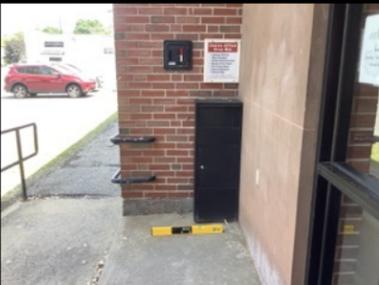
54	Clerks Office Drop Box	Ext.		Operable Parts / Reach Range	Drop Box

Clear floor space is not provided	3.6%	Ensure that drop box is located to have a 30" x 48" clear floor space that is sloped no more than 1:50 (2.00%) in all directions.	1	-	-
55	Main Entrance - Top Drop Box	Ext.		Operable Parts / Reach Range	Drop Box

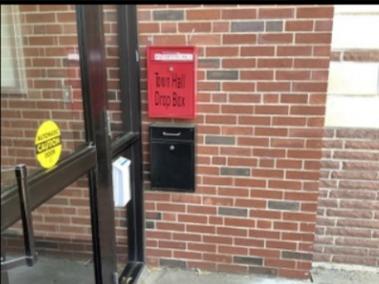
Reach < 15" or > 48"(forward/side approach)	57.5"	Relocate drop box so that controls are between 15"- 48" above the finished floor.	1	-	-

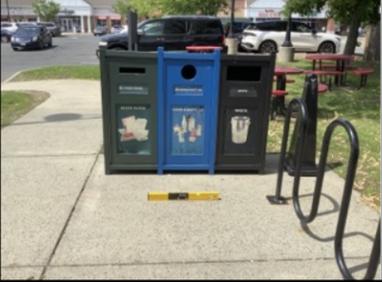
ID	Location	Floor	Room	Element	Type	Photo	Issues	Current Measure	Recommendations	Quantity	Price	Cost Estimation
56	Next to Accessible Parking Spaces	Ext.		Operable Parts / Reach Range	Trash/Recycling

Clear floor space is not provided	3.3%	Relocate bins to a level surface that is sloped no greater than 1:50 (2.00%).	1	-	-
57	Route by Book Donation Bin	Ext.		Operable Parts / Reach Range	Equipment

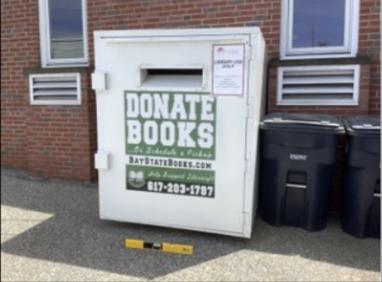
Clear floor space is not provided Reach < 15" or > 48"(forward/side approach)	2.8%, 6.9% 56.5"	Ensure that staff is available to assist visitors who need assistance.	1	-	-
<div style="background-color: #e0e0e0; padding: 5px;">Picnic Tables</div>												
58	Near Parking Lot	Ext.		Picnic Tables	N/A

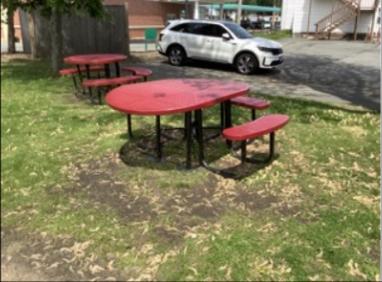
Picnic table not on an accessible route	-	Ensure that the picnic table is connected to an accessible route.	1	Labor	Labor
<div style="background-color: #e0e0e0; padding: 5px;">Toilet & Bathing Rooms</div>

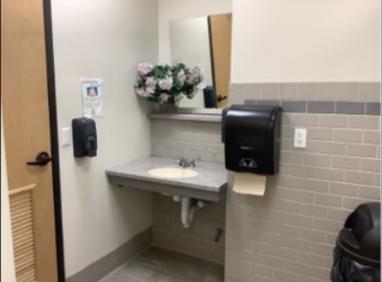
<div style="background-color: #e0e0e0; padding: 5px;">Lavatory</div>												
59	Women's Toilet Room	1		Lavatory	N/A

Mirror above lavatory w/reflective surface > 40"	49.5"	Lower mirror so that the bottom surface is at 40" max. above the finished floor.	1	Labor	Labor

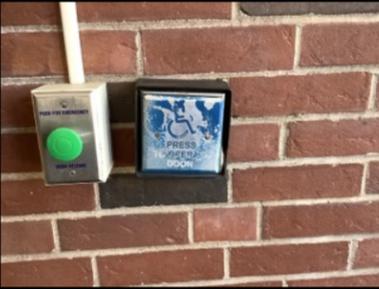
ID	Location	Floor	Room	Element	Type	Photo	Issues	Current Measure	Recommendations	Quantity	Price	Cost Estimation
69	Main Entrance Interior Automatic Door Opener	1

Recommend repainting the automatic door opener push button.	1	-	-
70	Main Entrance Interior Automatic Door Opener to Offices	1

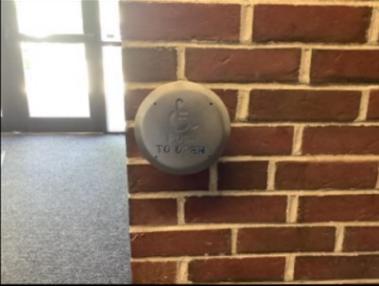
Recommend repainting the automatic door opener push button.	1	-	-
71	Men's Toilet Room and Women's Toilet Rooms	1

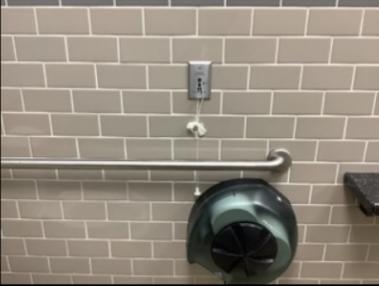
Emergency pull cords are tied in the toilet rooms. This may make it difficult for someone who has fallen to reach them. IHCD recommends ensuring that the pull cords extend down to 12" above the finished floor.	2	-	-
72	Mother's Room	1

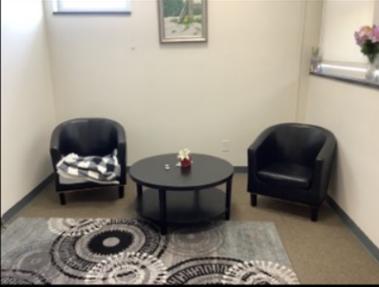
Recommend providing comfortable reclining seats with a back, armrests, lumbar, tension and height adjustments.	1	-	-
73	Public Stairs	1

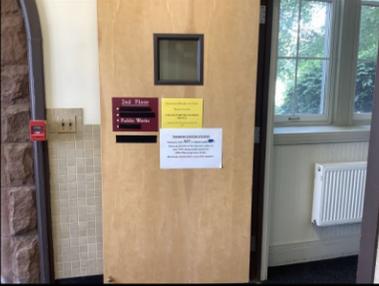
Recommend updating the informational sign on the door that lists Town departments.	1	-	-

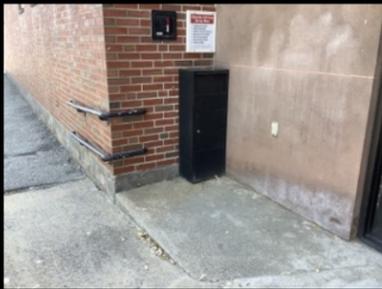
ID	Location	Floor	Room	Element	Type	Photo	Issues	Current Measure	Recommendations	Quantity	Price	Cost Estimation
74	Clerks Office Drop Box	Ext.

Recommend repairing the change in level at the drop box or providing a barrier at the edge to ensure anyone using the drop box doesn't trip/fall over the edge onto the ramp.	1	-	-
75	Curb Ramp Near Accessible Parking Spaces	Ext.

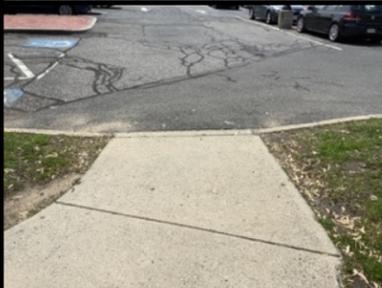
Recommend providing a detectable warning at the end of the curb ramp.	1	-	-
76	Entrance Near Building Department	Ext.

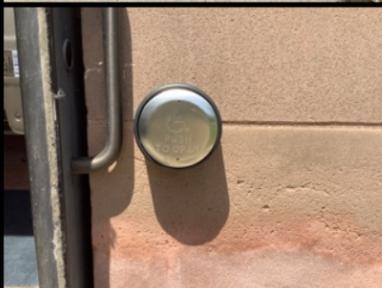
1"	Recommend repainting the automatic door opener push button.		-	-
77	Near Parking Lot	Ext.

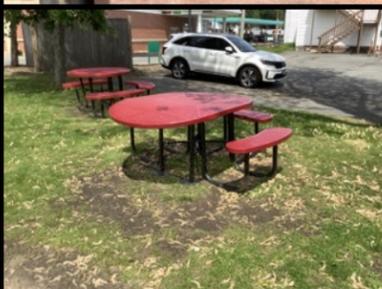
-	Recommend providing a stable, firm and slip-resistant surface that is 48" clear on all sides of at least one accessible picnic table that is located on an accessible route in each distinct area where picnic tables are provided.	1	-	-
78	Parking Lot	Ext.

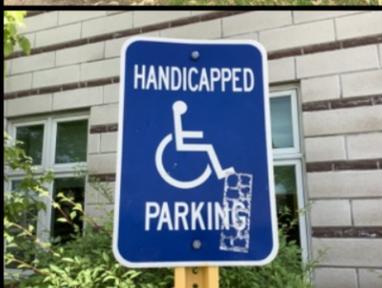
At all accessible parking spaces, recommend replacing the identification sign with one that includes the text "Accessible" parking instead of "Handicapped" parking.	1	-	-

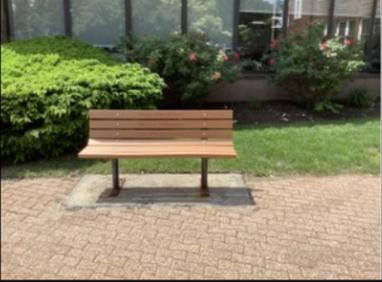
ID	Location	Floor	Room	Element	Type	Photo	Issues	Current Measure	Recommendations	Quantity	Price	Cost Estimation
79	Towards Entrance Near Building Department	Ext.

Recommend providing some benches with armrests to help assist people who have difficulty lifting from and lowering onto the bench.	1	-	-
