Town Hall Annex

Town of East Longmeadow ADA Transition Plan

June 2025

Institute for Human Centered Design

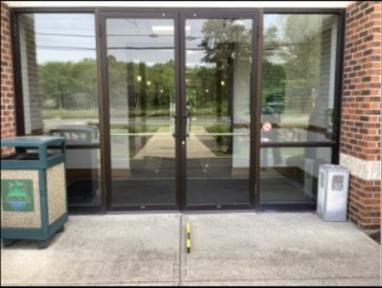
ID	Location	Floor	Room	Element	Type	Photo	Issues	Current Measure	Recommendations	Quantity	Price	Cost Estimation
Entrance												
6	Entrance Near North Main Street (North Side)	Ext.		Entrance	Secondary Entrance

Maneuvering clearance at door > 1:50 (2.00%)	2.6%	Provide an automatic door opener. Recommendation also applies to the entrance near the parking.	2	9900	\$10K - \$50K
											19800	
Access to Goods and Services												
Means of Egress												
7	Egress Near Parking (South Side)	1		Means of Egress	N/A

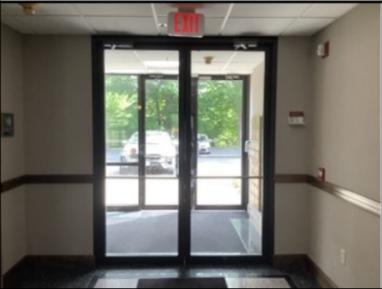
Tactile exit sign not provided	-	Ensure that a tactile exit sign with raised characters and braille is provided at the exit door. Mount the sign between 48"- 60" above the finished floor located on the latch side of the door. Recommendation also applies to the egress near North Main Street.	2	413	\$500 - \$1K
											826	
Doors, Doorways, & Gates												
8	Assessor's Office	2		Doors, Doorways, & Gates	Office

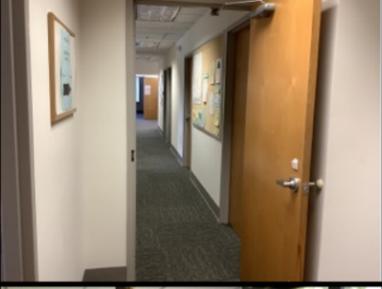
Maneuvering clearance(s) not provided	14.25"	Ensure door remains open during business hours.	1	Labor	Labor

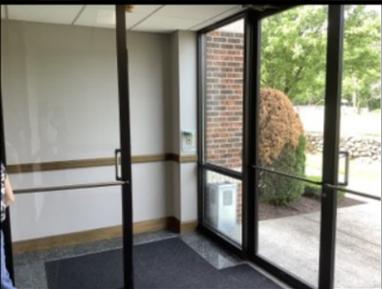
9	Egress Near North Main Street (North Side)	1		Doors, Doorways, & Gates	Vestibule

Distance between doors in series < 48"	46"	Provide an automatic door opener. Refer to ID #6 for further cost information.	1	-	-

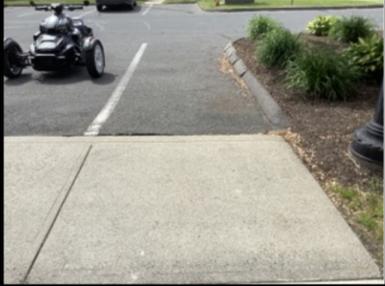
ID	Location	Floor	Room	Element	Type	Photo	Issues	Current Measure	Recommendations	Quantity	Price	Cost Estimation
Detectable Warning												
24	Parking	Ext.		Detectable Warning	N/A

-	Recommend providing a detectable warning at the entrance to the parking lot, to alert pedestrians they are entering a vehicular way.	1	-	-
Glare												
25	First Floor Hallway	1		Glare	N/A

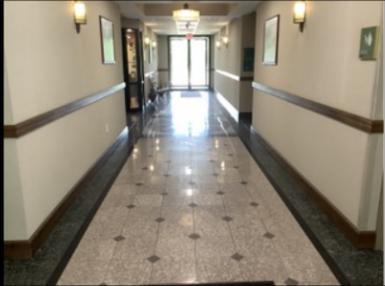
-	Recommend switching to a matte flooring finish. The floor is so highly polished that it creates a glare problem. Many people with low vision and some with perceptual disabilities may have difficulty navigating the floor surface.	1	-	-
Signage												
26	Elevator	2		Signage	N/A

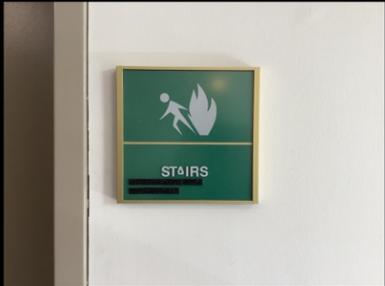
-	Recommend removing the sign that states "Stairs" as it is next to the elevator and can potentially be confusing, or provide a sign that states in simple language, "In case of fire, do not use elevator, use stairs".	1	-	-
Stairways

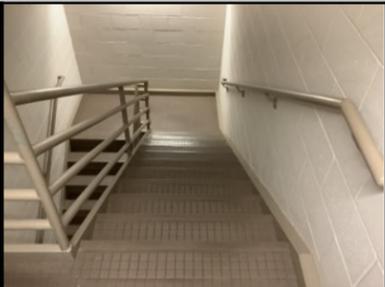
27	Stairs Near Elevator	2		Stairways	Interior

-	Recommend providing a contrasting strip at each stair tread on the stair so that each tread is readily apparent when viewed in descent. Recommendation applies to all interior stairs.	1	-	-
