Transfer Station

Town of East Longmeadow ADA Transition Plan

July 2025

Institute for Human Centered Design

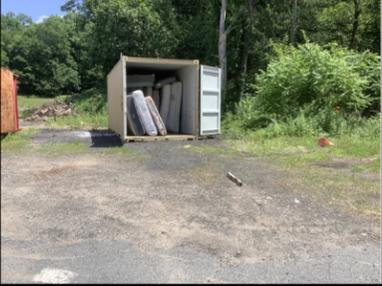
Running slope > 1:20 (5.00%) Surface is not stable, firm, and slip-resistant	11.7%	Near the various disposal areas where visitors are likely to navigate after exiting parked cars, reduce running slope to be no steeper than 1:20 (5.00%). Repair surface. Ensure that surface is stone dust, asphalt or concrete. Or assist visitors with disabilities as needed with disposing of items.	1	-	-
2	Transfer Station	1		Exterior Access Route	Exterior

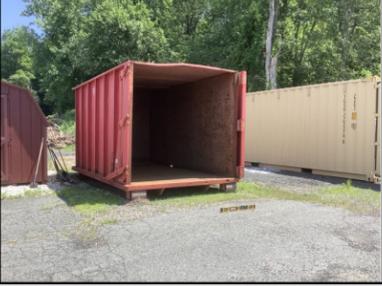
Cross slope > 1:50 (2.00%) Surface is not stable, firm, and slip-resistant	3.6%	Reduce cross slope to be no steeper than 1:50 (2.00%). Repair surface. Or assist visitors with disabilities as needed with disposing of items.	1	-	-

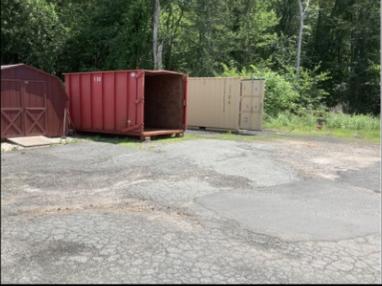
If staff continues their policy of not being able to assist visitors, we recommend providing an accessible parking space, sloped no greater than 1:50 (2.00%) in all directions and a marked access aisle at each disposal container so that people of all abilities are able to dispose of items. We recommend that staff is available by appointment to help people with disabilities dispose of their items.	1	-	-
