Heritage Park

Town of East Longmeadow ADA Transition Plan

October 2025

Institute for Human Centered Design

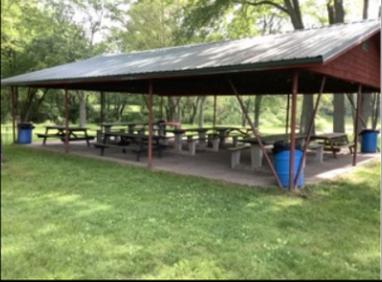
ID	Location	Floor	Room	Element	Type	Photo	Issues	Current Measure	Recommendations	Quantity	Price	Cost Estimation
11	Picnic Area	Ext.		Exterior Access Route	Exterior

Accessible route not provided	-	Ensure an accessible route is provided to the picnic area.	1	-	-
12	To Fields	Ext.		Exterior Access Route	Walkway

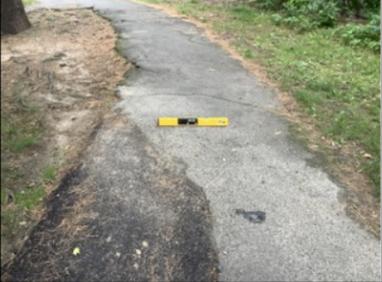
Cross slope > 1:50 (2.00%)	3.9%	Reduce cross slope to be no steeper than 1:50 (2.00%). Recommendation applies to the entire route from the playground to the fields.	1	-	-
13	To Fields	Ext.		Exterior Access Route	Exterior

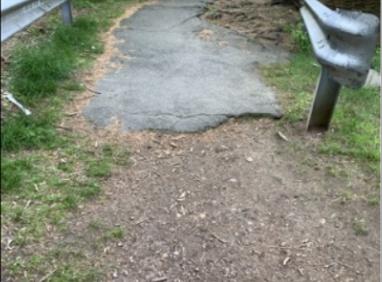
Level changes > 1/4"	2"	Alter change in level to be 1/4" high max.	1	-	-
14	To Fields	Ext.		Exterior Access Route	Walkway

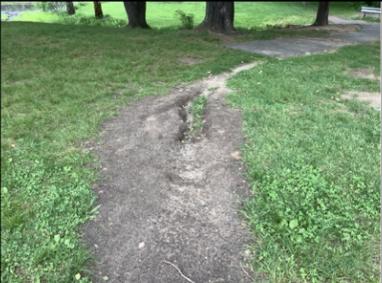
Route not maintained in operable working condition	-	Repair surface to ensure the accessible route is maintained in operable working condition. Recommendation applies to all walkways with a similar issue.	1	-	-
15	To Fields	Ext.		Exterior Access Route	Exterior

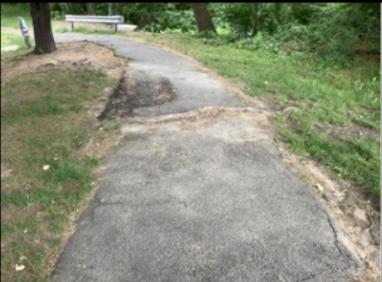
Level changes > 1/4" Route not maintained in operable working condition	2" -	Alter change in level to be 1/4" high max. Repair surface to ensure the accessible route is maintained in operable working condition.	1	-	-

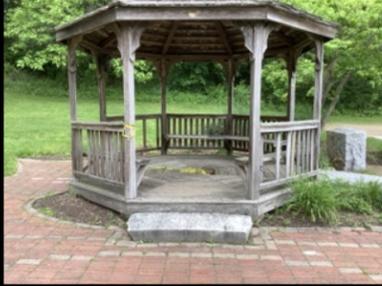
ID	Location	Floor	Room	Element	Type	Photo	Issues	Current Measure	Recommendations	Quantity	Price	Cost Estimation
Exterior Stair												
21	Gazebo	Ext.		Exterior Stair	N/A

Handrails not provided	-	Provide handrails on both sides. Recommendation applies to both sides of the gazebo.	2	-	-
22	Pavilion Near Pond	Ext.		Exterior Stair	N/A

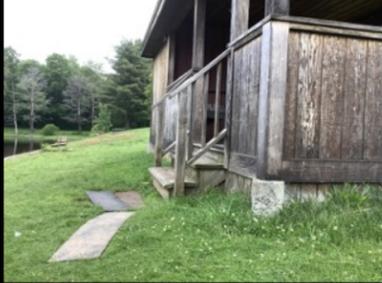
Bottom handrail extends < 12" + one tread Cross section of handrail is not compliant	- -	Bottom: Ensure that the sloped bottom extension extends one tread depth min. beyond last riser nosing in same direction as stair flight. Provide handrails with 1 1/4" - 2" circular cross sections.	1	-	-
Access to Goods and Services												
Doors, Doorways, & Gates												
23	Dog Park	Ext.		Doors, Doorways, & Gates	Other

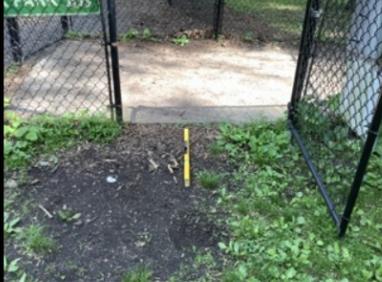
Maneuvering clearance at door > 1:50 (2.00%)	5%	Alter so that the slope in all directions is no greater than 1:50 (2.00%).	1	-	-
Operable Parts / Reach Range

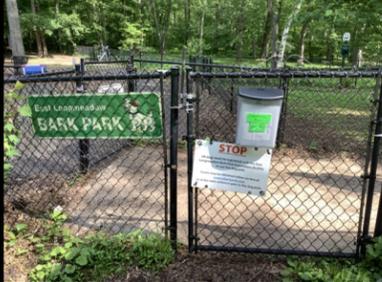
24	Dog Park	Ext.		Operable Parts / Reach Range	Other

Reach < 15" or > 48"(forward/side approach)	54"	Relocate gate plunger so that controls are no higher than 48" above the ground. Recommendation also applies to the small and large dog parks.	3	-	-

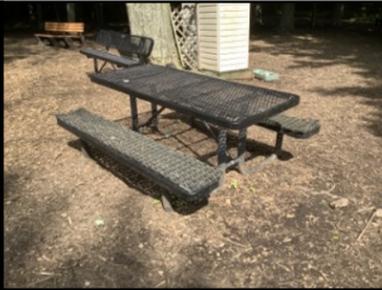
ID	Location	Floor	Room	Element	Type	Photo	Issues	Current Measure	Recommendations	Quantity	Price	Cost Estimation
Picnic Tables												
25	Large Dog Park	Ext.		Picnic Tables	N/A

Picnic table not on an accessible route	-	Ensure that the picnic table is connected to an accessible route. Recommendation also applies to picnic tables near the pond and the playground.	3	-	-
26	Near Desire Path	Ext.		Picnic Tables	N/A

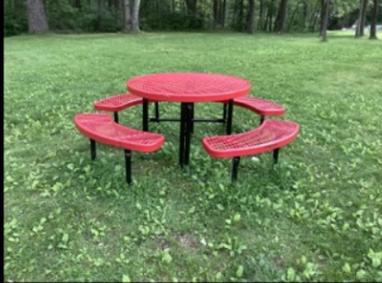
30" clear width not provided Picnic table not on an accessible route	17" -	Provide at least 1 accessible picnic table (or ensure that 5% of picnic tables are accessible) with a 30" by 48" clear floor space. Ensure that the picnic table is connected to an accessible route. (Cost estimate is for an accessible picnic table.)	1	2310	\$1K - \$5K
											2310	
27	Near Pavilion	Ext.		Picnic Tables	N/A

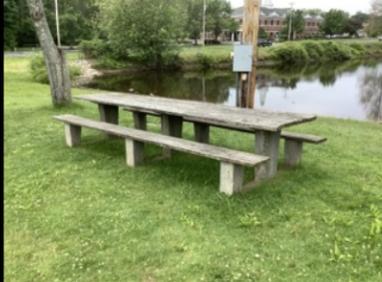
Picnic table not on an accessible route Knee clearance less than 19" deep	- 10"	Ensure that the picnic table is connected to an accessible route. Provide at least one picnic table with knee clearance that is 19" deep min. (Cost estimate is for an accessible picnic table.)	1	2310	\$1K - \$5K

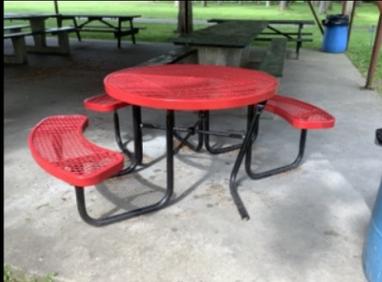
2310	
28	Picnic Area	Ext.		Picnic Tables	N/A

30" clear width not provided	25"	Provide at least 1 accessible picnic table (or ensure that 5% of picnic tables are accessible) with a 30" by 48" clear floor space. (Cost estimate is for an accessible picnic table.)	1	2310	\$1K - \$5K
											2310	
29	Small Dog Park	Ext.		Picnic Tables	N/A

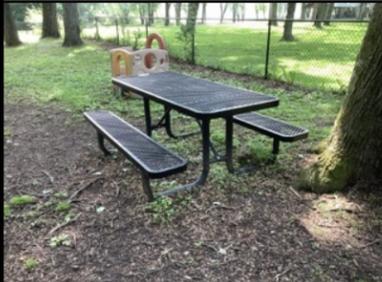
Picnic table not on an accessible route Knee clearance less than 19" deep	- 12.25"	Ensure that the picnic table is connected to an accessible route. Provide at least one picnic table with knee clearance that is 19" deep min. (Cost estimate is for an accessible picnic table.)	1	2310	\$1K - \$5K
											2310

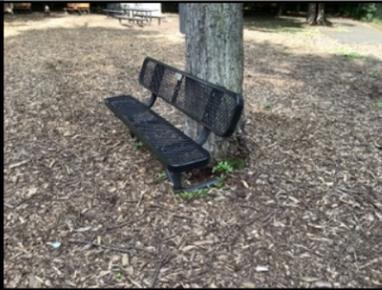
ID	Location	Floor	Room	Element	Type	Photo	Issues	Current Measure	Recommendations	Quantity	Price	Cost Estimation
Exterior Benches												
30	Large Dog Park	Ext.		Exterior Benches	N/A

No accessible route to one bench in area	-	Relocate one bench to an accessible route or provide an accessible route to one bench in this area. Recommendation also applies to benches near the pond, playground, and small dog park.	4	-	-
Toilet & Bathing Rooms												
Portable Toilet												
31	Near Baseball Field	Ext.		Portable Toilet	N/A

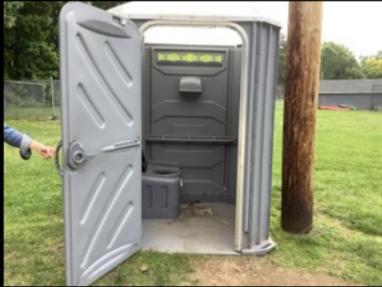
Not located on an accessible route 60" by 72" clear space not provided	- 56.75" x 57"	Locate portable toilet on an accessible route. Provide an accessible portable toilet that has 60" wide and 72" deep at the toilet. Recommendation also applies to a portable toilet near the soccer field.	2	-	-
Recreation Facilities												
Play Areas												
32	Playground	Ext.		Play Areas	N/A

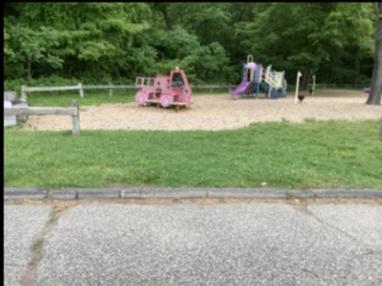
Accessible route not provided to playground	-	Install an accessible route to and around the playground.	1	-	-

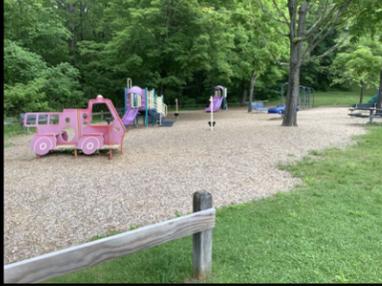
33	Playground	Ext.		Play Areas	N/A

Accessible route not provided around playground Accessible route not provided to play components	- -	Provide an accessible route around the play area. Provide a compliant impact-attenuating surface to and around the play components.	1	-	-

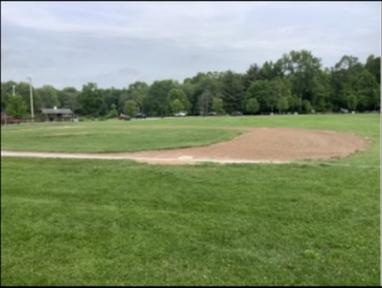
ID	Location	Floor	Room	Element	Type	Photo	Issues	Current Measure	Recommendations	Quantity	Price	Cost Estimation
Field												
34	Baseball Field	Ext.		Field	Baseball

Field not connected to an accessible route No accessible route to all areas of sport activity	- -	Provide an accessible route to the baseball field. Install an accessible route between all areas of sport activity. Recommendation applies to both baseball fields and the soccer field.	3	-	-
35	Baseball Field - Visitor Dugout	Ext.		Field	Baseball

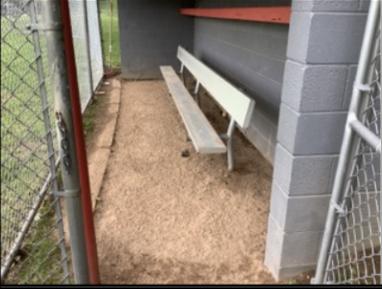
Accessible spaces not provided at team seating	-	Provide a 36" x 48" firm, stable, and slip-resistant clear floor space at team seating. Provide an accessible route to this space. Recommendation applies to the visitor and home dugouts at both baseball fields and the soccer field.	5	-	-
36	Near Baseball Field	Ext.		Field	Baseball

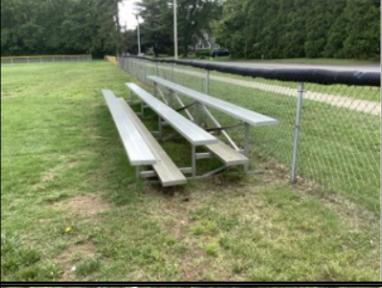
Accessible spaces not provided at sidelines seating No accessible route to all areas of sport activity	- -	Provide a 36" x 60" firm, stable, and slip-resistant clear floor space at sidelines seating. Based on the number of seats provided, look to 2010 ADA Table 221.2.1, and provide the minimum number of wheelchair seats based on that count. Provide an accessible route to this space. Install an accessible route between all areas of sport activity.	1	-	-

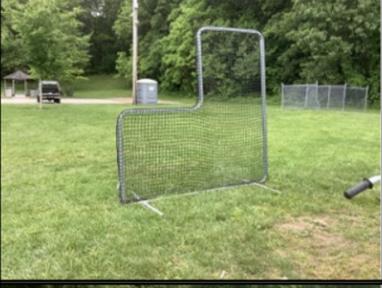
37	Near Baseball Field	Ext.		Field	Baseball

Practice areas are not on an accessible route	-	Provide an accessible route to practice areas.	1	-	-
38	To Soccer Field	Ext.		Field	Soccer

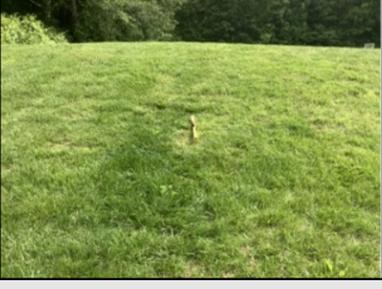
Field not connected to an accessible route	29.1%	Provide an accessible route to the soccer field.	1	-	-
Best Practice

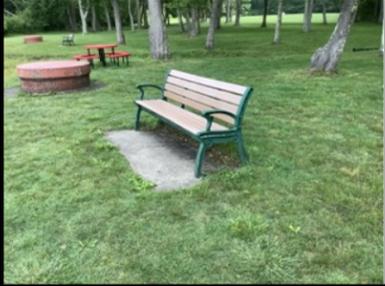
ID	Location	Floor	Room	Element	Type	Photo	Issues	Current Measure	Recommendations	Quantity	Price	Cost Estimation
Clear Floor Space												
39	Near Pond	Ext.		Clear Floor Space	N/A

-	Recommend providing a 36" min. by 48" min. stable, firm and slip-resistant surface adjacent to at least one bench in each area where benches are provided positioned to allow a person in a wheeled mobility device and a person sitting on the bench to have their shoulders aligned.	1	-	-
Exterior Access Route												
40	To Fields	Ext.		Exterior Access Route	Exterior

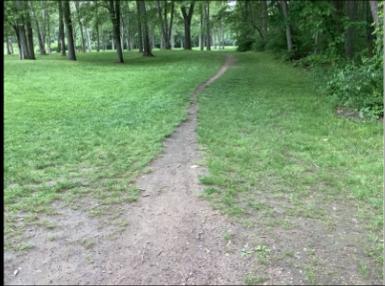
-	Recommend paving the existing desire path.	1	-	-
Off-Street Parking Lot or Garage												
41	Parking Near Dog Park	Ext.		Off-Street Parking Lot or Garage	Visitor

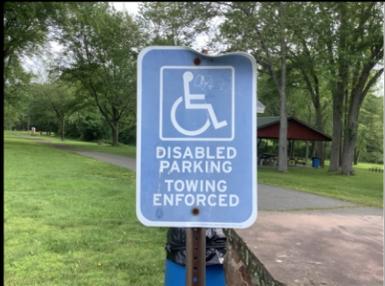
-	Recommend replacing the identification sign with one that includes the text "Accessible" parking instead of "Disabled" parking.	1	-	-
42	Parking Near Pavilion	Ext.		Off-Street Parking Lot or Garage	Visitor

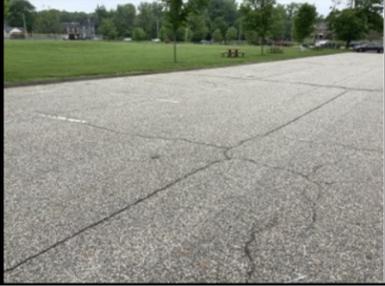
-	Recommend repainting the faded parking lines.	1	-	-
