Mapleshade Elementary School

Town of East Longmeadow ADA Transition Plan

October 2025

Institute for Human Centered Design

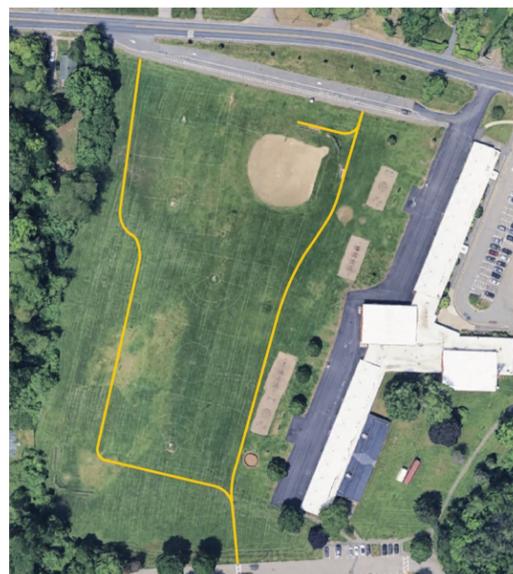
Figure 1: In the following image, the yellow lines show approximate routes to connect the softball and soccer/lacrosse fields, along with the team seating areas associated with each field, to the nearest accessible routes.

Accessibility issues include a lack of an accessible route to the softball and soccer/lacrosse fields.

Additional accessibility issues at the softball and soccer/lacrosse fields include lack of accessible spectator and team seating spaces.

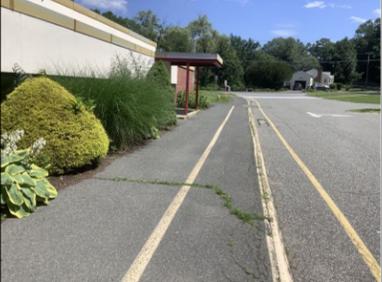
Surface openings > 1/2" Route not maintained in operable working condition	1"	Ensure that the surface opening is no greater than 1/2" max. Repair cracked openings in the surface to ensure the accessible route is maintained in operable working condition.	1	-	-
2	By Classroom 9	Ext.	-	Exterior Access Route	Walkway

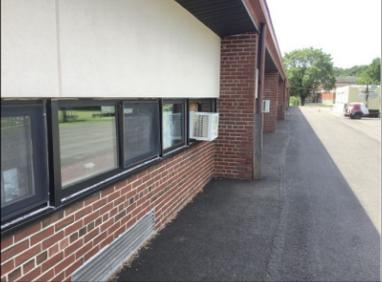
Obstructed by protruding objects	11.5"	Provide a cane-detectable barrier underneath the air conditioner unit located 27" max. above the ground. Recommendation applies to all air conditioner units with a similar issue. Note: Unit cost is provided for one instance of this repetitive item.	1	657	\$500 - \$1K

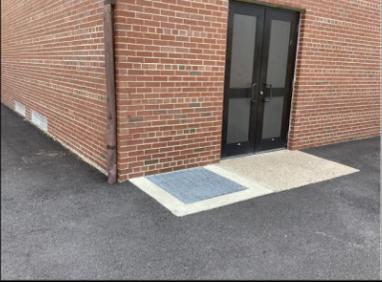
3	By Gymnasium West Egress	Ext.	-	Exterior Access Route	Walkway

Surface openings > 1/2"	1"	Replace drainage grates so that openings are 1/2" max. and the long opening dimension is perpendicular to the dominant direction of travel.	1	-	-
4	By South Side of Building	Ext.	-	Exterior Access Route	Walkway

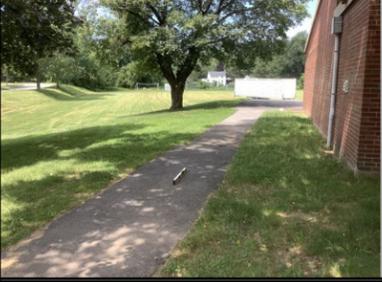
Cross slope > 1:50 (2.00%) Running slope > 1:20 (5.00%)	5.3% 7.5%	Reduce cross slope to be no steeper than 1:50 (2.00%). Reduce running slope to be no steeper than 1:20 (5.00%) or build a compliant ramp.	1	-	-
5	By South Side of Building	Ext.	-	Exterior Access Route	Walkway

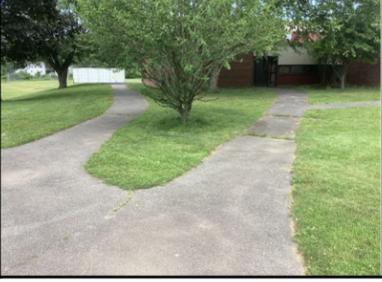
Route not maintained in operable working condition Vertical clearance < 80" above ground	- -	Repair cracked openings in the surface to ensure the accessible route is maintained in operable working condition. Trim and maintain low hanging tree branches so they are 80" min. above the ground.	1	- Labor	- Labor

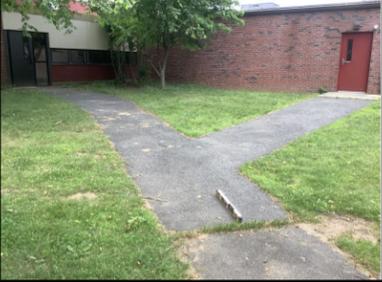
ID	Location	Floor	Room	Element	Type	Photo	Issues	Current Measure	Recommendations	Quantity	Price	Cost Estimation
6	From Classroom 17 Southwest Egress and Southeast Egress by Classroom 16	Ext.	-	Exterior Access Route	Walkway

Running slope > 1:20 (5.00%) Route not maintained in operable working condition	8% -	Reduce running slope to be no steeper than 1:20 (5.00%) or build a compliant ramp. Repair cracked openings in the surface to ensure the accessible route is maintained in operable working condition.	1	-	-
7	From Southeast Egress by Classroom 16	Ext.	-	Exterior Access Route	Walkway

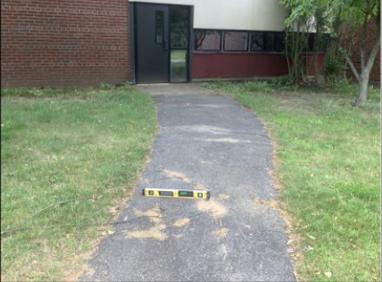
Cross slope > 1:50 (2.00%)	5.5%	Reduce cross slope to be no steeper than 1:50 (2.00%).	1	-	-
8	Parent Drop Off by Mapleshade Avenue	Ext.	-	Exterior Access Route	Sidewalk

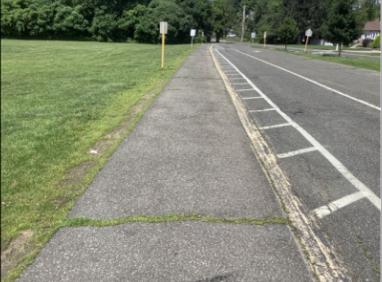
Surface openings > 1/2" Route not maintained in operable working condition	3" -	Ensure that the surface opening is no greater than 1/2" max. Repair cracked openings in the surface to ensure the accessible route is maintained in operable working condition.	1	-	-

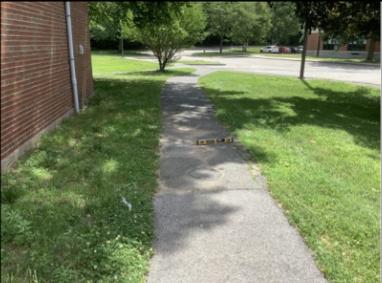
9	South Side of Building	Ext.	-	Exterior Access Route	Walkway

Cross slope > 1:50 (2.00%) Route not maintained in operable working condition	5.9%	Reduce cross slope to be no steeper than 1:50 (2.00%). Repair cracked openings in the surface to ensure the accessible route is maintained in operable working condition.	1	-	-
10	To Main Entrance - North Side	Ext.	-	Exterior Access Route	Walkway

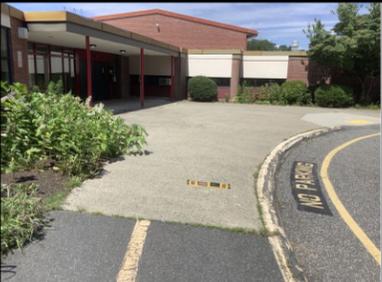
Surface openings > 1/2" Cross slope > 1:50 (2.00%)	1" 4.2%	Ensure that the surface opening is no greater than 1/2" max. Reduce cross slope to be no steeper than 1:50 (2.00%).	1	-	-

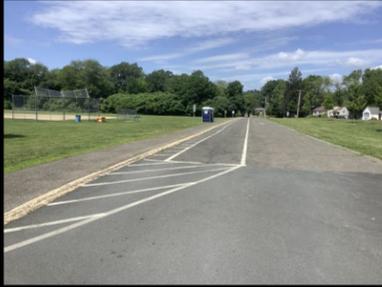
ID	Location	Floor	Room	Element	Type	Photo	Issues	Current Measure	Recommendations	Quantity	Price	Cost Estimation
21	Parent Drop Off by Mapleshade Avenue	Ext.	-	Passenger Loading Zones	N/A

Zone not connected to an accessible route Sign with ISA not provided (MAAB)	- -	Ensure the passenger loading zone is connected to an accessible route. Provide a sign that includes the International Symbol of Accessibility (ISA) at the head of the space. Locate the sign so that the bottom is 60" min. above the ground and the top is 96" max. above the ground. (Cost estimate is for signage.)	1	- 825	\$500 - \$1K
<p>Access to Goods and Services <input type="text" value="Access to Goods and Services"/></p> <p>Means of Egress <input type="text" value="Means of Egress"/></p>												
22	East Egress by Special Education Classroom 6	1	-	Means of Egress	N/A

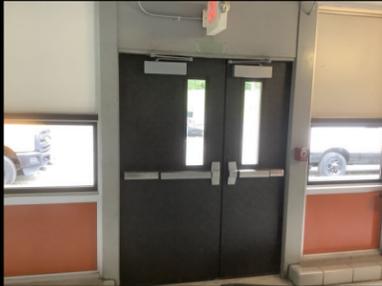
Tactile exit sign not provided Directional sign to accessible emergency exit not provided	- -	Ensure that a tactile exit sign with raised characters and braille is provided at the exit door. Mount the sign between 48" - 60" above the finished floor located on the right-side of the right-handed door. Provide a directional sign indicating the location of the nearest accessible emergency exit above the tactile sign. Recommendation also applies to the east egress door by Classroom 2 and the cafeteria egress.	3	413 413	\$1K - \$5K

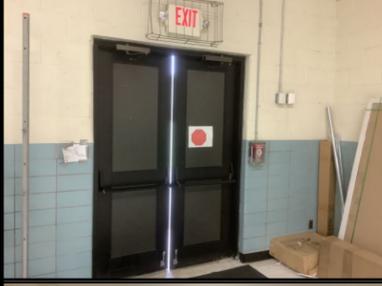
23	Gymnasium West Egress	1	-	Means of Egress	N/A

Tactile exit sign not provided Illuminated ISA symbol not provided (MAAB)	- -	Ensure that a tactile exit sign with raised characters and braille is provided at the exit door, located on the latch side of the door. When the illuminated exit sign is repaired or replaced, provide an illuminated sign with the International Symbol of Accessibility (ISA). Recommendation applies to all exit doors with a similar issue. Note: Unit cost is provided for one instance of this repetitive item.	1	413	\$1 - \$500
24	Main Exit - North Side	1	-	Means of Egress	N/A

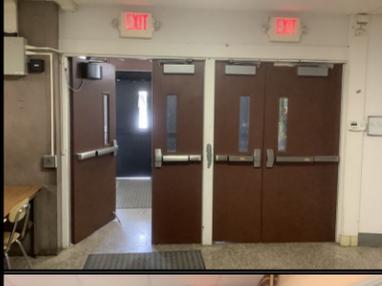
Tactile exit sign not provided Illuminated ISA symbol not provided (MAAB)	- -	Ensure that a tactile exit sign with raised characters and braille is provided at the exit door. Mount the sign between 48" - 60" above the finished floor located on the right side of the right handed door, at the right double-leaf door. When the illuminated exit sign is repaired or replaced, provide an illuminated sign with the International Symbol of Accessibility (ISA).	1	413	\$1 - \$500

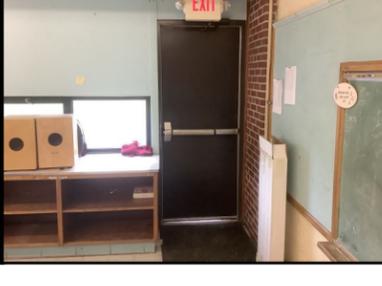
25	Music Classroom	1	8	Means of Egress	N/A

Tactile exit sign not provided Illuminated ISA symbol not provided (MAAB)	- -	Ensure that a tactile exit sign with raised characters and braille is provided at the exit door, located on the latch side of the door. When the illuminated exit sign is repaired or replaced, provide an illuminated sign with the International Symbol of Accessibility (ISA). Recommendation applies to all exit doors with a similar issue. Note: Unit cost is provided for one instance of this repetitive item.	1	413	\$1 - \$500

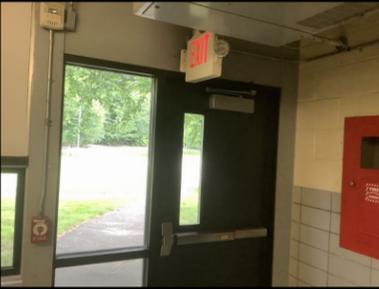
ID	Location	Floor	Room	Element	Type	Photo	Issues	Current Measure	Recommendations	Quantity	Price	Cost Estimation
31	East Egress by Classroom 16	1	-	Doors, Doorways, & Gates	Emergency Egress

Exterior door requires > 15 lbs. of force to open	30 lbs.	Adjust closers so doors do not require more than 15 pounds of force to open. Recommendation applies to all exterior doors with a similar issue.	1	Labor	Labor
32	Fourth Grade Classroom	1	9	Doors, Doorways, & Gates	Classroom

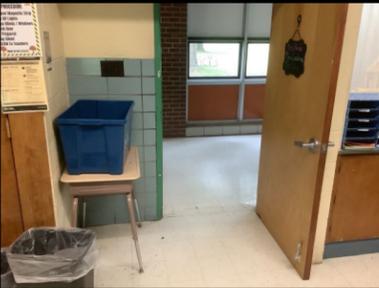
Maneuvering clearance(s) not maintained	-	Relocate the work surface to maintain the required 18" of pull side maneuvering clearance on the latch side of the door. Recommendation applies to all doors with a similar issue.	1	Labor	Labor
33	Gifted and Talented Classroom	1	-	Doors, Doorways, & Gates	Classroom

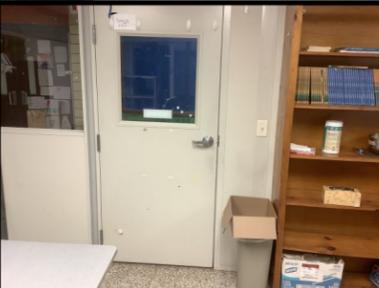
Maneuvering clearance(s) not maintained	16"	Relocate the book shelf and other stored items to maintain the 18" maneuvering clearance on the latch side of the door.	1	Labor	Labor

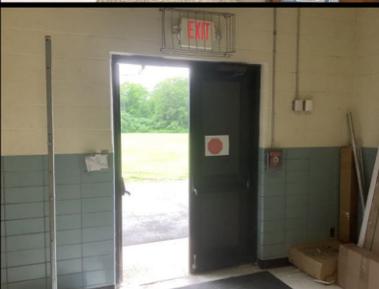
34	Gymnasium West Egress	1	-	Doors, Doorways, & Gates	Emergency Egress

If double-leaf door, neither compliant	27.5"	Provide an automatic door opener that opens both doors.	1	9900	\$5K - \$10K
35	Music Classroom	1	8	Doors, Doorways, & Gates	Emergency Egress

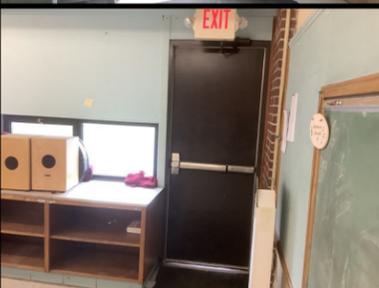
Maneuvering clearance not provided at recess > 6" Exterior door requires > 15 lbs. of force to open	25.25" 20 lbs.	Install an automatic door opener. Ensure that door opening pressure is monitored and kept in compliance at all doors by maintenance staff every 6 months. Exterior doors should require no more than 15 lbs. of force. Recommendation applies to all doors with a similar issue. Note: Unit cost is provided for one instance of this repetitive item.	1	9900 Labor	\$5K - \$10K

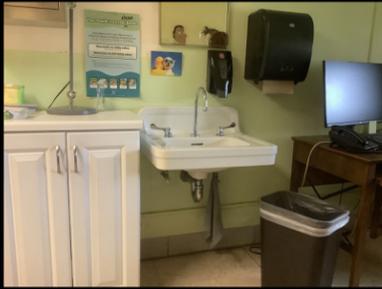
ID	Location	Floor	Room	Element	Type	Photo	Issues	Current Measure	Recommendations	Quantity	Price	Cost Estimation
69	Nurse's Office	1	-	Sink	N/A

Toe and knee clearances not provided Exposed plumbing underneath sink Mirror above sink w/reflective surface > 40"	23.25" - 50.25"	Ensure there is a 27" min. knee clearance positioned for a forward approach. Insulate or otherwise configure pipes at sink. Lower mirror so that the bottom surface is at 40" max. above the finished floor.	1	5106 248 825	\$5K - \$10K
<div style="border: 1px solid gray; padding: 5px; margin-bottom: 5px;"> Recreation Facilities </div> <div style="border: 1px solid gray; padding: 5px;"> Play Areas </div>												
70	North Playgrounds	Ext.	-	Play Areas	N/A

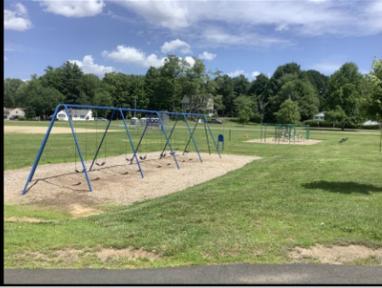
Accessible route not provided to playground Accessible route not provided around playground Accessible route not provided to play components	- - -	Install an accessible route to and around the playground. Provide an accessible route around the play area. Provide a compliant impact-attenuating surface to and around the play components. Recommendation applies to all playgrounds with a similar issue.	1	-	-

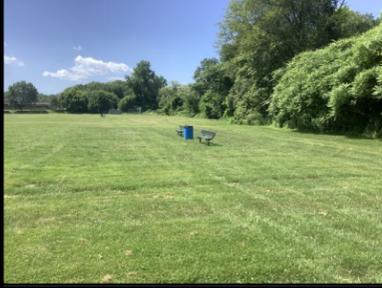
<div style="border: 1px solid gray; padding: 5px;"> Field </div>												
71	North Soccer/Lacrosse Field Spectator Seating	Ext.	-	Field	Soccer

Accessible spaces not provided at sidelines seating	-	Provide a 36" x 60" firm, stable, and slip-resistant clear floor space at sidelines seating. Provide an accessible route to this space.	1	-	-
72	North Softball Field	Ext.	-	Field	Softball

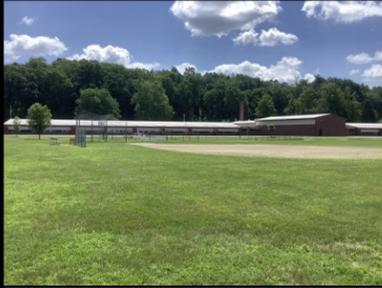
Field not connected to an accessible route No accessible route to all areas of sport activity	- -	Provide an accessible route to the boundary of sport activity at the softball field. Recommendation also applies to the north and south soccer/lacrosse fields.	3	-	-
73	North Softball Field - First Base Dugout	Ext.	-	Field	Softball

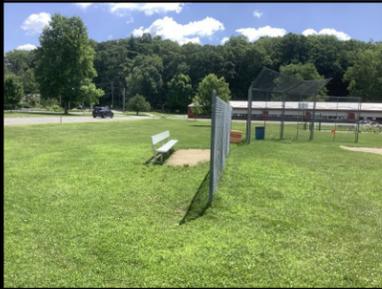
Accessible spaces not provided at team seating	-	Provide a 36" x 48" firm, stable, and slip-resistant clear floor space at team seating. Provide an accessible route to this space. Recommendation also applies to the third base dugout.	2	-	-

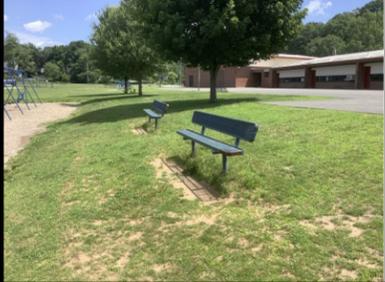
Recommend, when one of the benches is relocated to an accessible route, providing a 36" min. by 48" min. stable, firm and slip-resistant surface adjacent to at least one bench in each area where benches are provided positioned to allow a person in a wheeled mobility device and a person sitting on the bench to have their shoulders aligned.	1	-	-
<div style="border: 1px solid gray; padding: 2px;">Egress Maps</div>												
75	Cafeteria	1	-	Egress Maps	N/A

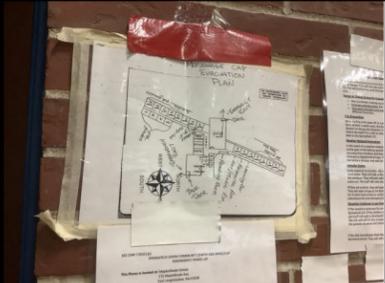
Recommend providing egress maps with text in horizontal orientation. Recommend providing text that is not script, highly decorative, or of other unusual forms. Recommendation applies to all egress maps.	1	-	-

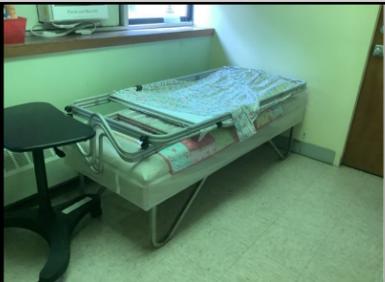
<div style="border: 1px solid gray; padding: 2px;">Exam Bed</div>												
76	Nurse's Office	1	-	Exam Bed	N/A

Recommend providing a height-adjustable exam bed in the nurse's office.	1	-	-
<div style="border: 1px solid gray; padding: 2px;">Lighting</div>												
77	Nurse's Office	1	-	Lighting	N/A

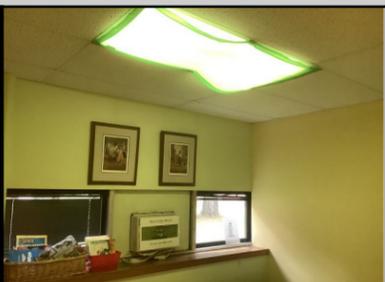
Recommend removing and replacing the green light cover. Note: IHCD survey team observed that the light cover created a green-colored hue within the room.	1	-	-

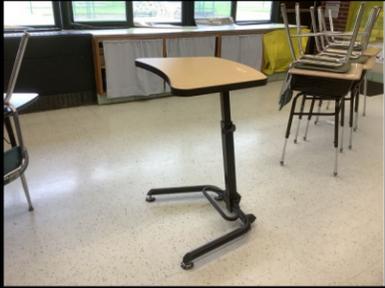
Recommend providing a height-adjustable podium with knee and toe clearance.	1	-	-
Signage												
79	Girls' Multi-User Toilet Room - Grade 3 Wing	1	-	Signage	Designation

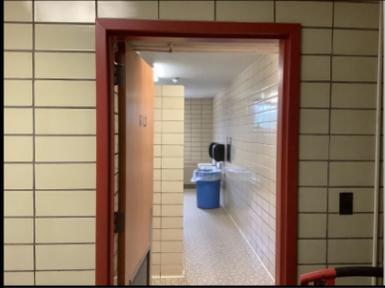
Recommend, for consistency, providing a sign with the International Symbol of Accessibility (ISA) at all toilet rooms.	1	-	-
80	Nurse's Office	1	-	Signage	Designation

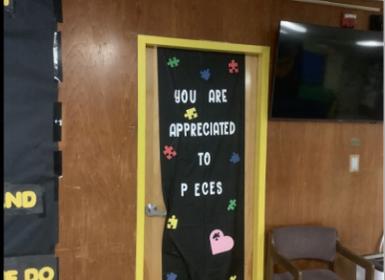
Recommend providing compliant designation signage with raised characters and braille at all permanent rooms that do not provide designation signage.	1	-	-
