Meadow Brook Elementary School

Town of East Longmeadow

ADA Transition Plan

September 2025

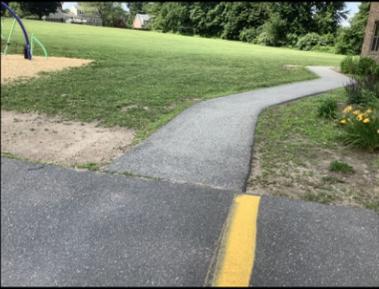
Surface is not stable, firm, and slip-resistant Route not maintained in operable working condition	- -	Remove loose dirt, gravel, and vegetation from surface. Repair cracked openings in the surface to ensure the accessible route is maintained in operable working condition.	1	Labor	Labor
12	By Southwest Egress by Library 39	Ext.	-	Exterior Access Route	Walkway

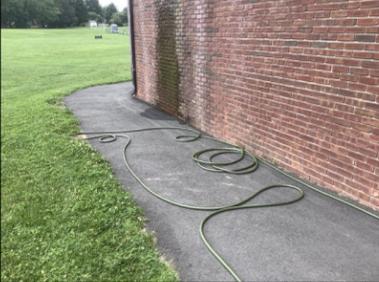
Route not maintained in operable working condition	-	Relocate the hose out of the accessible route.	1	Labor	Labor
13	From Southeast Egress by OT/PT 37	Ext.	-	Exterior Access Route	Walkway

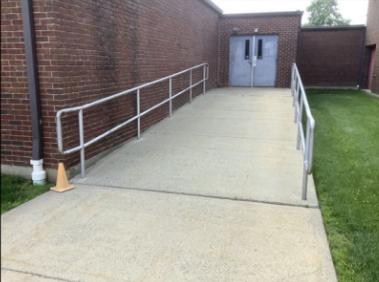
Level changes > 1/4"	1"	Alter change in level to be 1/4" high max.	1	-	-
14	From Southwest Egress by Library 39	Ext.	-	Exterior Access Route	Walkway

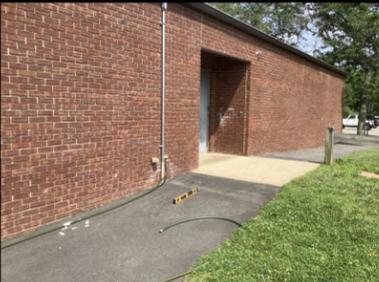
Running slope > 1:20 (5.00%)	9.8%	Reduce running slope to be no steeper than 1:20 (5.00%) or convert to be a compliant ramp.	1	-	-

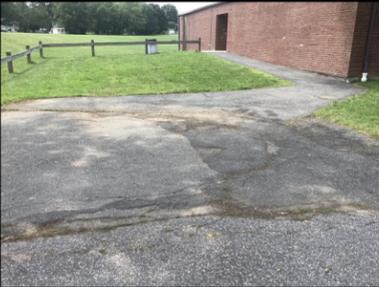
Surface is not stable, firm, and slip-resistant Route not maintained in operable working condition	- -	Remove loose dirt and gravel from the surface. Repair cracked openings in the surface to ensure the accessible route is maintained in operable working condition.	1	-	-
17	Northeast Egress by Gymnasium	Ext.	-	Exterior Access Route	Walkway

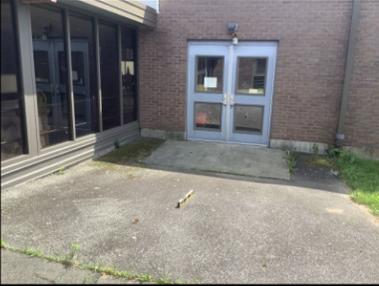
Running slope > 1:20 (5.00%) Level changes > 1/4"	10.2% 1"	Reduce running slope to be no steeper than 1:20 (5.00%). Alter change in level to be 1/4" high max.	1	-	-
18	Northwest Egress by Courtyard	Ext.	-	Exterior Access Route	Walkway

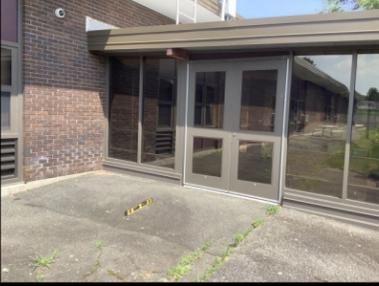
Running slope > 1:20 (5.00%) Route not maintained in operable working condition	9.7% -	Reduce running slope to be no steeper than 1:20 (5.00%). Repair cracked openings in the surface to ensure the accessible route is maintained in operable working condition.	1	-	-

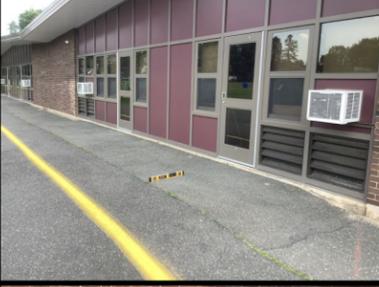
Cross slope > 1:50 (2.00%)	4.7%	Reduce cross slope to be no steeper than 1:50 (2.00%).	1	-	-
20	Southwest Egress by Library 39	Ext.	-	Exterior Access Route	Walkway

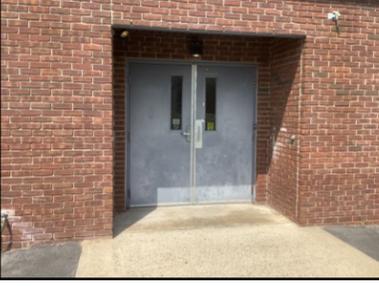
Level changes > 1/4"	0.5"	Alter change in level to be 1/4" high max.	1	-	-

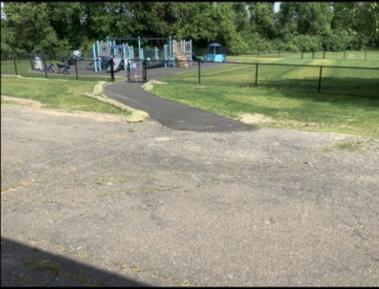
Surface is not stable, firm, and slip-resistant Route not maintained in operable working condition	- -	Remove loose dirt, gravel, and vegetation from surface. Repair cracked openings in the surface to ensure the accessible route is maintained in operable working condition.	1	-	-
22	To Parker Street	Ext.	-	Exterior Access Route	Sidewalk

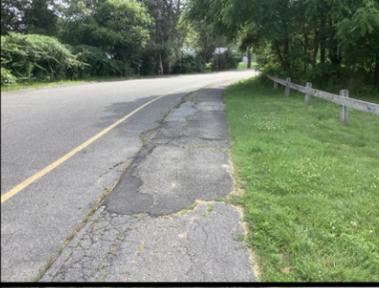
Route not maintained in operable working condition	-	Repair cracked openings in the surface to ensure the accessible route is maintained in operable working condition.	1	-	-
23	To Parker Street/By Baseball Field	Ext.	-	Exterior Access Route	Walkway

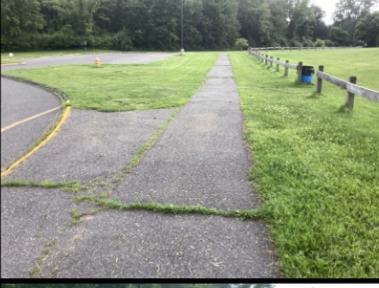
Route not maintained in operable working condition	-	Remove vegetation in the surface to ensure the accessible route is maintained in operable working condition.	1	-	-

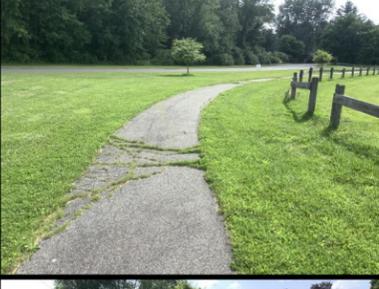
Route not maintained in operable working condition	-	Repair cracked openings and remove vegetation in the surface to ensure the accessible route is maintained in operable working condition.	1	-	-
25	To Porter Road	Ext.	-	Exterior Access Route	Walkway

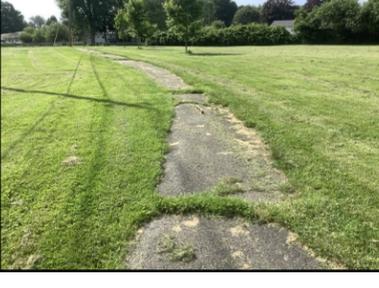
Exterior route < 48" wide Running slope > 1:20 (5.00%) Surface is not stable, firm, and slip-resistant Route not maintained in operable working condition	23" 6% - -	Ensure that a clear width of 48" min. is maintained at the accessible route. Reduce running slope to be no steeper than 1:20 (5.00%). Remove loose dirt, gravel, and vegetation from surface. Repair cracked openings in the surface to ensure the accessible route is maintained in operable working condition.	1	-	-

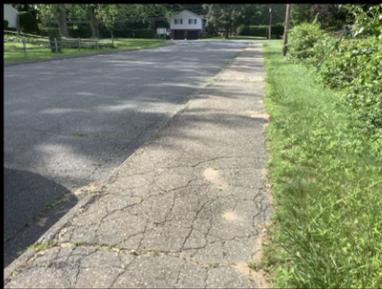
Route not maintained in operable working condition	-	Repair cracked openings in the surface to ensure the accessible route is maintained in operable working condition.	1	Labor	Labor
27	To Secondary Entrance - Northwest Side/Grade 2 Wing	Ext.	-	Exterior Access Route	Walkway

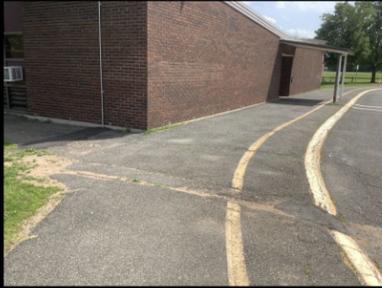
Route not maintained in operable working condition	-	Repair cracked openings in the surface to ensure the accessible route is maintained in operable working condition.	1	-	-
28	To Secondary Entrance - Southeast Side From Courtyard	Ext.	-	Exterior Access Route	Walkway

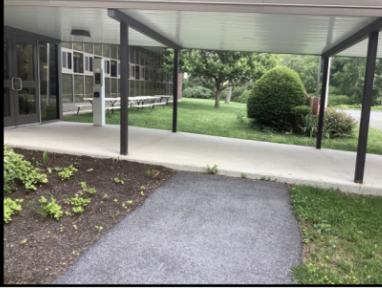
Level changes > 1/4"	4.5"	Alter change in level to be 1/4" high max.	1	-	-
Curb Ramp												
29	Access Road at Porter Road	Ext.	-	Curb Ramp	Blended Transition

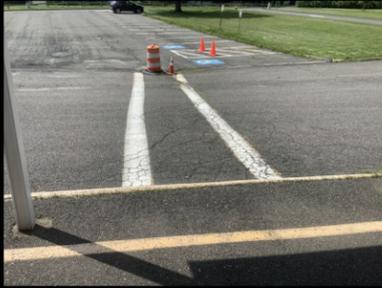
Curb ramp not provided	-	Provide a curb ramp at intersection of crosswalk and sidewalk.	1	-	-

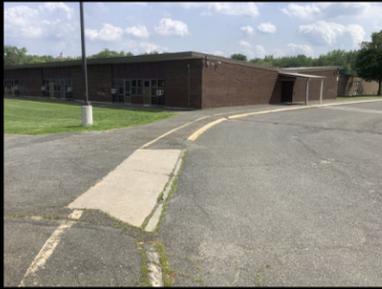
Access aisle not provided Sign with ISA not provided (MAAB)	- -	Provide a marked access aisle that is at least 60" wide and that extends the full length of the vehicle. Provide a sign that includes the International Symbol of Accessibility (ISA) at the head of the space. Locate the sign so that the bottom is 60" min. above the ground and the top is 96" max. above the ground. (Cost estimate is for signage.)	1	- 825	\$500 - \$1K
Exterior Ramp												
37	From Southeast Egress by OT/PT 37	Ext.	-	Exterior Ramp	N/A

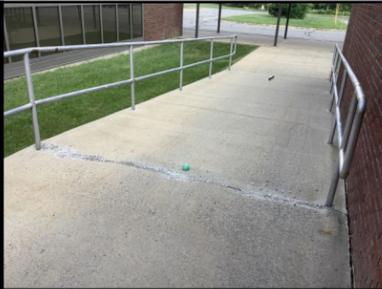
Edge protection < 4" high Not maintained in operable working condition	- -	Provide edge protection that prevents the passage of a 4" diameter sphere, where any portion of the sphere is within 4" of the finished floor or ground surface. Repair cracked openings in the surface to ensure the accessible route is maintained in operable working condition.	1	-	-

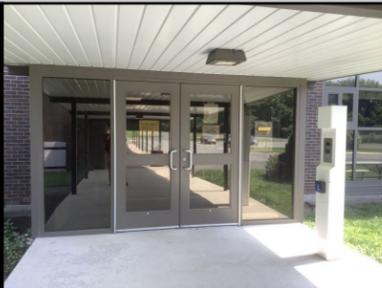
Automatic door opener not operable		Repair or replace the door opener.	1	Labor	Labor
39	Secondary Entrance - Northwest Side/Grade 2 Wing	1	-	Entrance	Secondary Entrance

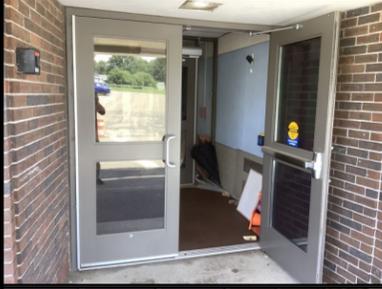
Threshold > 1/2" high Door requires > 15 lbs. of force to open	1" 17 lbs.	Alter threshold to be 1/2" high max. Adjust closers so doors do not require more than 15 pounds of opening force.	1	1650 Labor	\$1K - \$5K
40	Nurse/ABA Classroom Entrance	1	7	Entrance	Secondary Entrance

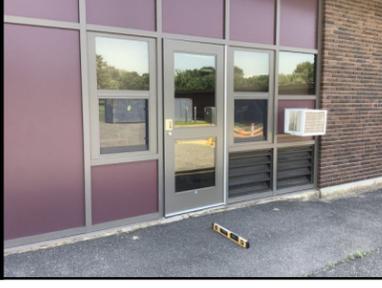
Threshold not beveled Threshold > 1/2" high	- 2.25"	Bevel the threshold. Alter threshold to be 1/2" high max.	1	1650	\$1K - \$5K

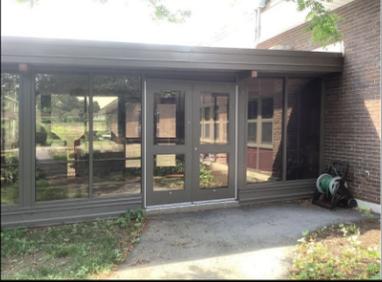
Threshold not beveled Threshold > 1/2" high	- 4.5"	Bevel the threshold. Alter threshold to be 1/2" high max. Note: The IHCD team was informed that this can be used as an entrance for students who are using crutches or a temporary mobility device if a student wants to use a less busy entrance. Due to the level change, a ramp may be necessary, and the cost of this will need further research.	1	1650	\$1K - \$5K
<div style="border: 1px solid #ccc; padding: 5px; margin-bottom: 5px;">Access to Goods and Services</div> <div style="border: 1px solid #ccc; padding: 5px;">Means of Egress</div>												
42	Main Exit - Southwest Side	1	-	Means of Egress	N/A

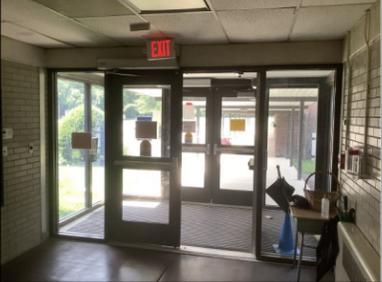
Tactile exit sign not provided Illuminated ISA symbol not provided (MAAB)	- -	Ensure that a tactile exit sign with raised characters and braille is provided at the exit door, located on the right side of the right handed door. When the illuminated exit sign is repaired or replaced, provide an illuminated sign with the International Symbol of Accessibility (ISA). Recommendation applies to all exit doors with a similar issue. Note: Unit cost is provided for one instance of this repetitive item.	1	413 Labor	\$1 - \$500

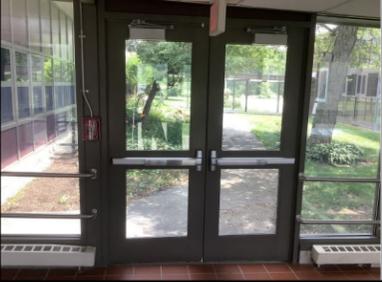
Tactile exit sign not provided Directional sign to accessible emergency exit not provided	- -	Ensure that a tactile exit sign with raised characters and braille is provided at the exit door. Mount the sign between 48"- 60" above the finished floor located on the right side of the right handed door. Provide a directional sign indicating the location of the nearest accessible emergency exit.	1	413 413	\$500 - \$1K
44	Pre-K Classroom Egress	1	12	Means of Egress	N/A

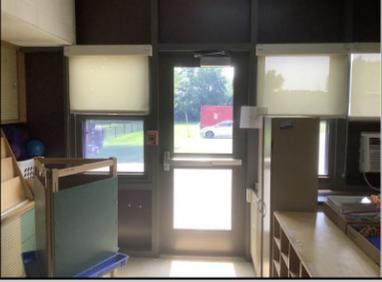
Tactile exit sign not provided Directional sign to accessible emergency exit not provided	- -	Ensure that a tactile exit sign with raised characters and braille is provided at the exit door. Mount the sign on the latch side of the door. Provide a directional sign indicating the location of the nearest accessible emergency exit. Recommendation applies to all egress doors in classrooms with a similar issue. Note: Unit cost is provided for one instance of this repetitive item.	1	413	\$1 - \$500

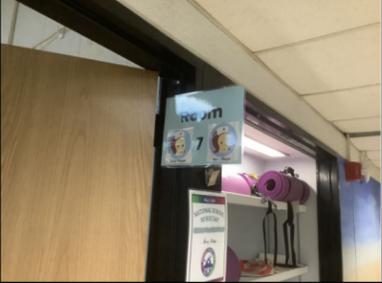
Vertical clearance < 80" above finished floor	-	Relocate blade sign so that the bottom edge of the sign is 80" min. above the finished floor. Recommendation applies to all blade signs with a similar issue. Note: Unit cost is provided for one instance of this repetitive item.	1	825	\$500 - \$1K
											825

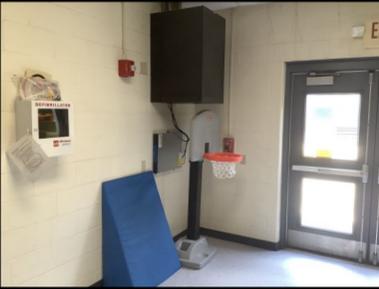
Vertical clearance < 80" above finished floor	69"	Provide a cane-detectable barrier underneath the black box.	1	657	\$500 - \$1K
											657	
47	By School Counselor Office 14	1	-	Interior Access Route	N/A

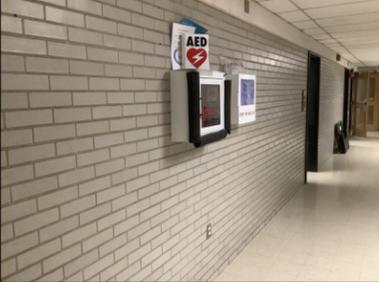
Obstructed by protruding objects	8.25"	Provide a cane-detectable barrier such as a fixed trash can or railing underneath the defibrillator located 27" max. above the finished floor or relocate the object. Recommendation applies to all defibrillators with a similar issue. Note: Unit cost is provided for one instance of this repetitive item.	1	657	\$500 - \$1K
											657	
48	Girls' Multi-User Toilet Room - Grade 1 Wing	1	-	Interior Access Route	N/A

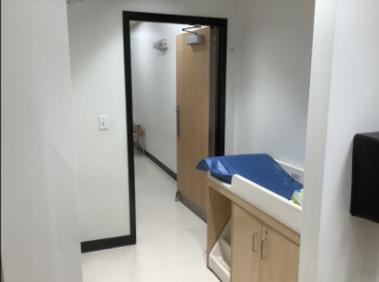
Route < 36" wide	24.5"	Relocate the baby changing table to maintain the required clear width, as well as the required 48" of maneuvering clearance depth on the push-side of the door. Ensure that maintenance staff is aware that a 36" clear route should be kept clear leading to each interior space.	1	Labor	Labor

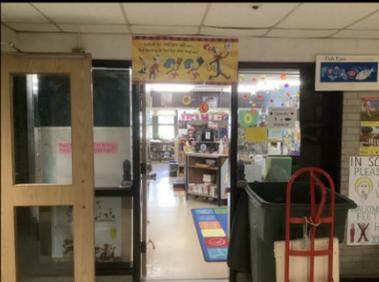
Vertical clearance < 80" above finished floor	76"	Relocate the banner out of the circulation path.	1	Labor	Labor

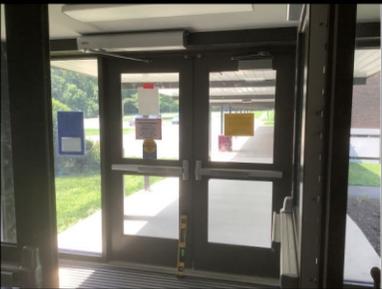
Exterior door requires > 15 lbs. of force to open	25 lbs.	Adjust closers so doors do not require more than 15 pounds of force to open. Recommendation applies to all exterior doors with a similar issue.	1	Labor	Labor
57	Nurse/ABA Classroom		7	Doors, Doorways, & Gates	Classroom

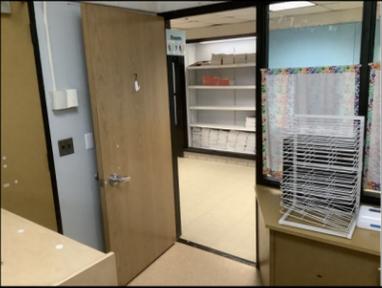
Maneuvering clearance(s) not provided	-	Provide an automatic door opener. Recommendation applies to all doors with a similar issue. Note: Unit cost is provided for one instance of this repetitive item.	1	9900	\$5K - \$10K
											9900	
58	Boys' Multi-User Toilet Room - Grade 2 Wing	1	-	Doors, Doorways, & Gates	Toilet Room

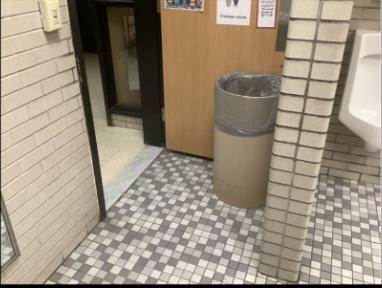
Maneuvering clearance(s) not provided Threshold not beveled	33" -	Ensure the door remains open while school is in session, or provide an automatic door opener. Bevel the threshold. (Cost is for beveling the threshold.)	1	- 1650	\$1K - \$5K

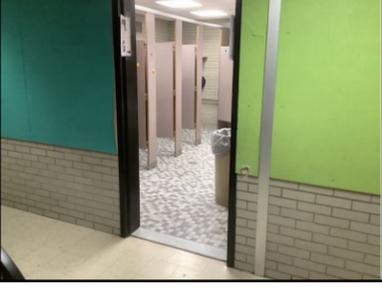
Threshold not beveled	-	Bevel the threshold.	1	1650	\$1K - \$5K
											1650

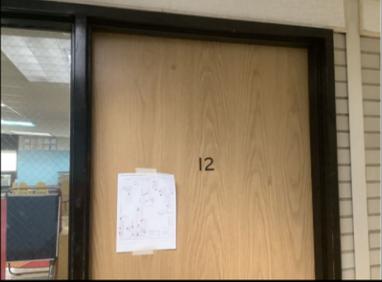
Raised characters not provided on sign Braille not provided on sign Location of tactile sign not compliant		Provide text with raised characters duplicated in braille on the sign, located alongside the door on the latch side. Recommendation applies to all designation signs with a similar issue. Note: Unit cost is provided for one instance of this repetitive item.	1	413	\$1 - \$500
72	Library	1	39	Signage	Designation

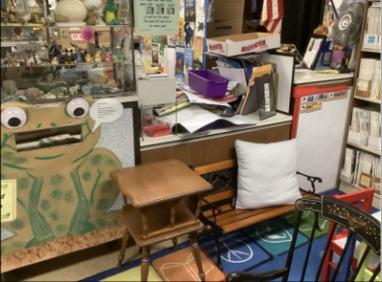
Accessible service counter is not maintained	-	Ensure that the accessible service counter is kept clear and that objects are not stored in the 30" by 48" clear floor space.	1	Labor	Labor

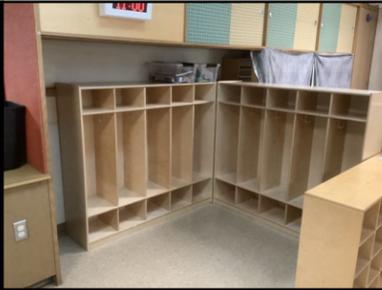
Reach < 20" or > 36" (Ages 3 - 4)	10.75" low, 41" high	Relocate so that at least one cubby has storage located between 20" and 36" above the finished floor.	1	-	-
77	Kindergarten Classroom	1	30	Children's Reach Ranges	Cubbies

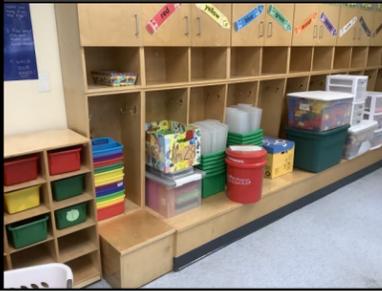
30" x 48" clear space not provided Reach < 18" or > 40" (Ages 5 - 8)	- 10.75"	Provide at least one cubby with 30" min. by 48" min. clear floor space and with storage located between 18" and 40" above the finished floor. Recommendation applies to all classrooms with a similar issue.	1	-	-
Dining or Work Surfaces												
78	Library and Museum	1	-	Dining or Work Surfaces	Work Surface

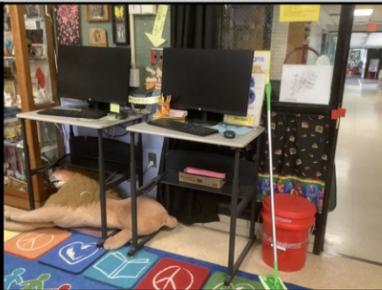
Knee or toe clearance not provided Knee clearance less than 19" deep	24.5" 9"	Provide at least one work surface with 30" wide min. and 19" deep min. knee and toe clearance.	1	1155	\$1K - \$5K

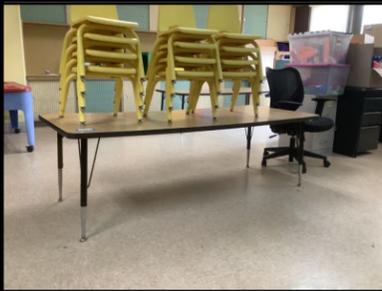
Knee or toe clearance not provided	21"	Alter the knee and toe clearance height of at least one work surface to be 24" min. high. Recommendation applies to all classrooms with a similar issue.	1	Labor	Labor
80	Assistant Principal's Office	1	13	Dining or Work Surfaces	Work Surface

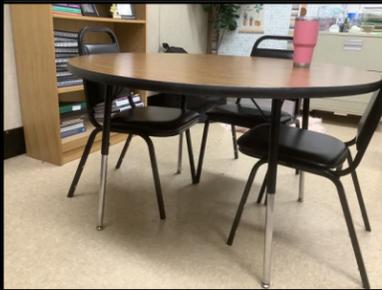
Knee or toe clearance not provided	24.5" wide	Provide at least one work surface with 30" min. wide. knee and toe clearance. Recommendation applies to all faculty offices, where meetings with members of the public are held, with a similar issue. Note: Unit cost is provided for one instance of this repetitive item.	1	1155	\$1K - \$5K
											1155

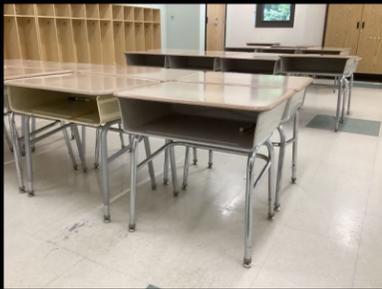
Knee or toe clearance not provided	17.5"	Provide at least one work surface with 24" min. high and 30" min. wide knee and toe clearance. Recommendation applies to all classrooms with a similar issue. Note: Unit cost is provided for one instance of this repetitive item.	1	751	\$500 - \$1K
Assembly Area												
82	Gymnasium and Cafetorium	1	-	Assembly Area	N/A

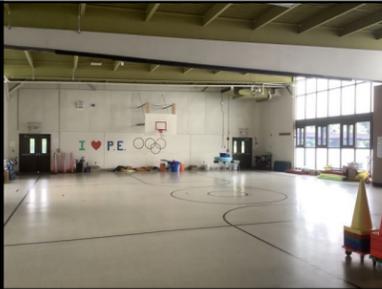
Number of seats Assistive listening devices not provided	175 -	If audible communication is integral to the use of the space, provide an assistive listening system. Recommendation also applies to the cafetorium.	2	5123	\$10K - \$50K
Picnic Tables												
83	By East Playground	Ext.	-	Picnic Tables	N/A

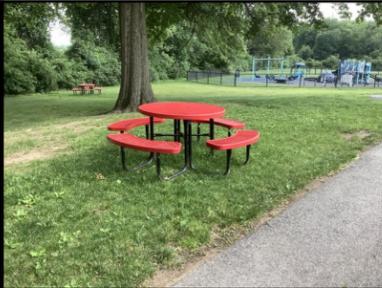
30" clear width not provided Toe or knee clearance at tables not provided Picnic table not on an accessible route	- - -	Provide at least 1 picnic table (or ensure that 5% of picnic tables) with 27" high min. and 30" wide min. toe and knee clearance. Ensure that the picnic table is connected to an accessible route.	1	2310 -	\$1K - \$5K

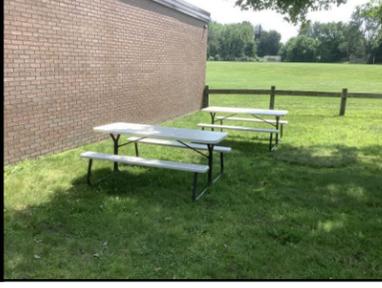
Knee clearance less than 19" deep	6"	Provide at least one picnic table with knee clearance that is 19" deep min.	1	2310	\$1K - \$5K

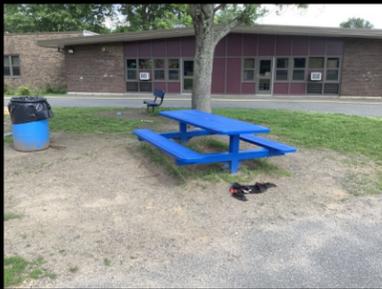
Surface not stable, firm and slip-resistant Knee clearance less than 19" deep	10"	Remove loose dirt and gravel from surface. Provide at least one picnic table with knee clearance that is 19" deep min.	1	Labor 2310	\$1K - \$5K
2310												
Exterior Benches												
87	By Sidewalk to Parker Street/South Soccer Field	Ext.	-	Exterior Benches	N/A

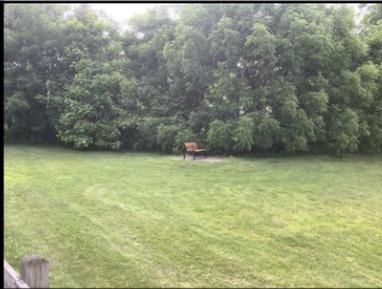
No accessible route to one bench in area	-	Provide an accessible route to one bench in this area.	1	-	-
88	North Playground	Ext.	-	Exterior Benches	N/A

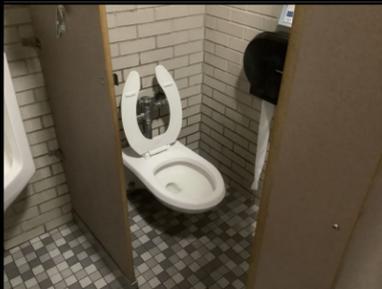
Accessible plumbing fixtures or stalls not provided		In at least one Pre-K and Grade 1 classroom, renovate each boys' and girls' multi-user toilet room to become an accessible single-user toilet room.	4	52776	\$100K - \$500K
											211104

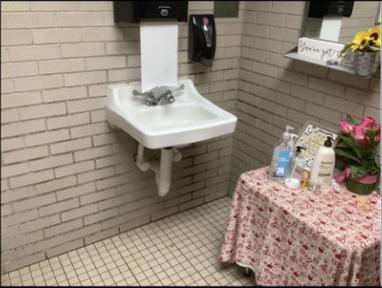
Clear floor space not provided at lavatory	-	Relocate the table to maintain the required 30" min. by 48" min. clear floor space positioned for a forward approach.	1	Labor	Labor
Single-User Toilet												
92	Staff Single-User Toilet Room by Main Office (Used by Parents and the Public)	1	-	Single-User Toilet	N/A

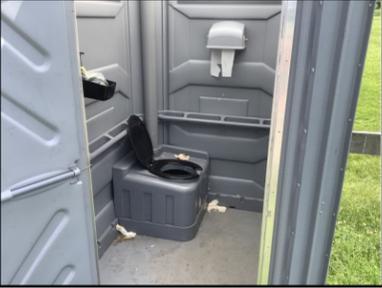
Noncompliant toilet paper dispenser 60" by 72" clear space not provided	56" 58.5" x 57"	Provide an accessible portable toilet that has 60" wide and 72" deep at the toilet. When a new portable toilet is provided, ensure the toilet paper dispenser is located 24" min. high, located under the grab bar, and between 7" and 9" from the front of the toilet.	1	-	-

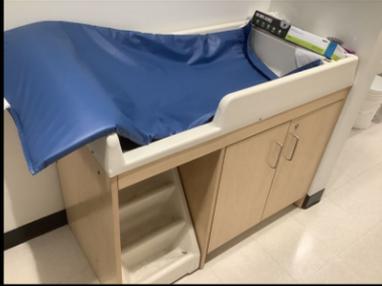
Changing table lacks 27" high knee clearance	-	Provide a baby changing station with knee and toe clearance positioned for a forward approach.	1	743	\$500 - \$1K
											743	
Toilet Rooms for Children												
Single-User Toilet (Children)												
96	Gymnasium - Single-User Toilet Rooms	1	-	Single-User Toilet (Children)	All Gender

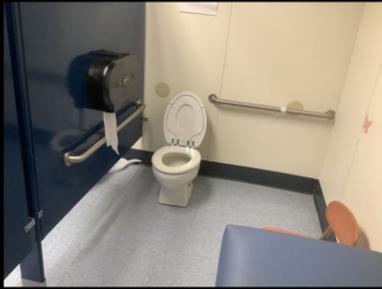
Side or rear grab bar < 20" or > 25" high (Ages 5 - 8) Centerline < 12" or > 15" (Ages 5 - 8) Noncompliant toilet paper dispenser	28.75" 16.5" -	Relocate the rear grab bar to 20"- 25" above the finished floor. Relocate toilet so that the centerline is between 12" and 15" from the side wall. Relocate toilet paper dispenser so that it is between 14"- 19" above the finished floor and between 7"- 9" in front of the toilet. Recommendation applies to all accessible toilet compartments with a similar issue. Note: Unit cost provided for one instance of repetitive item.	1	1238 6066 825	\$5K - \$10K
Lavatory (Children)												
105	Boys' and Girls' Multi-User Toilet Rooms - Grade 1 Wing	1	-	Lavatory (Children)	N/A

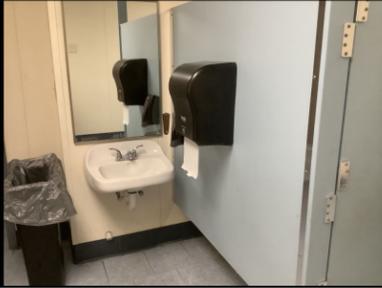
Dispenser acts as a protruding object	10"	Relocate dispenser out of the circulation path. Recommendation applies to all paper towel dispensers with a similar issue. Note: Unit cost is provided for one instance of this repetitive item.	1	825	\$500 - \$1K
Urinal (Children)												
107	Boys' Multi-User Toilet Room - Grade 2 Wing	1	-	Urinal (Children)	N/A

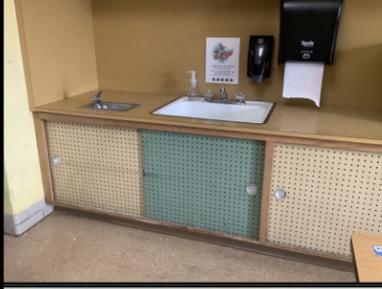
Toe and knee clearances not provided Noncompliant faucet	- -	Ensure there is a 27" min. knee clearance positioned for a forward approach. Install faucets that do not require tight grasping, pinching, or twisting of the wrist. Recommendation applies to all sinks in classrooms with a similar issue. Note: Unit cost is provided for one instance of this repetitive item.	1	5106 1627	\$5K - \$10K
