Mountain View Elementary School

Town of East Longmeadow ADA Transition Plan

October 2025

Background

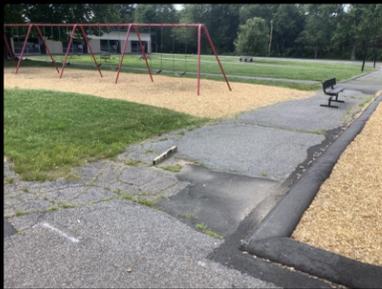
ID	Location	Floor	Room	Element	Type	Photo	Issues	Current Measure	Recommendations	Quantity	Price	Cost Estimation
6	By West Playgrounds	Ext.	-	Exterior Access Route	Walkway

Surface openings > 1/2" Running slope > 1:20 (5.00%) Route not maintained in operable working condition	3" 11.4% -	Ensure that the surface opening is no greater than 1/2" max. Reduce running slope to be no steeper than 1:20 (5.00%). Repair cracked openings in the surface to ensure the accessible route is maintained in operable working condition.	1	-	-
7	Courtyard	Ext.	-	Exterior Access Route	Walkway

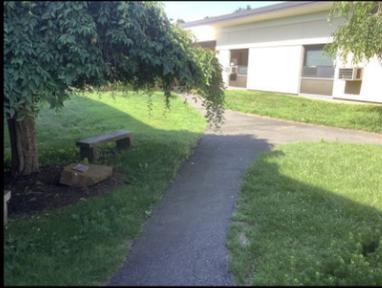
Obstructed by protruding objects	-	Trim low hanging branches in trees.	1	Labor	Labor
8	Courtyard	Ext.	-	Exterior Access Route	Walkway

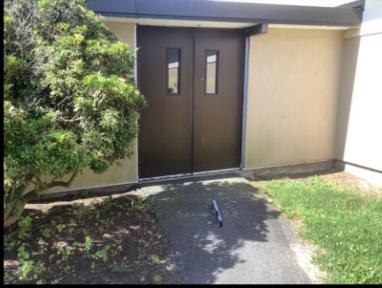
Running slope > 1:20 (5.00%)	7.6%	Reduce running slope to be no steeper than 1:20 (5.00%) or build a compliant ramp.	1	-	-
9	Courtyard	Ext.	-	Exterior Access Route	Walkway

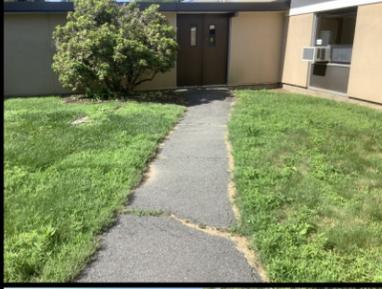
Surface openings > 1/2" Level changes > 1/4"	2" 0.75"	Ensure that surface openings are no greater than 1/2" max. Alter changes in level to be 1/4" high max.	1	-	-

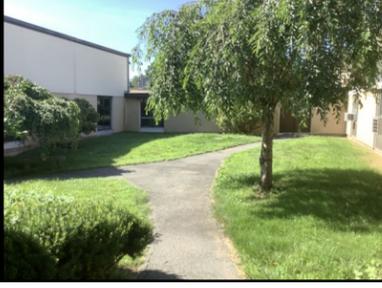
10	Courtyard	Ext.	-	Exterior Access Route	Walkway

Vertical clearance < 80" above ground		Trim low hanging tree branches.	1	-	-

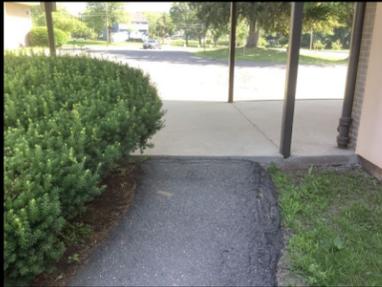
ID	Location	Floor	Room	Element	Type	Photo	Issues	Current Measure	Recommendations	Quantity	Price	Cost Estimation
11	Courtyard - To Hampden Road Lot Parent Drop-Off	Ext.	-	Exterior Access Route	Walkway

Level changes > 1/4"	1.5"	Alter change in level to be 1/4" high max.	1	-	-
12	Courtyard - To Main Entrance (East Side)	Ext.	-	Exterior Access Route	Walkway

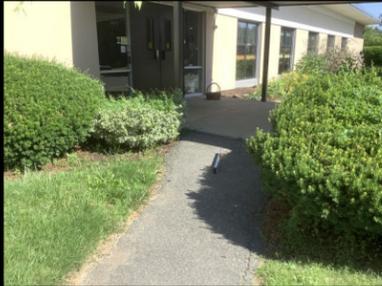
Running slope > 1:20 (5.00%) Level changes > 1/4"	9.2% 1.5"	Reduce running slope to be no steeper than 1:20 (5.00%) or build a compliant ramp. Alter change in level to be 1/4" high max.	1	-	-
13	From Classroom 8 Egress	Ext.	-	Exterior Access Route	Exterior

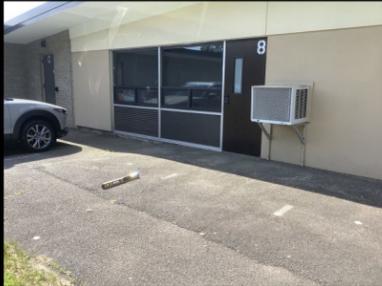
Running slope > 1:20 (5.00%)	8.1%	Reduce running slope to be no steeper than 1:20 (5.00%).	1	-	-
14	Garden by North Side of Building	Ext.	-	Exterior Access Route	Exterior

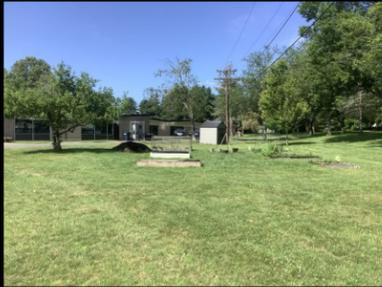
Accessible route not provided	-	Ensure an accessible route is provided to the garden.	1	-	-
15	Hampden Lot Parent Drop-Off/To Main Entrance (East Side)	Ext.	-	Exterior Access Route	Walkway

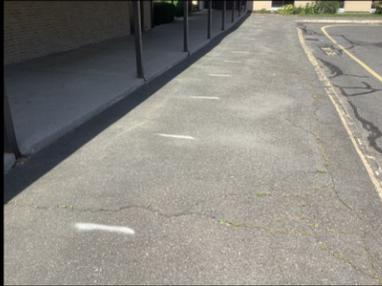
Surface openings > 1/2"	1"	Ensure that the surface opening is no greater than 1/2" max.	1	-	-

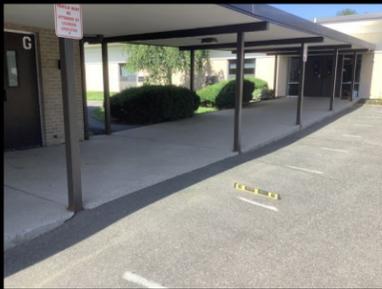
ID	Location	Floor	Room	Element	Type	Photo	Issues	Current Measure	Recommendations	Quantity	Price	Cost Estimation
16	Hampden Lot Parent Drop-Off/To Main Entrance (East Side)	Ext.	-	Exterior Access Route	Walkway

Running slope > 1:20 (5.00%)	9.8%	Reduce running slope to be no steeper than 1:20 (5.00%).	1	-	-
17	Hampden Road Lot/By Gymnasium	Ext.	-	Exterior Access Route	Exterior

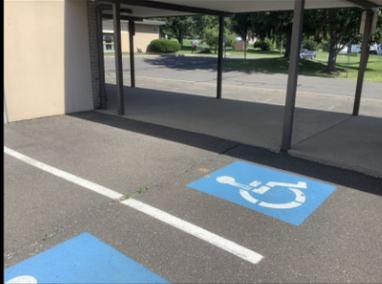
Surface openings > 1/2" Level changes > 1/4"	1" 1"	Ensure that surface openings are no greater than 1/2" max. Alter changes in level to be 1/4" high max. Recommendation applies to all accessible parking spaces with a similar issue.	1	-	-
18	To Basketball Courts	Ext.	-	Exterior Access Route	Walkway

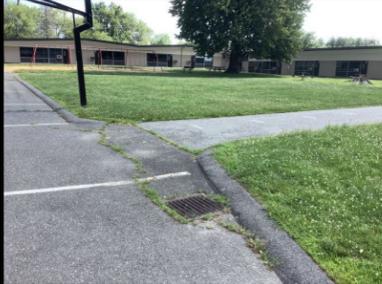
Surface openings > 1/2" Route not maintained in operable working condition	1" -	Ensure that the surface opening is no greater than 1/2" max. Repair cracked openings in the surface to ensure the accessible route is maintained in operable working condition.	1	-	-

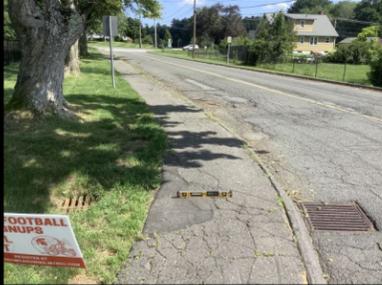
Cross slope > 1:50 (2.00%) Route not maintained in operable working condition	8% -	Reduce cross slope to be no steeper than 1:50 (2.00%). Repair cracked openings in the surface to ensure the accessible route is maintained in operable working condition.	1	-	-
20	To Hampden Road	Ext.	-	Exterior Access Route	Sidewalk

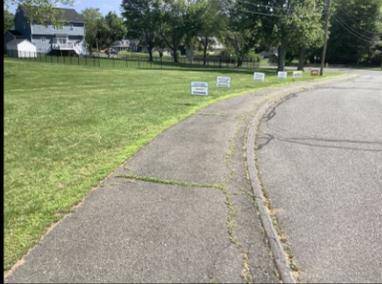
Surface openings > 1/2" Route not maintained in operable working condition	2" -	Ensure that the surface opening is no greater than 1/2" max. Repair cracked openings in the surface to ensure the accessible route is maintained in operable working condition.	1	-	-

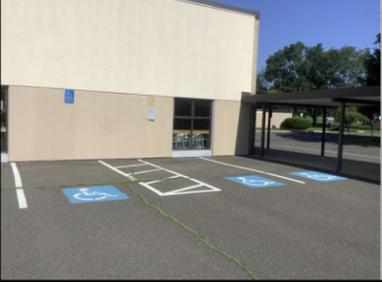
ID	Location	Floor	Room	Element	Type	Photo	Issues	Current Measure	Recommendations	Quantity	Price	Cost Estimation
36	Hampden Road Lot/By Gymnasium	Ext.	-	Off-Street Parking Lot or Garage	Visitor

Access aisle not provided Access aisle < 60" wide at car/van space Sign with the International Symbol of Acc. not provided Sign bottom < 60" above finished grade	- 53" - 72"	Provide a marked access aisle that is at least 60" wide at the space on the right side of the photo. Repaint the marked access aisle to be at least 60" wide. Provide a sign with the International Symbol of Accessibility (ISA) with the bottom of the sign 60" min. above the ground and the top 96" max. above the ground. Locate sign (left in photo) with the bottom of the sign 60" above the ground. (Cost estimate is for signage.)	1	- - 825 -	\$500 - \$1K
Passenger Loading Zones												
37	Hampden Lot Parent Drop-Off	Ext.	-	Passenger Loading Zones	N/A

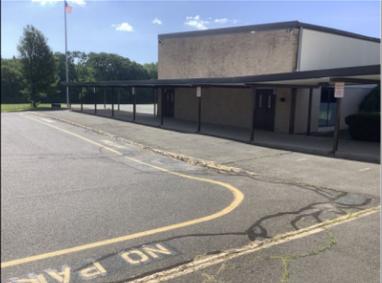
Access aisle not provided Sign with ISA not provided (MAAB)	- -	Provide a marked access aisle that is at least 60" wide and that extends the full length of the vehicle. Provide a sign that includes the International Symbol of Accessibility (ISA) at the head of the space. Locate the sign so that the bottom is 60" min. above the ground and the top is 96" max. above the ground. (Cost estimate is for signage.)	1	- 825	\$500 - \$1K

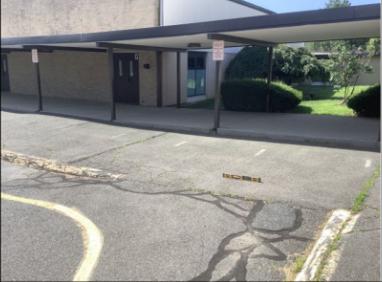
Running or cross slope at aisle > 1:50 (2.00%)	5.7%	Reduce running or cross slope to be no steeper than 1:50 (2.00%).	1	-	-
39	Somers Road Lot/Bus Drop-Off	Ext.	-	Passenger Loading Zones	N/A

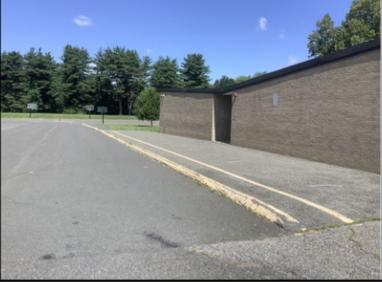
Access aisle not provided Sign with ISA not provided (MAAB)	- -	Provide a marked access aisle that is at least 60" wide and that extends the full length of the vehicle. Provide a sign that includes the International Symbol of Accessibility (ISA) at the head of the space. Locate the sign so that the bottom is 60" min. above the ground and the top is 96" max. above the ground. (Cost estimate is for signage.)	1	- 825	\$500 - \$1K
Entrance												
40	Secondary Entrance - North Side at Courtyard	1	-	Entrance	Secondary Entrance

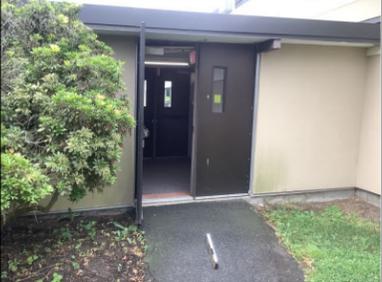
Clear width at door is < 32" Maneuvering clearance at door > 1:50 (2.00%) Threshold not beveled Threshold > 1/2" high	30.5" 7.3% - 1.75"	Ensure that at least one of the active leaves is at least 32" min. wide. Alter so that the slope in all directions is no greater than 1:50 (2.00%). Bevel the threshold and alter to be 1/2" high max. Note: The IHCD team was informed that this can be used as an entrance for students with autism who prefer to use a less busy entrance. An automatic door opener could be provided rather than leveling the maneuvering clearance.	1	7221 - 1650 -	\$5K - \$10K

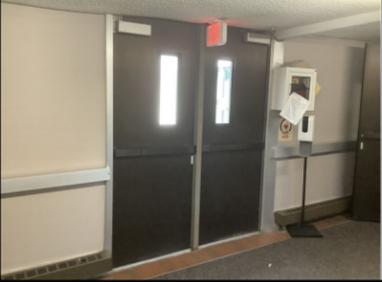
ID	Location	Floor	Room	Element	Type	Photo	Issues	Current Measure	Recommendations	Quantity	Price	Cost Estimation
46	South Egress (Across From Courtyard)	1	10	Means of Egress	N/A

Tactile exit sign not provided Directional sign to accessible emergency exit not provided	- -	Ensure that a tactile exit sign with raised characters and braille is provided at the exit door. Mount the sign between 48" - 60" above the finished floor located on the latch side of the door. Provide a directional sign indicating the location of the nearest accessible emergency exit.	1	413 413	\$500 - \$1K
Interior Access Route												
47	By Main Office	1	-	Interior Access Route	N/A

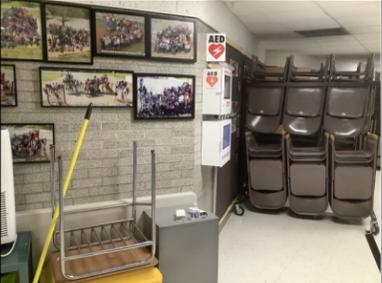
Obstructed by protruding objects	7.5"	Provide a cane-detectable barrier such as a fixed trash can or railing underneath the defibrillator. Ensure that the barrier is located 27" max. above the finished floor or relocate the object. Recommendation applies to all defibrillators with a similar issue. Note: Unit cost is provided for one instance of this repetitive item.	1	657	\$500 - \$1K

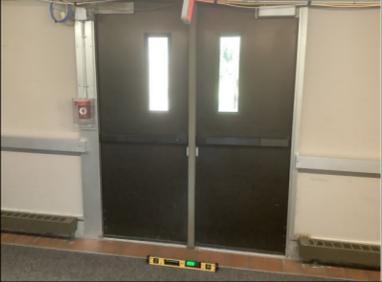
Cross slope > 1:50 (2.00%)	3.7%	Further study will be needed to determine whether it is technically feasible to bring the route into full compliance with the ADA Standards. Recommendation applies to the south egress across from the courtyard.	2	-	-
49	Staff Single-User Toilet Room by Main Office	1	-	Interior Access Route	N/A

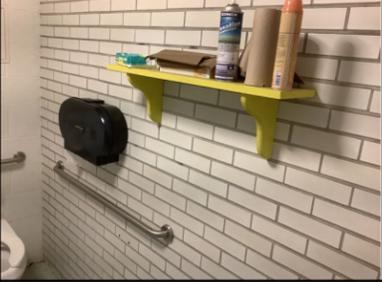
Obstructed by protruding objects	7.5"	Relocate the shelf out of the circulation path. Recommendation applies to all shelves over grab bars with a similar issue. Note: Unit cost is provided for one instance of this repetitive item.	1	825	\$500 - \$1K
50	Stage/OT Meeting Area	1	-	Interior Access Route	N/A

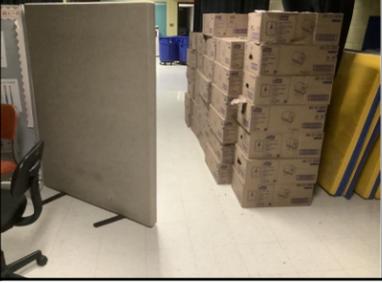
Route < 36" wide	28.25"	Ensure that maintenance staff is aware that a 36" clear route should be kept clear leading to each interior space. Recommendation applies to all interior routes with a similar issue.	1	Labor	Labor

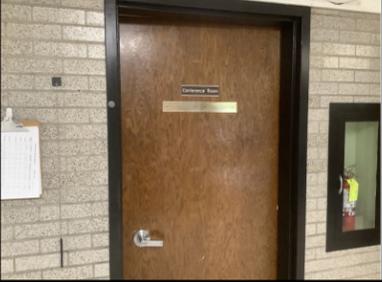
ID	Location	Floor	Room	Element	Type	Photo	Issues	Current Measure	Recommendations	Quantity	Price	Cost Estimation
66	Conference Room by Main Office	1	-	Signage	Designation

Raised characters not provided on sign Braille not provided on sign Location of tactile sign not compliant	- - -	Provide text with raised characters duplicated in braille on the sign. Locate sign alongside the door on the latch side. Recommendation applies to all designation signage with a similar issue. Note: Unit cost is provided for one instance of this repetitive item.	1	413	\$1 - \$500
67	Girls' Multi-User Toilet Room by Main Office	1	-	Signage	Designation / Directional

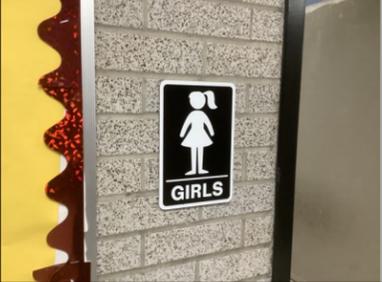
Raised characters not provided on sign Braille not provided on sign International Symbol of Acc. not provided	- - -	Provide text with raised characters duplicated in braille on the sign. Replace the sign with a sign containing the International Symbol of Accessibility (ISA). Recommendation applies to all designation signage at accessible toilet rooms with a similar issue. Note: Unit cost is provided for one instance of this repetitive item.	1	413 413	\$500 - \$1K

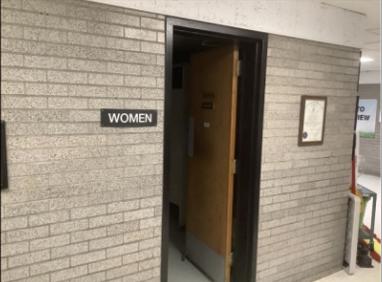
Directional sign to access toilet not provided	-	Install a sign indicating the location of the nearest accessible toilet room.	1	413	\$1 - \$500
69	Hampden Road Lot/By Gymnasium	Ext.	-	Signage	Parking

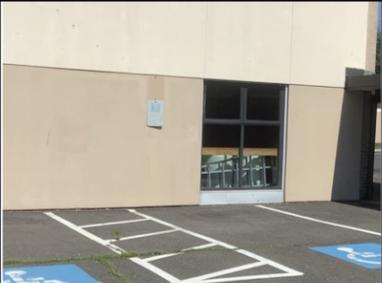
Non-glare finish and contrast not provided on sign Not in operable working condition	- -	Replace the sign as the characters and International Symbol of Accessibility (ISA) have worn off.	1	825	825
Operable Parts / Reach Range												
70	By Main Office	1	-	Operable Parts / Reach Range	Defibrillator

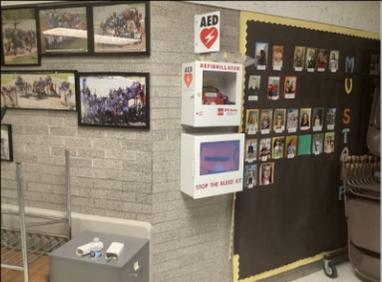
Reach < 15" or > 48"(forward/side approach)	62.25"	Relocate the defibrillator so that controls are between 15"- 48" above the finished floor. Recommendation applies to all defibrillators with a similar issue. Note: Unit cost is provided for one instance of this repetitive item.	1	825	\$500 - \$1K

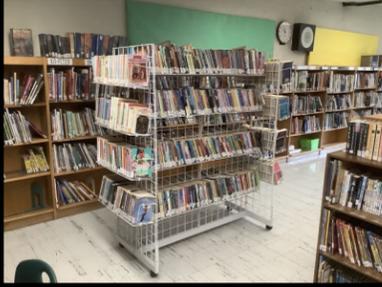
ID	Location	Floor	Room	Element	Type	Photo	Issues	Current Measure	Recommendations	Quantity	Price	Cost Estimation
71	Library	1	-	Operable Parts / Reach Range	Book Shelves

Reach < 15" or > 48"(forward/side approach)	56"	Ensure that staff is available to assist visitors who need assistance.	1	Labor	Labor
72	Staff Single-User Toilet Room by Main Office	1	-	Operable Parts / Reach Range	Clothes Rod/Hooks

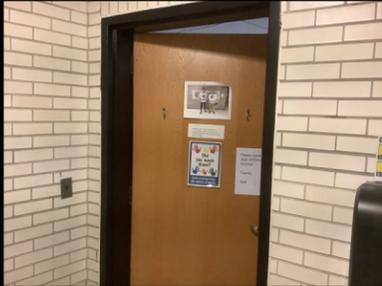
Side reach > 54"	62.5"	Provide an additional coat hook located 48" above the finished floor. Recommendation applies to all toilet rooms with a similar issue. Note: Unit cost is provided for one instance of this repetitive item.	1	124	\$1 - \$500
73	Staff Single-User Toilet Room by Main Office	1	-	Operable Parts / Reach Range	Door Lock

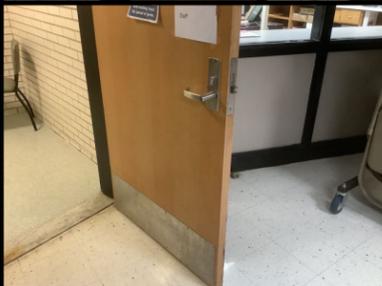
Not compliant	-	Provide a door lock that can be operable with one hand and not require tight grasping, pinching, or twisting of the wrist. Recommendation applies to all book shelves with a similar issue.	1	-	-

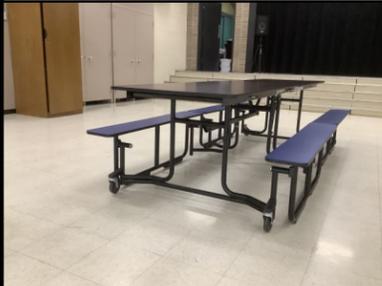
Knee clearance less than 19" deep	15"	Provide at least one dining surface (or 5% total) with knee clearance that is 19" deep min.	1	1815	\$1K - \$5K
75	Conference Room by Main Office	1	-	Dining or Work Surfaces	Work Surface

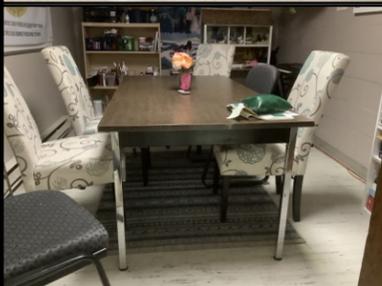
Knee or toe clearance not provided	24.5"	Provide at least one work surface with 27" min. high and 30" min. wide knee and toe clearance.	1	1155	\$1K - \$5K

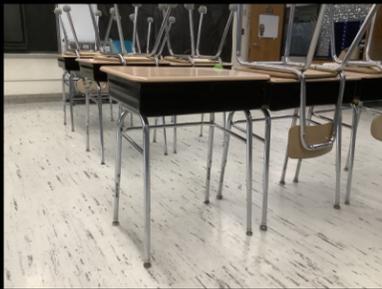
ID	Location	Floor	Room	Element	Type	Photo	Issues	Current Measure	Recommendations	Quantity	Price	Cost Estimation
76	Grade 4 Classroom	1	10	Dining or Work Surfaces	Work Surface

Knee or toe clearance not provided	23.25"	Provide at least one work surface with 24" min. high and 30" min. wide knee and toe clearance. Recommendation applies to all classrooms with a similar issue. Note: Unit cost is provided for one instance of this repetitive item.	1	751	\$500 - \$1K
77	ASD Classroom	1	14	Dining or Work Surfaces	Work Surface

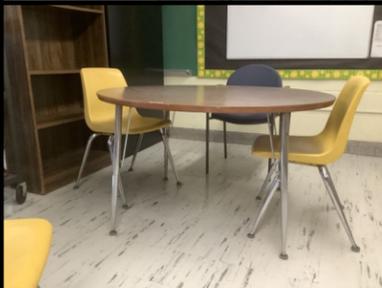
Knee or toe clearance not provided	29.75" wide	Provide at least one (or 5% total) work surface with 30" min. wide knee and toe clearance. Recommendation applies to the stage/OT meeting area and all classrooms with a similar issue. Note: Unit cost is provided for one instance of this repetitive item.	1	1155	\$1K - \$5K
Assembly Area												
78	Cafetorium and Gymnasium	1	-	Assembly Area	N/A

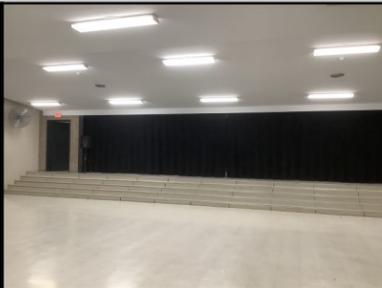
Assistive listening devices not provided	-	If audible communication is integral to the use of the space, provide an assistive listening system. Note: Ensure that assistive listening devices are provided based on the 2010 ADA Standards, Table 219.3. (Note: Cost is based on a room capacity of 600.) Recommendation applies to the gymnasium.	2	8125	\$10K - \$50K

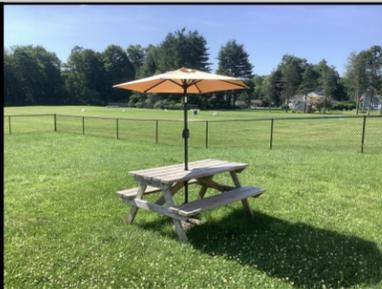
Toe or knee clearance at tables not provided Picnic table not on an accessible route	- -	Provide at least 1 picnic table (or ensure that 5% of picnic tables) have toe and knee clearance. Ensure that the picnic table is connected to an accessible route. (Cost estimate is for an accessible picnic table.)	1	2310 -	\$1K - \$5K
80	By Classrooms 11 and 13	Ext.	-	Picnic Tables	N/A

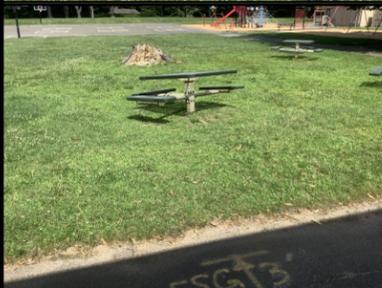
Picnic table not on an accessible route Picnic table not maintained in operable working condition	- -	Ensure that the picnic table is connected to an accessible route. Ensure the picnic table is maintained in operable working condition.	1	-	-

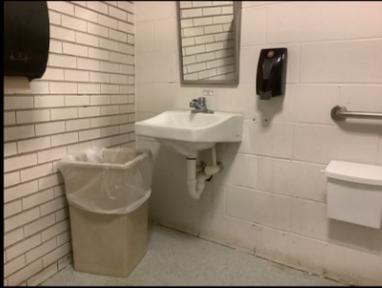
ID	Location	Floor	Room	Element	Type	Photo	Issues	Current Measure	Recommendations	Quantity	Price	Cost Estimation
Lavatory												
85	Staff Single-User Toilet Room by Main Office	1	-	Lavatory	N/A

Clear floor space not provided at lavatory	-	Relocate the trash can to maintain the required 30" min. by 48" min. clear floor space positioned for a forward approach. Recommendation applies to all lavatories with a similar issue.	1	Labor	Labor
Single-User Toilet												
86	Single-User Toilet Room by Gymnasium	1	-	Single-User Toilet	N/A

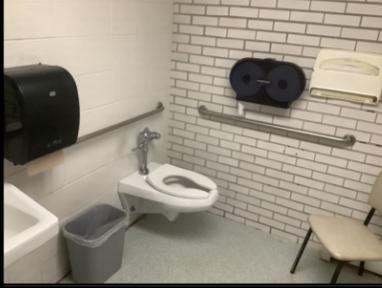
Item mounted over grab bar (MAAB) Not maintained in operable working condition	- -	Relocate the paper towel, toilet paper, and toilet seat cover dispensers so that they are not mounted over the grab bar. (Note: Unit cost is provided for one instance of this repetitive item.) Relocate the chair to maintain the required 72" of depth at the toilet.	1	825 Labor	\$500 - \$1K

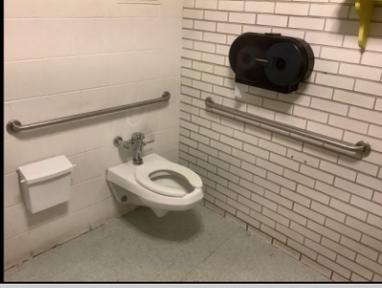
Flush control not on open side Item mounted over grab bar (MAAB)	- -	Relocate the flush control to the open side. Relocate toilet paper so that it is 24" min. high, located under the grab bar, and between 7" and 9" from the front of the toilet.	1	1650 1320	\$1K - \$5K
											2970	
Dispensers												
88	Staff Single-User Toilet Room by Main Office	1	-	Dispensers	Paper Towel Dispenser

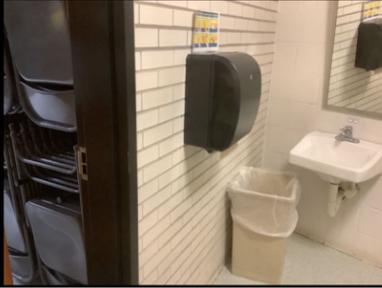
Dispenser acts as a protruding object	9.5"	Relocate the paper towel dispenser out of the circulation path, or provide a cane-detectable barrier such as a fixed trash can or railing located 27" max. above the finished floor. (Note: Cost provided is to relocate the paper towel dispenser.) Recommendation applies to all paper towel dispensers with a similar issue. Note: Unit cost is provided for one instance of this repetitive item.	1	825	\$500 - \$1K

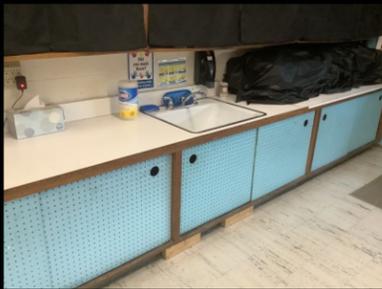
Toe and knee clearances not provided	-	Ensure there is a 27" min. knee clearance positioned for a forward approach. Recommendation applies to all sinks in classrooms with a similar issue. Note: Unit cost is provided for one instance of this repetitive item.	1	5106	\$5K - \$10K
105	ASD Classroom	1	3	Sink	N/A

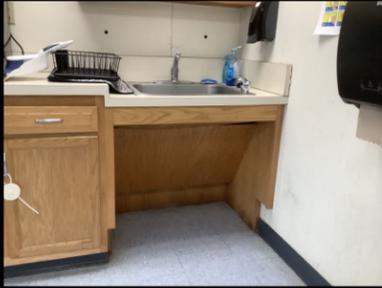
Toe and knee clearances not provided	7.5"	Relocate panel at the sink/drinking fountain to ensure the toe clearance is 9" min. above the finished floor. Recommendation applies to all sink/drinking fountains with a similar issue. Note: Unit cost is provided for one instance of this repetitive item.	1	1320	\$1K - \$5K
<div style="background-color: #f0f0f0; padding: 5px; border: 1px solid #ccc;"> Recreation Facilities </div> <div style="background-color: #f0f0f0; padding: 5px; border: 1px solid #ccc; margin-top: 5px;"> Play Areas </div>

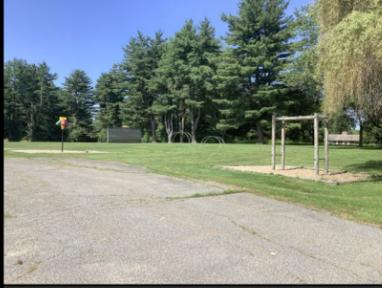
Accessible route not provided to playground Accessible route not provided around playground Accessible route not provided to play components	- - -	Install an accessible route to and around the playground. Provide a compliant impact-attenuating surface to and around the play components.	1	-	-
107	Southeast Playground	Ext.	-	Play Areas	N/A

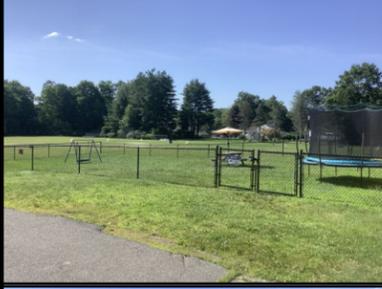
Accessible route not provided to playground Accessible route not provided around playground Accessible route not provided to play components	- - -	Install an accessible route to and around the playground. Provide a compliant impact-attenuating surface to and around the play components.	1	-	-
108	West Playground	Ext.	-	Play Areas	N/A

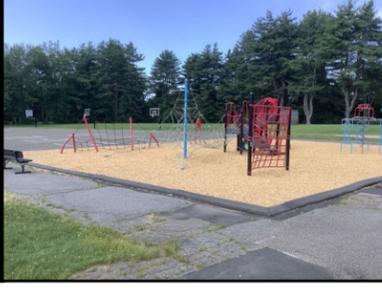
Accessible route not provided to playground Accessible route not provided to play components	- -	Install an accessible route to the playground. Provide a compliant impact-attenuating surface to and around the play components.	1	-	-

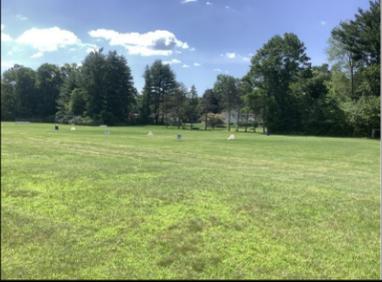
Field not connected to an accessible route No accessible route to all areas of sport activity		Provide an accessible route to the field. Install an accessible route between all areas of sport activity.	1	-	-
<div style="border: 1px solid #ccc; padding: 2px; margin-bottom: 5px;">Best Practice ▼</div> <div style="border: 1px solid #ccc; padding: 2px; margin-bottom: 5px;">Benches</div>												
115	By Basketball Courts	Ext.	-	Benches	N/A

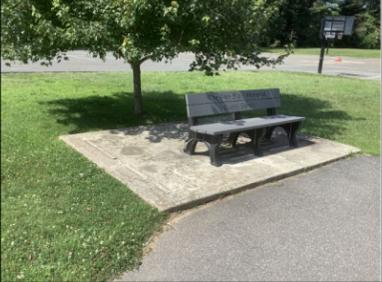
Recommend providing a 36" min. by 48" min. stable, firm and slip-resistant surface adjacent to at least one bench in each area where benches are provided positioned to allow a person in a wheeled mobility device and a person sitting on the bench to have their shoulders aligned.	1	-	-
<div style="border: 1px solid #ccc; padding: 2px; margin-bottom: 5px;">Coat Rack</div>
