Pine Knoll Recreation Area

Town of East Longmeadow ADA Transition Plan

October 2025

Institute for Human Centered Design

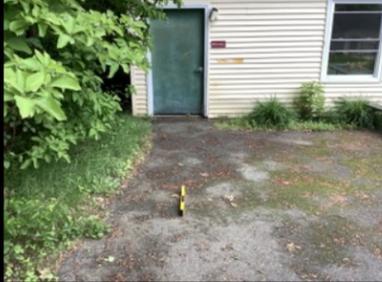
Running slope > 1:20 (5.00%)	9.8%	Reduce running slope to be no steeper than 1:20 (5.00%), or provide a compliant ramp.	1	-	-
2	Camp Office - Secondary Entrance	Ext.		Exterior Access Route	Walkway

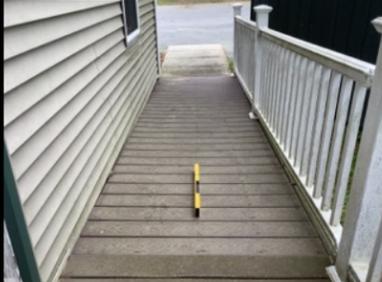
Cross slope > 1:50 (2.00%) Running slope > 1:20 (5.00%)	2.7% 5.4%	Reduce cross slope to be no steeper than 1:50 (2.00%). Reduce running slope to be no steeper than 1:20 (5.00%), or provide compliant handrails, platforms and edge protection for a ramp.	1	-	-
3	Camp Office - Secondary Entrance	Ext.		Exterior Access Route	Walkway

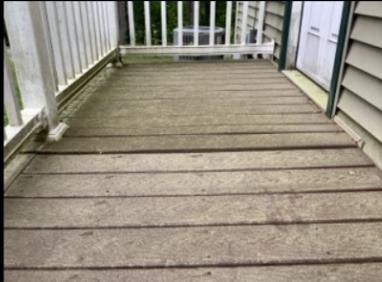
Level changes > 1/4"	.5"	Alter change in level to be 1/4" high max.	1	-	-

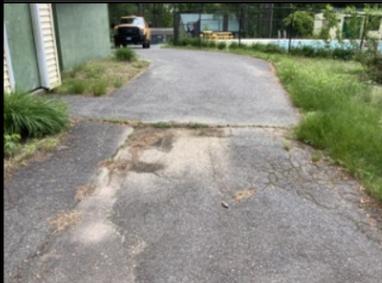
4	Near Birch Hall	Ext.		Exterior Access Route	Walkway

Route not maintained in operable working condition	-	Repair surface to ensure the accessible route is maintained in operable working condition. Recommendation applies to all walkways with a similar issue.	1	-	-
5	Near Camp Rooms	Ext.		Exterior Access Route	Walkway

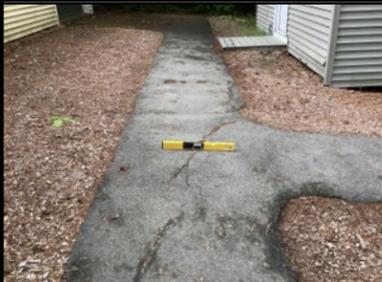
Cross slope > 1:50 (2.00%)	9.8%	Reduce cross slope to be no steeper than 1:50 (2.00%). Recommendation also applies to the route behind the changing rooms.	2	-	-

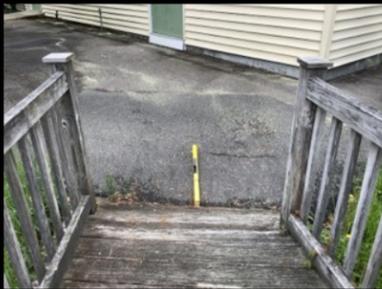
Running slope > 1:20 (5.00%)	17%	Reduce running slope to be no steeper than 1:20 (5.00%).	1	-	-
7	Near Changing Rooms	Ext.		Exterior Access Route	Walkway

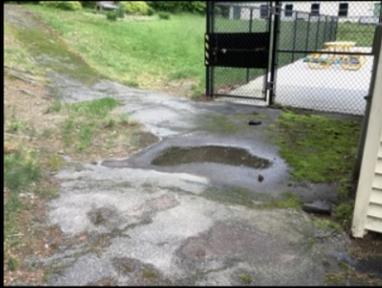
Does not prevent accumulation of water Route not maintained in operable working condition	- -	Repair surface to ensure water does not accumulate within the accessible route. Repair surface to ensure the accessible route is maintained in operable working condition. Recommendation applies to the entire route behind the changing rooms and towards Birch Hall.	1	-	-
8	Near Pine Lodge	Ext.		Exterior Access Route	Walkway

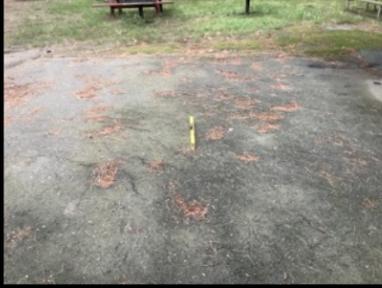
Running slope > 1:20 (5.00%)	8.5%	Reduce running slope to be no steeper than 1:20 (5.00%).	1	-	-
9	Near Pine Lodge	Ext.		Exterior Access Route	Walkway

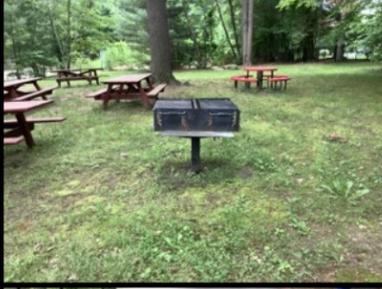
Accessible route not provided	-	Ensure an accessible route is provided to the grill. Recommendation also applies to a grill near the volleyball court.	2	-	-

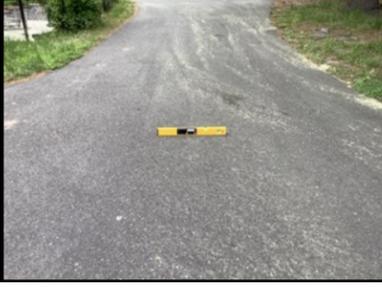
10	Near Pool Entrance	Ext.		Exterior Access Route	Walkway

Cross slope > 1:50 (2.00%)	4%	Reduce cross slope to be no steeper than 1:50 (2.00%).	1	-	-

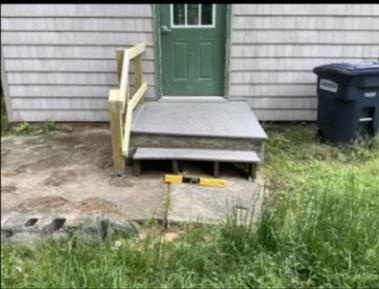
Cross slope > 1:50 (2.00%) Route not maintained in operable working condition	12.9% -	Reduce cross slope to be no steeper than 1:50 (2.00%). Repair surface to ensure the accessible route is maintained in operable working condition.	1	-	-
12	Pine Knoll Recreation Area	Ext.		Exterior Access Route	Exterior

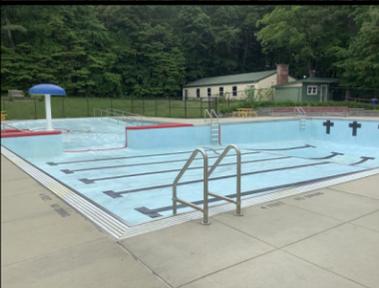
Accessible route not provided	-	To achieve program access, provide either a route to all recreation area amenities or provide transportation to each amenity, which may require a staff member to assist. Examples of accessible electric shuttles: https://www.motoelectricvehicles.com/vehicles/vehicles_list/ada-electric-shuttle/	1	-	-
13	Pine Lodge	Ext.		Exterior Access Route	Exterior

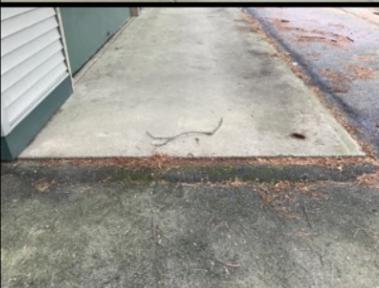
Surface openings > 1/2"	2"	Repair surface to ensure that the surface opening is no greater than 1/2" max.	1	-	-

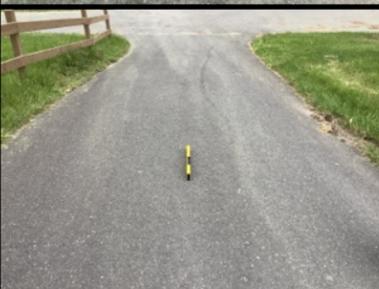
14	Route to Pool Near Pine Knoll	Ext.		Exterior Access Route	Walkway

Running slope > 1:20 (5.00%)	18.5%	When an accessible route is provided to the pool, provide a directional sign with the International Symbol of Accessibility (ISA) directing visitors to the accessible route. Reduce running slope to be no steeper than 1:20 (5.00%). Or provide accessible transportation between amenities.	1	-	-
15	Stairs From Fields	Ext.		Exterior Access Route	Exterior

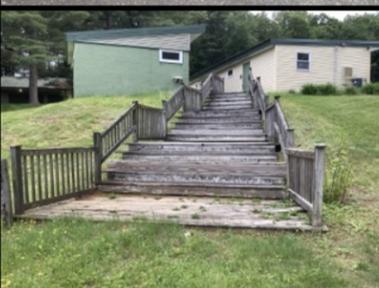
Accessible route not provided	-	Ensure an accessible route is provided to the stairs. Recommendation also applies to both stairs at the upper and lower parking areas.	3	-	-

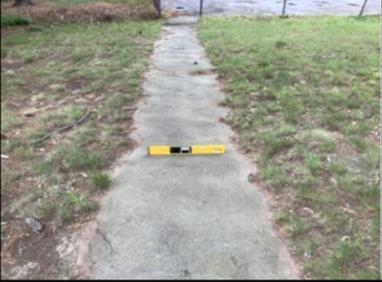
Cross slope > 1:50 (2.00%)	5.1%	Reduce cross slope to be no steeper than 1:50 (2.00%).	1	-	-
17	To Fields	Ext.		Exterior Access Route	Exterior

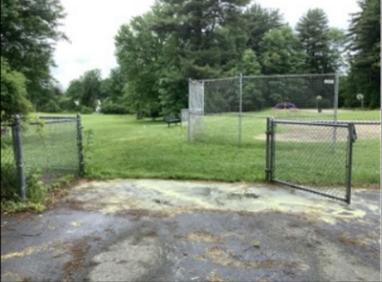
Does not prevent accumulation of water		Repair surface to ensure water does not accumulate within the accessible route. Recommendation applies to all walkways with a similar issue.	1	-	-
18	Towards Birch Hall	Ext.		Exterior Access Route	Walkway

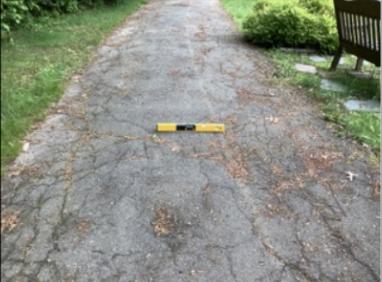
Cross slope > 1:50 (2.00%)	11.3%	Reduce cross slope to be no steeper than 1:50 (2.00%).	1	-	-
19	Towards Camp Rooms	Ext.		Exterior Access Route	Walkway

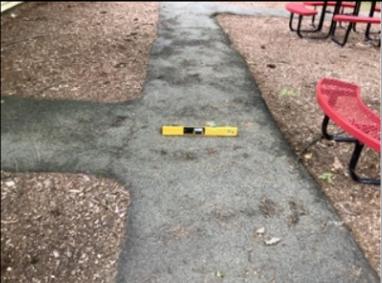
Cross slope > 1:50 (2.00%)	10.3%	Reduce cross slope to be no steeper than 1:50 (2.00%).	1	-	-
20	Towards Camp Rooms	Ext.		Exterior Access Route	Walkway

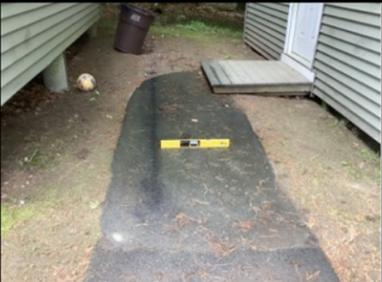
Cross slope > 1:50 (2.00%)	2.6%	Reduce cross slope to be no steeper than 1:50 (2.00%).	1	-	-

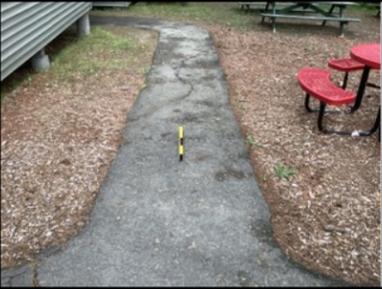
Cross slope > 1:50 (2.00%) Running slope > 1:20 (5.00%)	2.2% 12.8%	Reduce cross slope to be no steeper than 1:50 (2.00%). Reduce running slope to be no steeper than 1:20 (5.00%). Or provide accessible transportation between amenities.	1	-	-
22	Towards Pine Knoll	Ext.		Exterior Access Route	Walkway

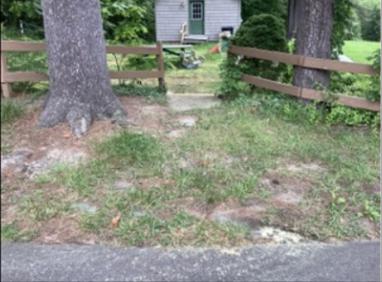
Accessible route not provided	-	Ensure an accessible route is provided to Pine Knoll. Recommendation also applies to the Pine Knoll building.	2	-	-
23	Towards Pine Lodge From Pool	Ext.		Exterior Access Route	Walkway

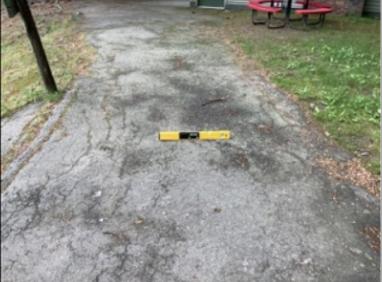
Cross slope > 1:50 (2.00%)	3.5%	Reduce cross slope to be no steeper than 1:50 (2.00%).	1	-	-
24	Towards Pine Lodge From Pool	Ext.		Exterior Access Route	Walkway

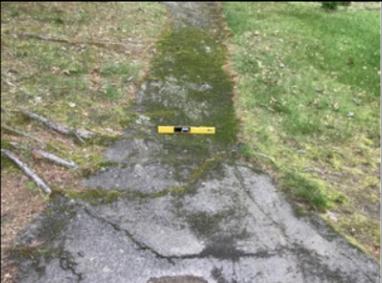
Cross slope > 1:50 (2.00%) Running slope > 1:20 (5.00%)	6.3% 14%	Reduce cross slope to be no steeper than 1:50 (2.00%). Reduce running slope to be no steeper than 1:20 (5.00%). Or provide accessible transportation between amenities.	1	-	-

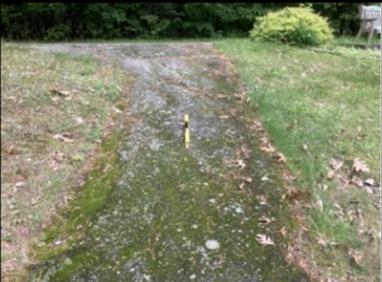
25	Towards Pine Lodge From Pool	Ext.		Exterior Access Route	Walkway

Cross slope > 1:50 (2.00%) Running slope > 1:20 (5.00%)	15.7% 22.2%	Reduce cross slope to be no steeper than 1:50 (2.00%). Reduce running slope to be no steeper than 1:20 (5.00%). Or provide accessible transportation between amenities.	1	-	-

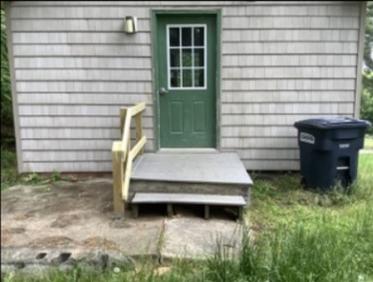
Handrail height < 34" or > 38" Bottom handrail extends < 12" + one tread Cross section of handrail is not compliant Handrail not provided on both sides Not maintained in operable working condition Stair has open risers	31" - - - -	Alter so the handrails are 34"- 38" high above the ground. Bottom: Ensure that the sloped bottom extension extends one tread depth min. beyond last riser nosing in same direction as stair flight. Provide handrails with 1 1/4" - 2" circular cross sections. Provide a handrail on each side. Repair treads and risers to ensure stairs are maintained in operable working condition. Ensure stairs have closed risers.	1	-	-
32	Stairs From Fields	Ext.		Exterior Stair	N/A

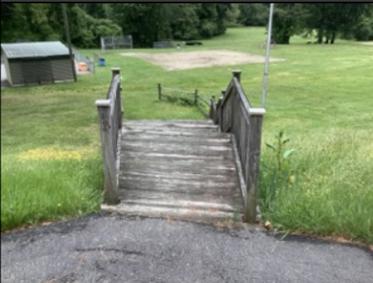
Cross section of handrail is not compliant	-	Provide handrails with 1 1/4" - 2" circular cross sections.	1	-	-

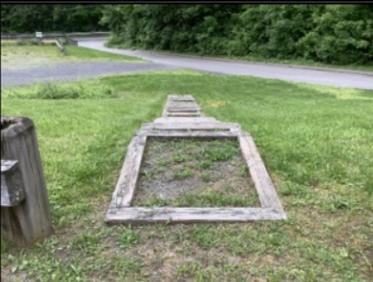
33	To Lower Parking	Ext.		Exterior Stair	N/A

Surface not stable, firm, and slip-resistant Not maintained in operable working condition Handrails not provided	- - -	Repair the surface to ensure treads are firm, stable, and slip-resistant. Repair treads and risers to ensure stairs are maintained in operable working condition. Provide handrails with 1 1/4" - 2" circular cross sections.	1	-	-
34	To Recreation Complex From Upper Parking	Ext.		Exterior Stair	N/A

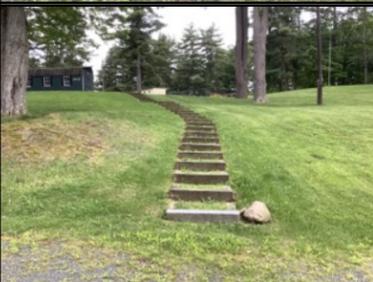
Surface not stable, firm, and slip-resistant Handrails not provided	- -	Repair the surface to ensure treads are firm, stable, and slip-resistant. Provide handrails with 1 1/4" - 2" circular cross sections.	1	-	-
35	Towards Pine Knoll	Ext.		Exterior Stair	N/A

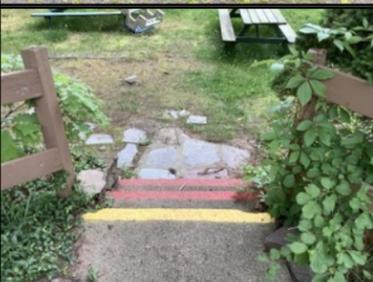
Handrails not provided	-	Provide handrails with 1 1/4" - 2" circular cross sections.	1	-	-

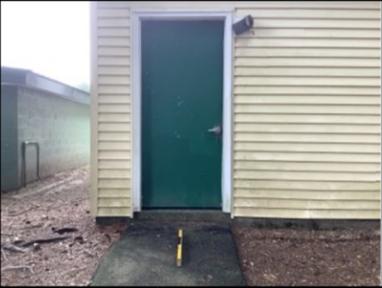
Maneuvering clearance at door > 1:50 (2.00%) Threshold > 1/2" high	11.1% 4.5"	Provide a directional sign indicating the location of the nearest accessible entrance.	1	743	\$500 - \$1K
											743	
37	Birch Hall - Secondary Entrance	Ext.		Entrance	Other

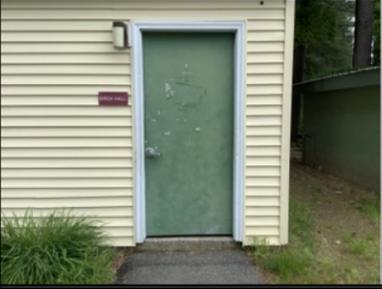
Directional sign to accessible entrance not provided	4"	Provide a directional sign indicating the location of the nearest accessible entrance. Recommendation also applies to the main entrance to the camp office.	2	743	\$1K - \$5K
											1486	
38	Camp Office - Secondary Entrance	Ext.		Entrance	Secondary Entrance

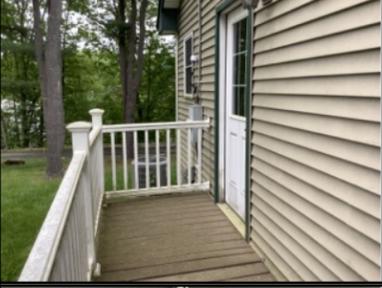
International Symbol of Accessibility not provided	-	Provide a sign with the International Symbol of Accessibility (ISA). Recommendation also applies to the main entrance to Birch Hall.	2	743	\$1K - \$5K

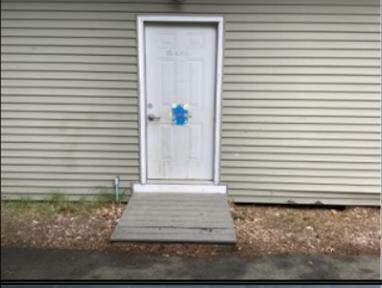
Entrance not on an accessible route	4"	Provide an accessible entrance into the camp room. Recommendation applies to both camp rooms.	2	-	-
40	Inaccessible Men's Toilet and Changing Room	Ext.		Entrance	Other

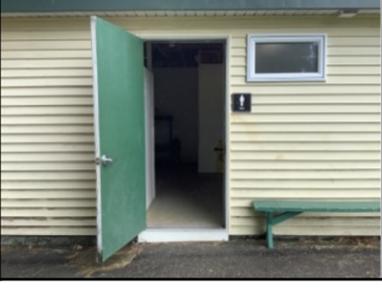
Directional sign to accessible entrance not provided	5.5"	Provide a directional sign indicating the location of the nearest accessible toilet and changing room. Recommendation also applies to both entrances to the inaccessible men's and women's toilet and changing room.	4	743	\$1K - \$5K
											2972

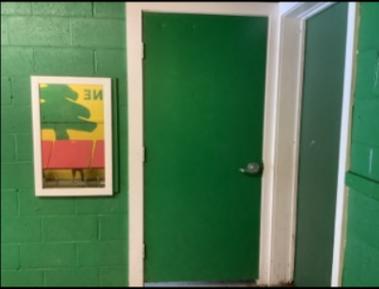
Maneuvering clearance(s) not provided	-	Provide an automatic door opener.	1	9900	\$5K - \$10K
											9900	
52	Pine Lodge - Main Egress	1		Doors, Doorways, & Gates	Emergency Egress

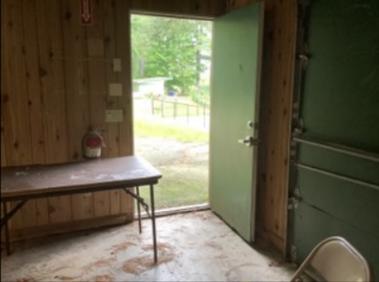
Maneuvering clearance(s) not provided	-	Relocate table to maintain the required 18" min. maneuvering clearance at the pull-side of the door. Recommendation applies to all doors with a similar issue.	1	Labor	Labor
53	Women's Toilet and Changing Room	1		Doors, Doorways, & Gates	Other

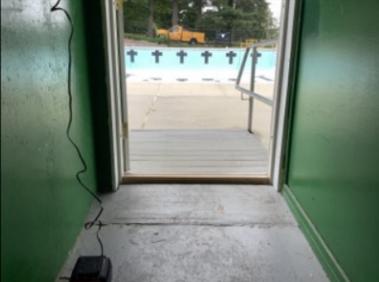
Threshold not beveled Threshold > 1/2" high	- 1.5"	Bevel the threshold. Alter the threshold to be 1/2" high max.	1	1650	\$1K - \$5K
											1650	
54	Birch Hall - Main Entrance	Ext.		Doors, Doorways, & Gates	Other

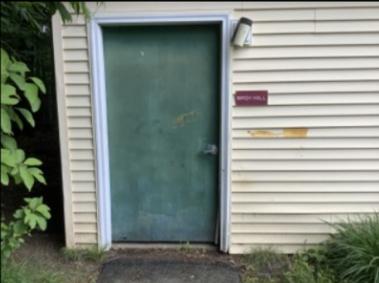
Maneuvering clearance(s) not provided Threshold not beveled Threshold > 1/2" high	- - 1.5"	Extend the concrete platform to provide the required 12" min. maneuvering clearance at the push-side of the door, or provide an automatic door opener. Bevel the threshold. Alter the threshold to be 1/2" high max. (Cost estimate is for an automatic door opener and renovating the threshold.)	1	9900 1650	\$10K - \$50K

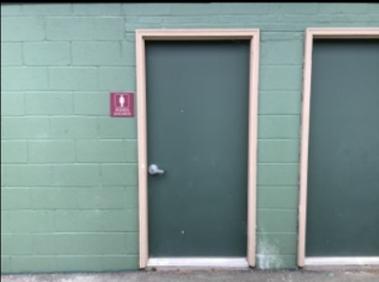
Threshold not beveled Threshold > 1/2" high	- 2.25"	Bevel the threshold. Alter the threshold to be 1/2" high max. Recommendation also applies to the men's shower room.	2	1650	\$1K - \$5K
											3300

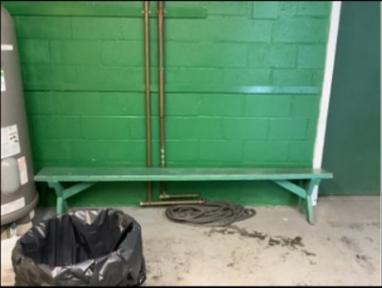
30" clear not provided alongside bench Bench < 24" deep	- 9.25"	Provide a 30" min. by 48" min. clear space along the side of the bench so that wheelchair users can transfer. Provide a bench that is 24" deep.	1	990	\$500 - \$1K
											990	
Picnic Tables												
62	Camp Room	1		Picnic Tables	N/A

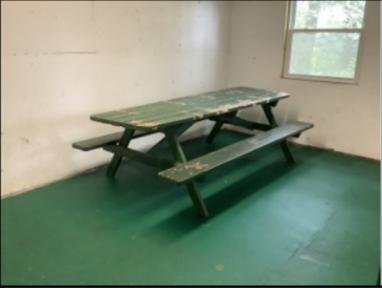
At least 5% accessible spaces not provided Knee clearance less than 19" deep	- 14"	Ensure that at least 5% (minimum one) of picnic tables are accessible. Provide at least one picnic table with knee clearance that is 19" deep min. Recommendation applies to all picnic tables with a similar issue.	1	2310	\$1K - \$5K
											2310	
63	Near Basketball Court	Ext.		Picnic Tables	N/A

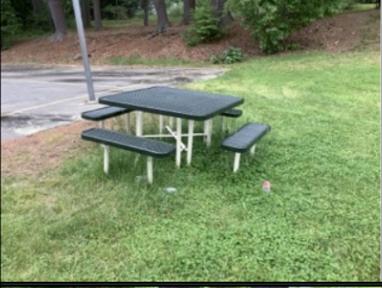
At least 5% accessible spaces not provided 30" clear width not provided Picnic table not on an accessible route	- 16" -	Provide at least 1 accessible picnic table (or ensure that 5% of picnic tables are accessible) with a 30" by 48" clear floor space. Ensure that the picnic table is connected to an accessible route. (Cost estimate is for an accessible picnic table.) Recommendation applies to 5% of picnic tables with a similar issue in each area where tables are provided.	1	2310	\$1K - \$5K

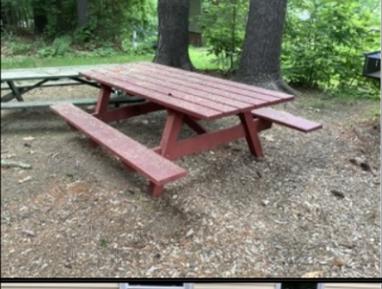
Picnic table not on an accessible route	-	Ensure that the picnic table is connected to an accessible route. Recommendation applies to all picnic tables with a similar issue.	1	-	-
65	Near Birch Hall	Ext.		Picnic Tables	N/A

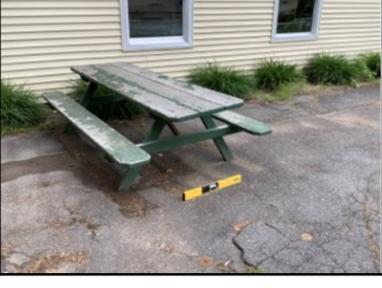
Picnic table not on an accessible route Knee clearance less than 19" deep	4.1% cross x 7.3% run 15.5"	Ensure that the picnic table is connected to an accessible route. Provide at least one picnic table with knee clearance that is 19" deep min. (Cost estimate is for an accessible picnic table.)	1	2310	\$1K - \$5K
											2310

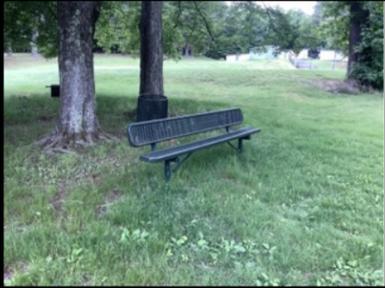
No accessible route to one bench in area	-	Relocate one bench to an accessible route. Recommendation also applies to a bench near the Pine Lodge.	1	-	-
Toilet & Bathing Rooms												
Overall Access												
67	Men's Toilet and Changing Room - Toilet Room	1		Overall Access	Toilet Room

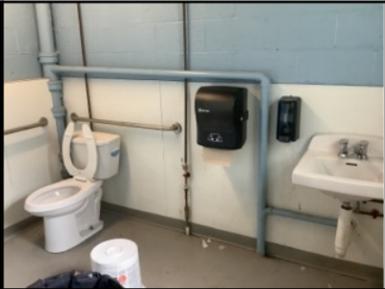
Audible and visible alarm not provided	-	When fire system is updated, ensure that a visible and audible fire alarm is installed. Recommendation also applies to the women's toilet room.	2	-	-
Lavatory												
68	Camp Office - Single-User Toilet Room	1		Lavatory	N/A

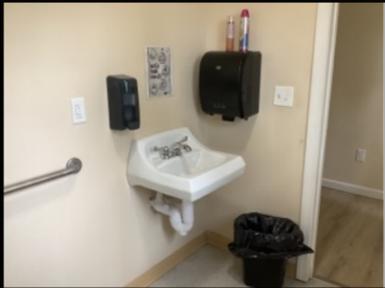
Clear floor space not provided at lavatory	-	Relocate trash can to maintain a 30" min. by 48" min. clear floor space positioned for a forward approach. Recommendation applies to all lavatories with a similar issue.	1	Labor	Labor

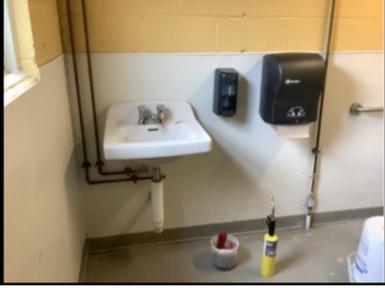
Plumbing underneath is exposed	-	Insulate or otherwise configure pipes to prevent contact for at least one lavatory.	1	248	\$1 - \$500
											248

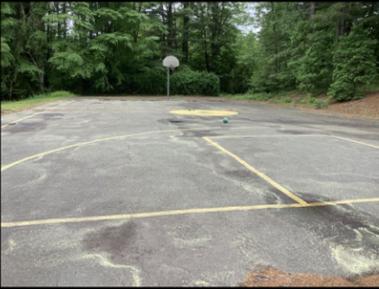
Court not maintained in operable working condition	-	Repair surface to ensure that the basketball court is maintained in operable working condition.	1	-	-
85	Court	Ext.		Court	Other

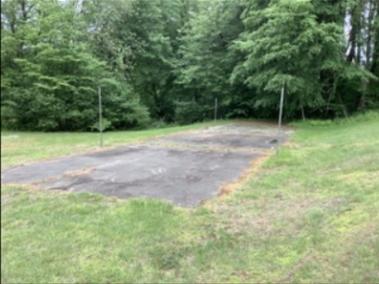
Court not maintained in operable working condition	-	If this court is still in use, provide an accessible route and ensure that the court is maintained in operable working condition.	1	-	-
86	Gaga Ball Pit	Ext.		Court	Gaga Ball

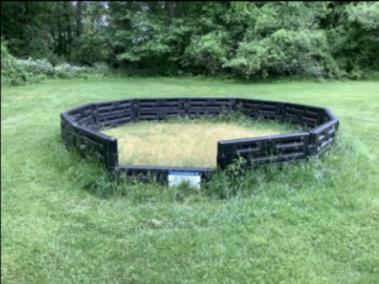
Court is not connected to an accessible route Court not maintained in operable working condition No accessible route between all areas of sport activity	- - -	Provide an accessible route to the gaga ball pit. Trim vegetation to ensure that the court is maintained in operable working condition. Install an accessible route between all areas of sport activity.	1	-	-

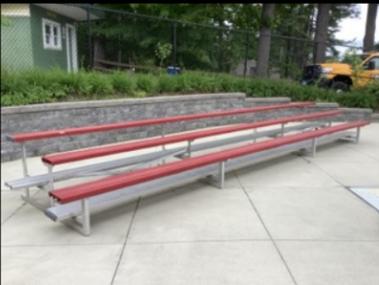
87	Near Pool	Ext.		Court	Other

Accessible spaces are not provided at sidelines seating	-	Provide a 36" x 60" firm, stable, and slip-resistant clear floor space at sidelines seating. Based on the number of seats provided, look to 2010 ADA Table 221.2.1, and provide the minimum number of wheelchair seats based on that count. Provide an accessible route to this space.	1	-	-
88	Tennis Courts	Ext.		Court	Tennis

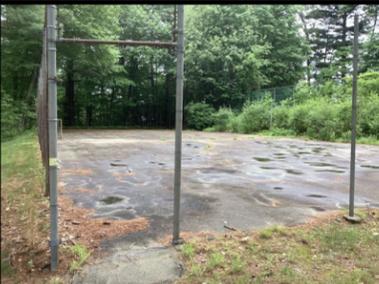
Court not maintained in operable working condition	-	If the tennis courts are still in use, repair surface to ensure that the court is maintained in operable working condition. Recommendation applies to both tennis courts.	2	-	-

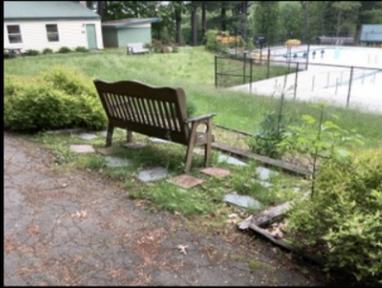
-	Recommend providing a 36" min. by 48" min. stable, firm and slip-resistant surface adjacent to at least one bench in each area where benches are provided positioned to allow a person in a wheeled mobility device and a person sitting on the bench to have their shoulders aligned.	1	-	-
Locker Room												
90	Women's Toilet and Changing Room	1		Locker Room	Women's

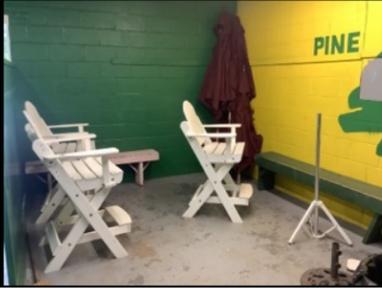
-	Recommend providing a private changing stall that is 78" by 72" min. Recommendation also applies to the men's toilet and changing room.	2	-	-
Operable Parts / Reach Range												
91	Camp Office - Single-User Toilet Room	1		Operable Parts / Reach Range	Emergency Pull Cord

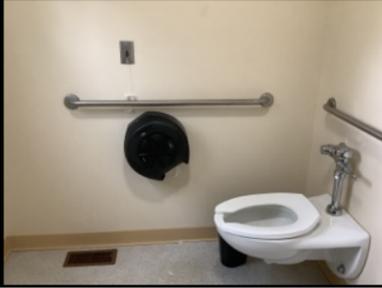
-	Ensure the emergency pull cord is not tied so that it extends to within 12" of the floor.	1	-	-

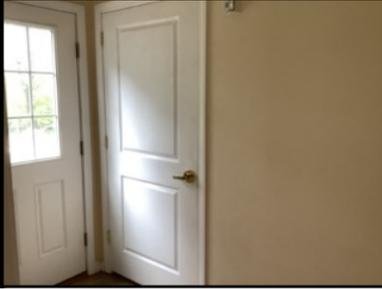
-	Recommend providing a designation sign with raised characters and braille alongside the door on the latch side. Recommendation applies to all permanent rooms that lack a designation sign.	1	-	-

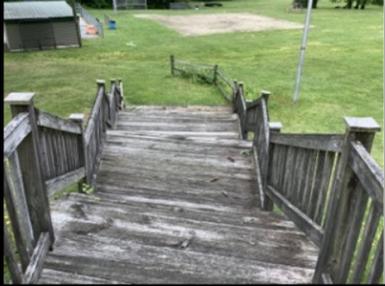
-	<p>Recommend providing a contrasting strip at each stair tread on the stair so that each tread is readily apparent when viewed in descent or ascent.</p> <p>Recommendation applies to all stairs.</p>	1	-	-
