## 5.A

### SITE DEVELOPMENT NARRATIVE

#### Existing Conditions

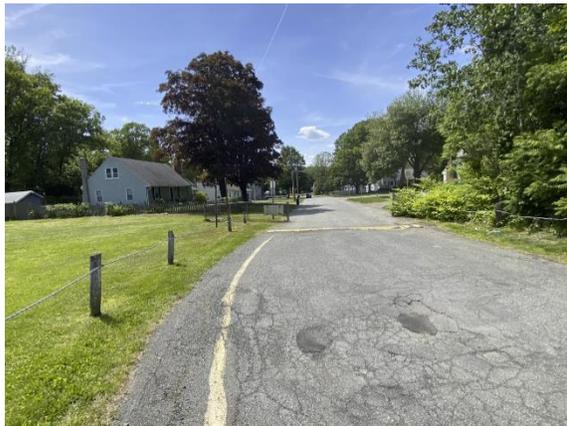
Norden Street access facing west

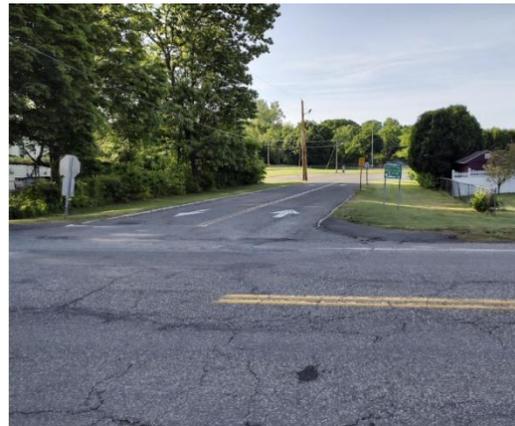
access to main parking Lot

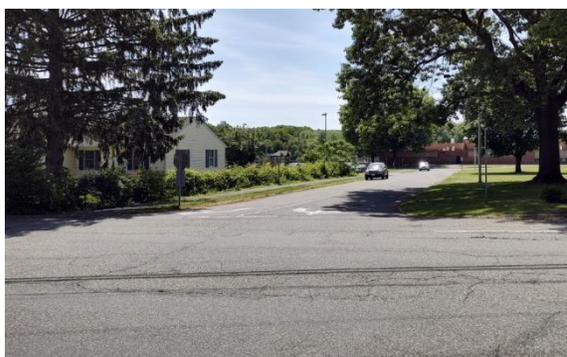
Front drive exit

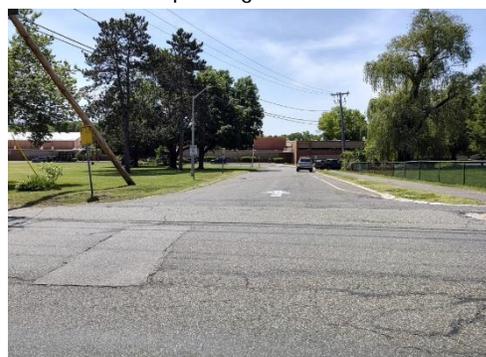
Front drive entry

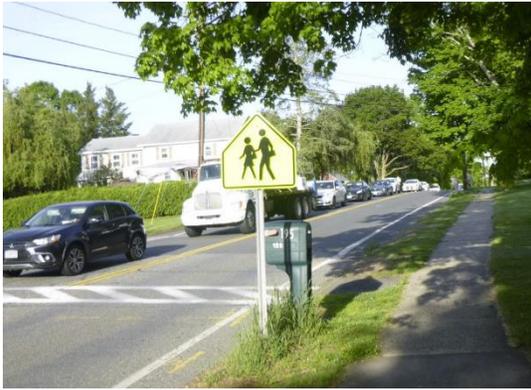
- Queuing of parent vehicles in the exit lanes of the front drive reached approximately 8 vehicles.
- Vehicle backups on both the eastbound and westbound lanes on Maple Street were observed at the westernmost curb cut of the front drive due to insufficient queuing length in the drive, and due to vehicles waiting to take a left turn into the site. Eastbound and westbound backups on Maple Street were also observed at the easternmost parking lot entrance. Maple Street is not wide enough to allow for vehicles to bypass the queued vehicles waiting to enter the site.

Maples Street eastbound traffic at western entry point during AM drop-off operation

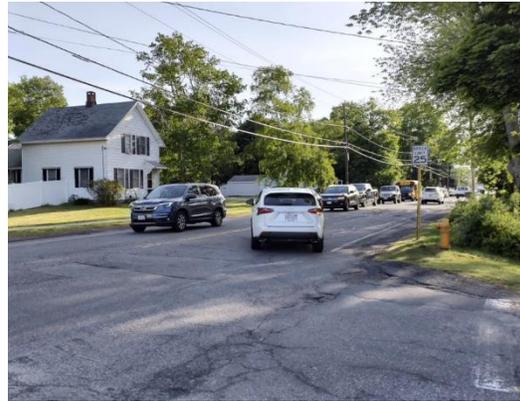
Maples Street westbound traffic at easternmost entry during AM drop-off operation

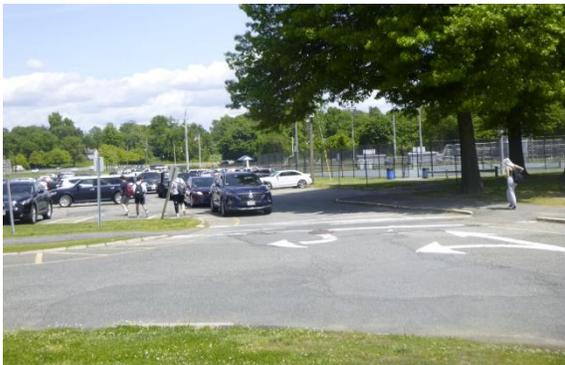
- Some parent vehicles queue in the front drive, behind the last bus. It appeared that students walked to these cars while waiting for the buses to leave. Additional parent vehicles enter the front drive after buses have exited the site and proceed in a line towards the front building entrance where students await, and then proceed to exit the front drive.

Parent vehicle queues amongst pedestrians during pick-up operations

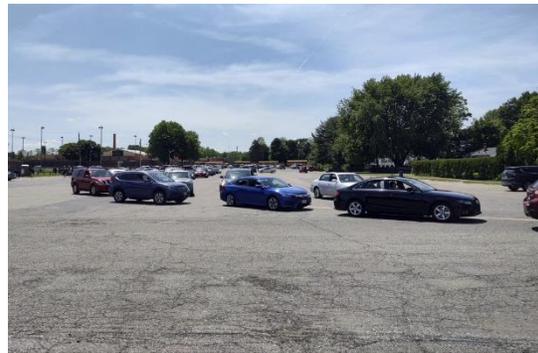
- Due to the lack of interior islands and other traffic calming and channeling measures, multiple lanes of student vehicles converge at a single location to exit at the easternmost access drive, creating significant congestion. Some vehicles were observed travelling in the opposing lane of the access drive to try and bypass queued vehicles exiting onto

Maple Street. Higher than normal speeds in the parking lot area were observed. School staff indicated that there have been multiple vehicular accidents in this area.

Student vehicle congestion at south end of main parking lot

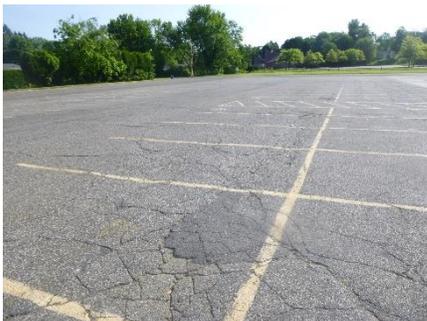
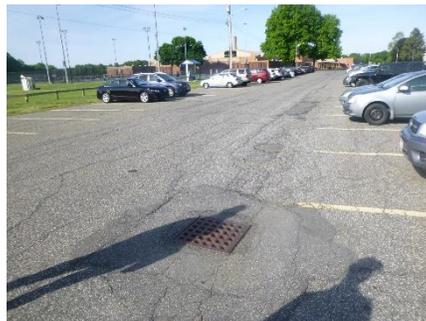
Parking lots and access drives consist of bituminous pavement that is generally in poor overall condition due to areas of dense fatigue cracking, undulations from settlement or heaving, and

surface deterioration that is starting to form potholes in specific areas. The pavement is still functional for vehicular traffic but is nearing the end of its useful life.

Northeast parking Lot

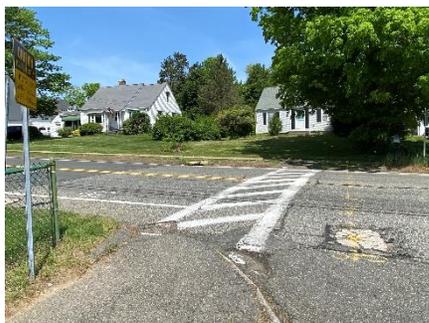
Several portions of the bituminous walkways consist of an uneven surface due to settlement and heaving, cracks, broken edges, or general surface deterioration, and are therefore not considered accessible. Routes from designated accessible parking spaces are not compliant due to slope exceedances, lack of tactile warning panels at curb ramps, surface conditions, or incorrect configurations. In some instances, there is no designated pedestrian route provided to the accessible parking space, requiring the user to walk in vehicular ways. At multiple locations, bituminous walkways are not flush with adjacent concrete egress pads for the building. Curb ramps in general lack tactile warning panels, lack flush transitions, or exceed slope requirements.

Sidewalk to Maple St crosswalk

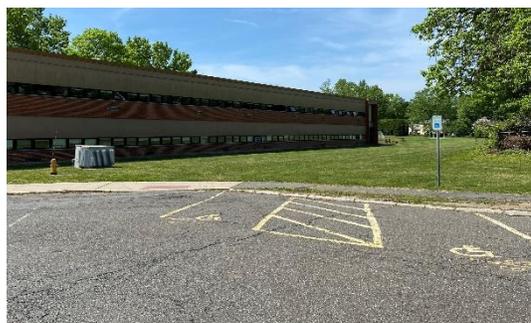
Route from accessible spaces in the front drive

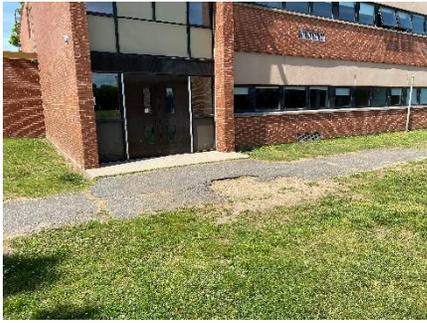
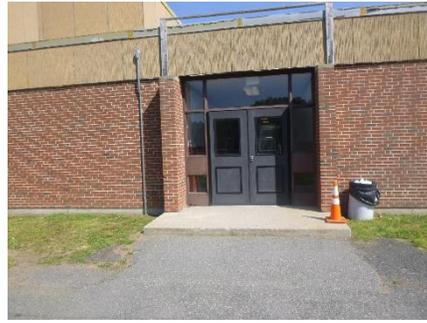
Walkway and egress pad on south side of building

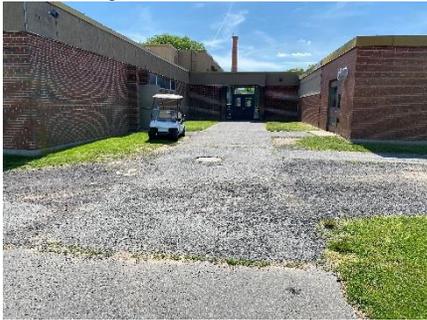
Bituminous walks along the east side of building

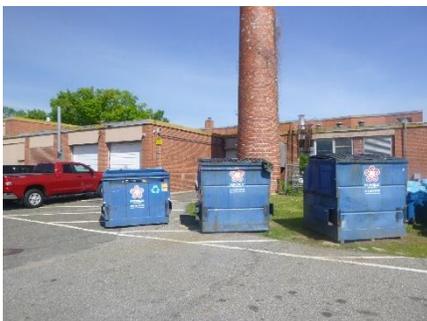
The service area is located on the south side of the school with 3 (three) unscreened dumpsters: one (1) for recyclables and two (2) for trash. There is no dedicated concrete pad for the dumpsters and they are located in pavement and lawn areas, adjacent to an area setup for outdoor dining. Blue tote barrels for recyclables from individual classrooms are stacked in the lawn area adjacent to the dumpsters. There is no screening of these dumpsters or totes.

Unscreened dumpsters

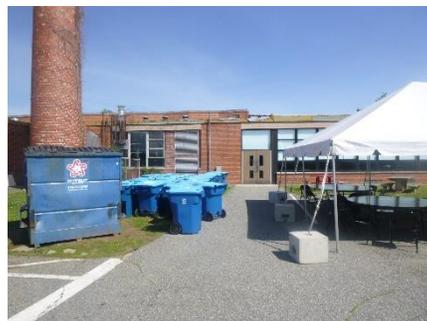
Equipment stored outside

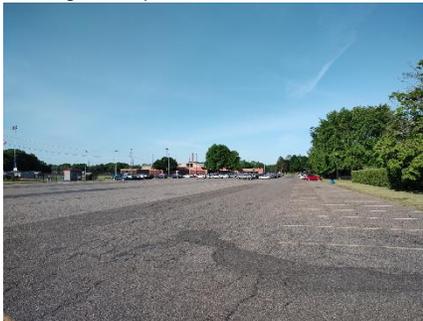
Existing parking lot void of landscape islands and vegetation

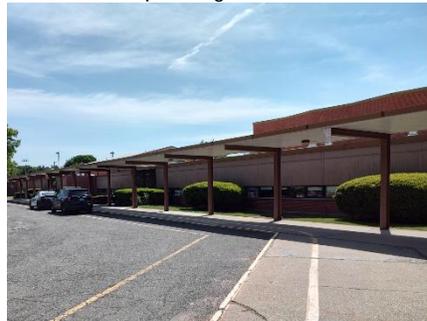
Overgrown shrubs blocking exterior views for rooms at front of school

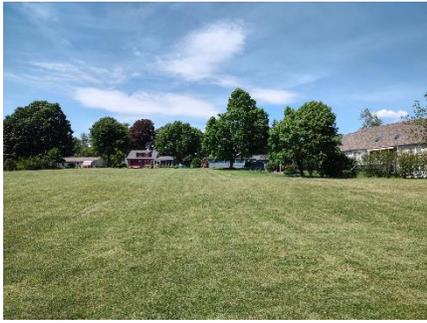
Existing sparse vegetated buffer to north of classroom wing

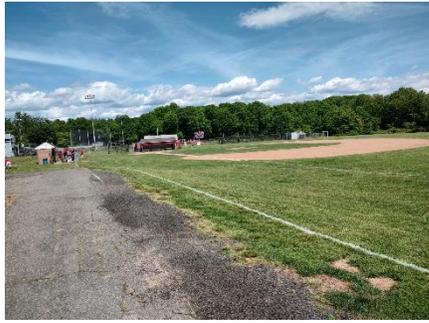
Varsity baseball field

- A varsity baseball field is located adjacent to the southeast corner of the school. The outfield is also utilized as a practice field. The baseball field consists of a dirt infield, dugouts set on concrete pads, stone dust team areas, a chain link backstop, and associated chain link fencing enclosing the dugouts/team areas. No permanent chain link fencing is provided down the left or right field lines, but a temporary chain link outfield fence is installed during baseball season. There is a two-sided electronic scoreboard just beyond the centerfield portion of the temporary outfield fence. We understand that the side of the scoreboard facing the baseball field is functional, while the opposite side facing the JV football field (see below) is not functional. Batting practice and warm-up cages and large shipping containers for storage are also present behind the visitor dugout and just outside the left field foul ground. The chain link fencing around the team areas is in poor condition, and the baseball field is not properly oriented for optimal performance.

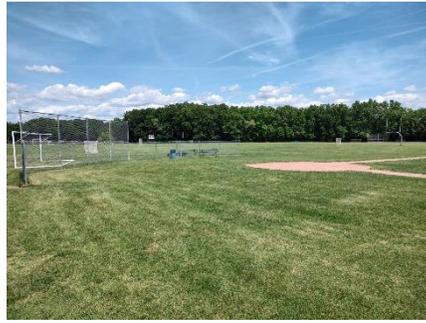
Junior varsity baseball field

- A junior varsity baseball field is located southwest of the existing school building. The outfield is also utilized as a soccer and practice field. The baseball field consists of a dirt infield, small portable steel and plastic team benches, unenclosed stone dust/dirt team areas, a chain link backstop that appears to be insufficient in height, and associated chain link fencing limited to the area immediately between the playfield and the team benches.

No permanent chain link fencing is provided down the left or right field lines. The chain link fencing and team areas are in poor condition, and the baseball field is not properly oriented for optimal performance.
