East Longmeadow Police Station

Town of East Longmeadow ADA Transition Plan

September 2025

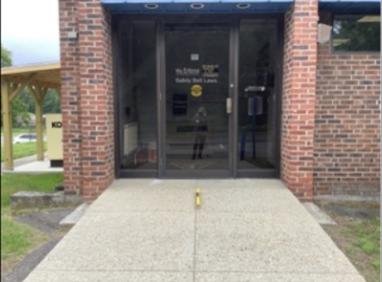
Running slope > 1:20 (5.00%)	8.1%	Reduce running slope to be no steeper than 1:20 (5.00%).	1	-	-
2	To Parking	Ext.		Exterior Access Route	Sidewalk

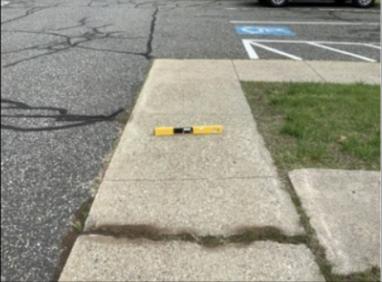
Cross slope > 1:50 (2.00%) Running slope > 1:20 (5.00%) Route not maintained in operable working condition	2.3% 6.7% -	Reduce cross slope to be no steeper than 1:50 (2.00%). Reduce running slope to be no steeper than 1:20 (5.00%). Repair surface to ensure the accessible route is maintained in operable working condition.	1	-	-
Off-Street Parking Lot or Garage												
3	Parking	Ext.		Off-Street Parking Lot or Garage	Visitor

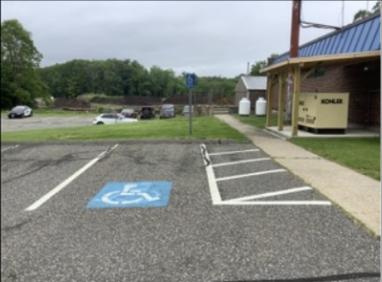
Total # of parking Total # of designated car accessible parking spaces Total # of designated van accessible spaces Access aisle < 96" wide at van space Sign does not have the designation "Van Accessible"	40 0 1 58.5" -	Provide a car accessible space with a sign with the International Symbol of Accessibility. Provide a marked access aisle that is at least 96" wide. Add the designation "Van Accessible" to the sign located at the van accessible space. (Cost is for a "Van Accessible" sign and a sign with the International Symbol of Accessibility).	2	825	\$1K - \$5K

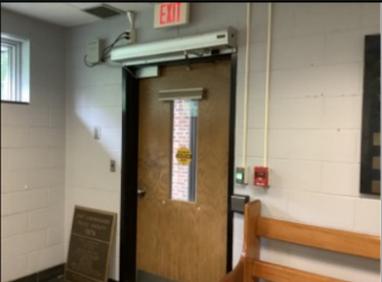
1650	
Access to Goods and Services												
Means of Egress												
4	Main Egress	1		Means of Egress	N/A

Tactile exit sign not provided Illuminated ISA symbol not provided (MAAB)	- -	Ensure that a tactile exit sign with raised characters and braille is provided at the exit door. Mount the sign between 48"- 60" above the finished floor located on the latch side of the door. Provide an illuminated sign with the International Symbol of Accessibility (ISA).	1	413 330	\$500 - \$1K
											743

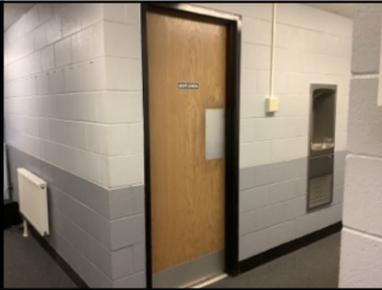
ID	Location	Floor	Room	Element	Type	Photo	Issues	Current Measure	Recommendations	Quantity	Price	Cost Estimation
Signage												
15	Men's Multi-User Toilet Room	LL		Signage	Designation

Raised characters not provided on sign Braille not provided on sign Location of tactile sign not compliant	- - -	Provide text with raised characters duplicated in braille on the sign. Locate sign alongside the door on the latch side. Unit cost is provided for one instance of this repetitive item.	1	413	\$1 - \$500
											413	
Service Counter												
16	Lobby	1		Service Counter	N/A

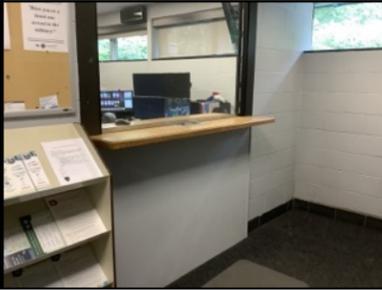
Counter > 36" high	45.5"	Provide a counter that is 36" max. above the ground or finished floor.	1	1888	\$1K - \$5K
											1888	
Operable Parts / Reach Range												
17	Booking	1		Operable Parts / Reach Range	Equipment

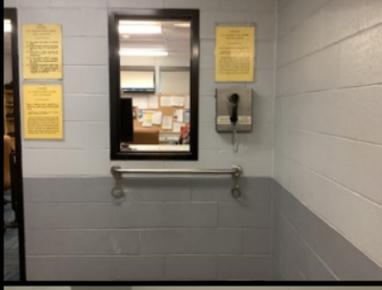
Reach < 15" or > 48"(forward/side approach)	58.75"	Relocate phone so that controls are no higher than 48" above the finished floor. Recommendation also applies to the phone in the main entrance vestibule.	2	825	\$1K - \$5K

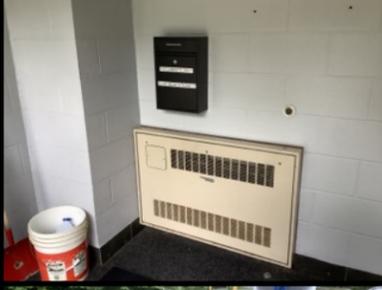
1650	
18	Vestibule	1		Operable Parts / Reach Range	Other

Reach < 15" or > 48"(forward/side approach)	51.25"	Relocate drop box so that controls are no higher than 48" above the finished floor.	1	825	\$500 - \$1K
											825	
19	Near Main Entrance	Ext.		Operable Parts / Reach Range	Other

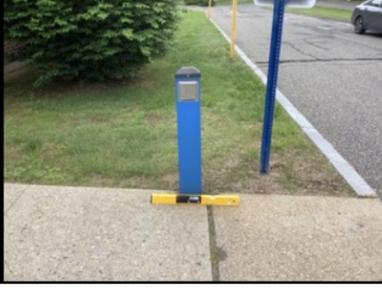
Element not on an accessible route Clear floor space is not provided	7.7% -	Ensure that the automatic door opener is located on an accessible route that is sloped no greater than 5%. Ensure that the 30" by 48" clear floor space at the automatic the automatic door opener is sloped no more than 1:50 (2.00%) in all directions.	1	-	-

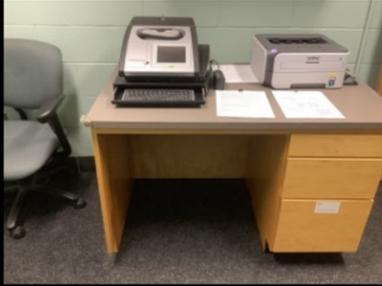
ID	Location	Floor	Room	Element	Type	Photo	Issues	Current Measure	Recommendations	Quantity	Price	Cost Estimation
Dining or Work Surfaces												
20	Fingerprinting	1		Dining or Work Surfaces	Work Surface

30" clear width not provided	28.5"	Provide at least one accessible work surface with a 30" min. by 48" min. clear floor space.	1	1155	\$1K - \$5K
											1155	
21	Interview Room	LL		Dining or Work Surfaces	Work Surface

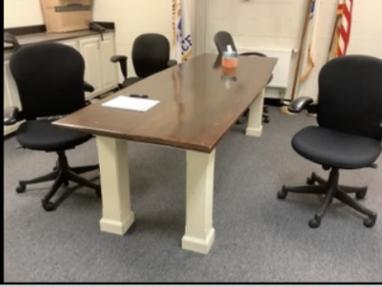
Knee or toe clearance not provided	25.5"	Provide at least one work surface with 27" min. high knee and toe clearance.	1	1502	\$1K - \$5K
											1502	
Detention Facilities												
22	Men's Holding Cells	1		Detention Facilities	Men's

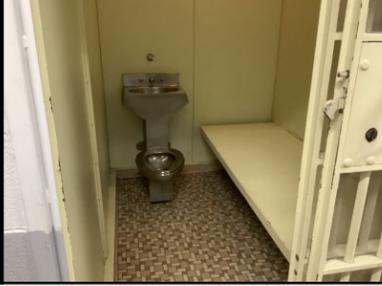
< 3% of holding cells have mobility features Mobility cell lacks 60" turning space Mobility cell lacks access to accessible toilet/lavatory Clear width at door < 32"	- 31.75" - 23.75"	In the current configuration, there is a cell door with a lack of adequate clear width, lack of turning space and lack of an accessible toilet/lavatory. The Town can achieve program access by making arrangements to transfer men and women who need a mobility accessible holding cell to another City or Town holding cell that is accessible. Applies to the men's and women's holding cells.	1	-	-

Note: The Town can achieve program access by making arrangements to transfer men and women who need a mobility accessible holding cell to another town, county or state holding cell that is accessible. The document at the following link provides additional information about accessible cells in correction facilities: <https://archive.ada.gov/accessiblecells.htm>.

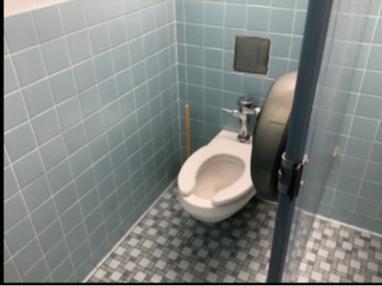
Toilet & Bathing Rooms												
Overall Access												
23	Single-User Toilet Room	1		Overall Access	Toilet Room

Accessible plumbing fixtures or stalls not provided	-	Provide one accessible wheelchair compartment. Recommendation also applies to the men's and women's toilet rooms on the lower level if and when an accessible route is provided to the lower level.	1	13262	\$10K - \$50K
											13262

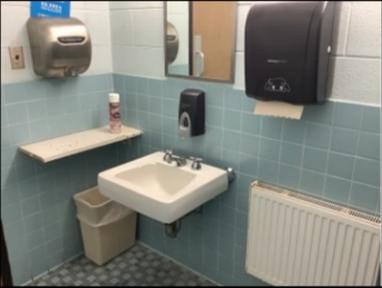
ID	Location	Floor	Room	Element	Type	Photo	Issues	Current Measure	Recommendations	Quantity	Price	Cost Estimation
Lavatory												
24	Single-User Toilet Room	1		Lavatory	N/A

Plumbing underneath is exposed Mirror above lavatory w/reflective surface > 40"	- 49.25"	Insulate or otherwise configure pipes to prevent contact for at least one lavatory. Lower mirror so that the bottom surface is at 40" max. above the finished floor.	1	248 1320	\$1K - \$5K
											1568	
25	Men's Multi-User Toilet Room	LL		Lavatory	N/A

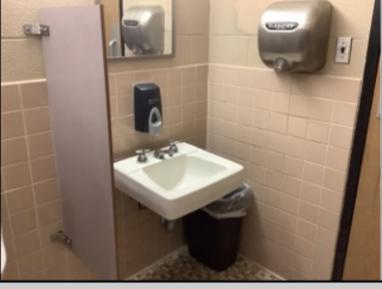
Plumbing underneath is exposed Mirror above lavatory w/reflective surface > 40"	- 49.25"	If and when an accessible route is provided to this level, insulate or otherwise configure pipes to prevent contact for at least one lavatory. Lower mirror so that the bottom surface is at 40" max. above the finished floor. Recommendation also applies to the women's toilet room.	2	248 1320	\$1K - \$5K

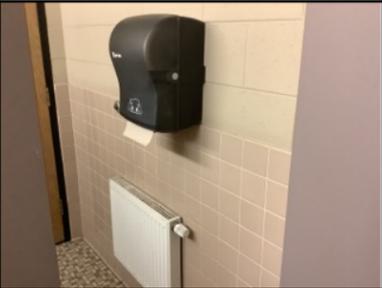
3136	
Dispensers												
26	Men's Multi-User Toilet Room	LL		Dispensers	Paper Towel Dispenser

Dispenser acts as a protruding object	10"	Relocate dispenser out of the circulation path. Recommendation also applies to the women's toilet room and the single-user toilet room.	3	1320	\$1K - \$5K
											3960
