East Longmeadow High School

EXISTING CONDITIONS SURVEY

Architects, Engineers & Hazmat Assessment Team visit
June 17, 2022

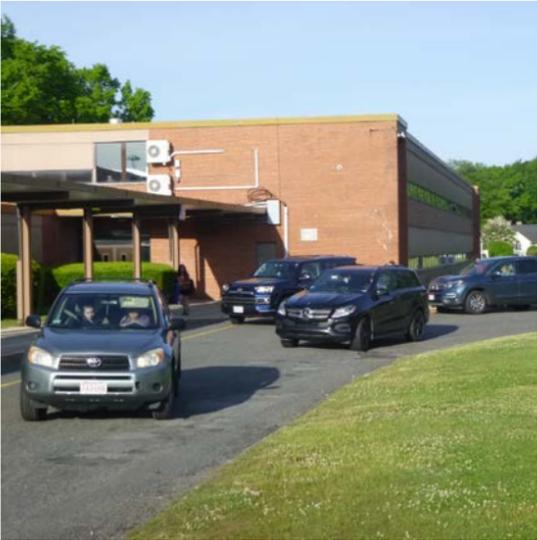
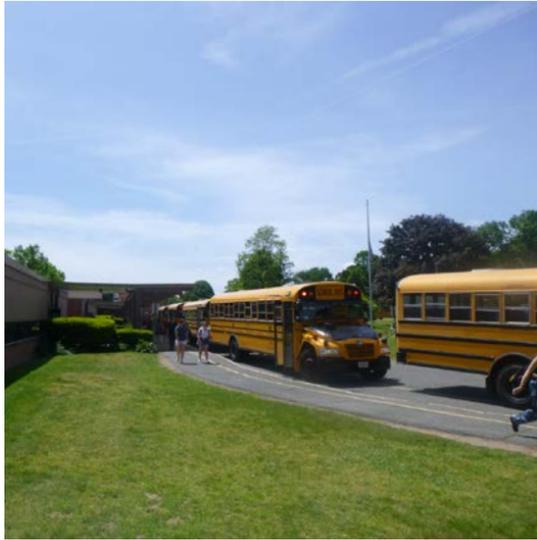
AM Arrival Patterns

Lack of Separation Between School Bus and Passenger Vehicle Traffic.

General Safety Concerns and Lack of Efficiency with Overall Vehicular Circulation.

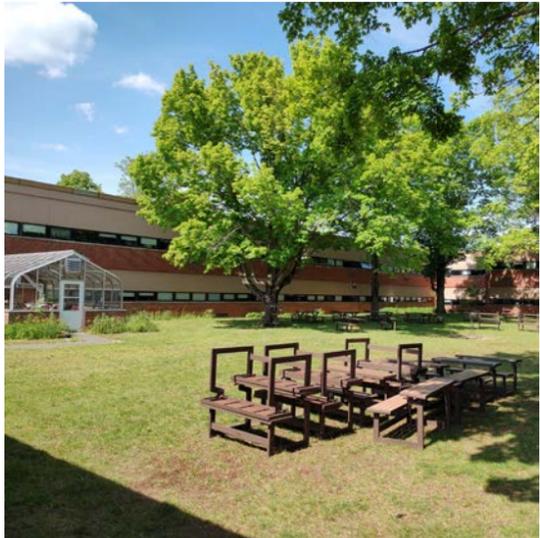
Internal Courtyards

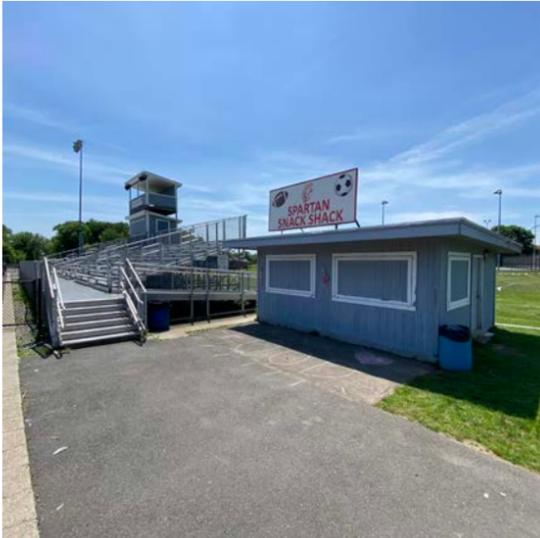
Concessions | Press Box | Storage

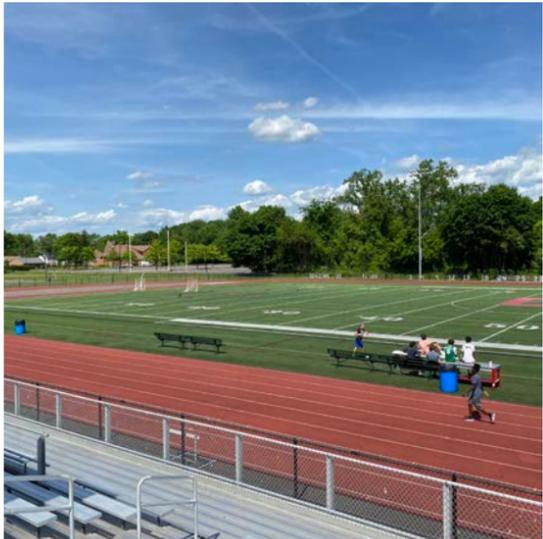
Athletic Fields and Courts are Extensive and in Good Overall Condition.

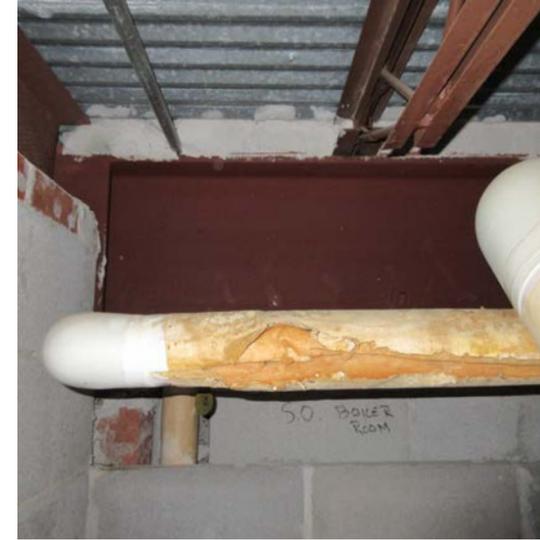
(2) Elevated floor framing

(2) Elevated floor structure consists of open web steel joists, steel girders and concrete floor slab on deck

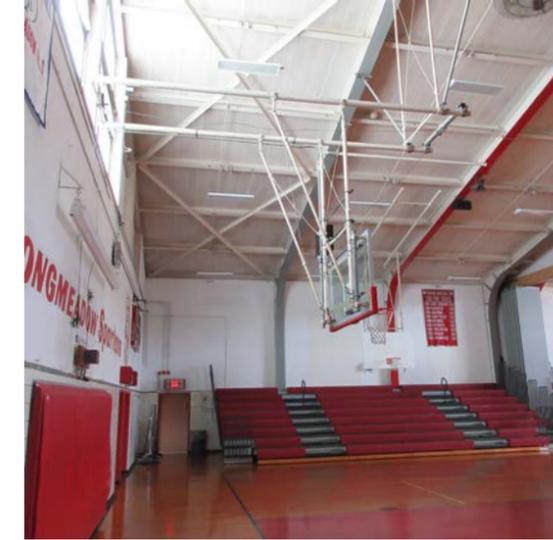
(3) Main Gym Structure

(3) Original gym roof consists of steel bents supporting steel beam purlins and metal roof deck.

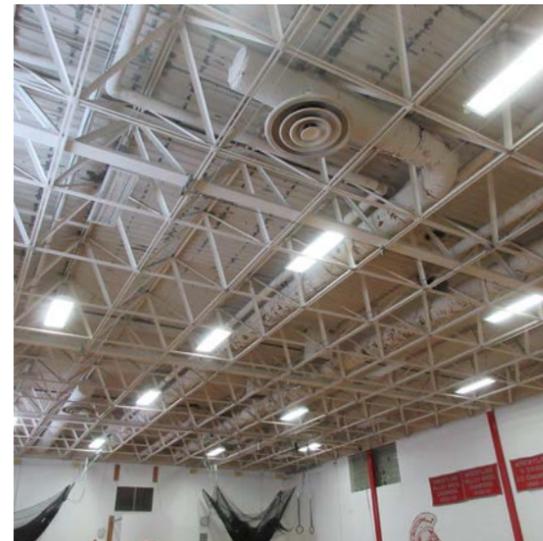
(4) Gym 1973 Addition Structure

(4) Gym addition & industrial arts addition roofs are structured with steel space trusses and metal roof deck

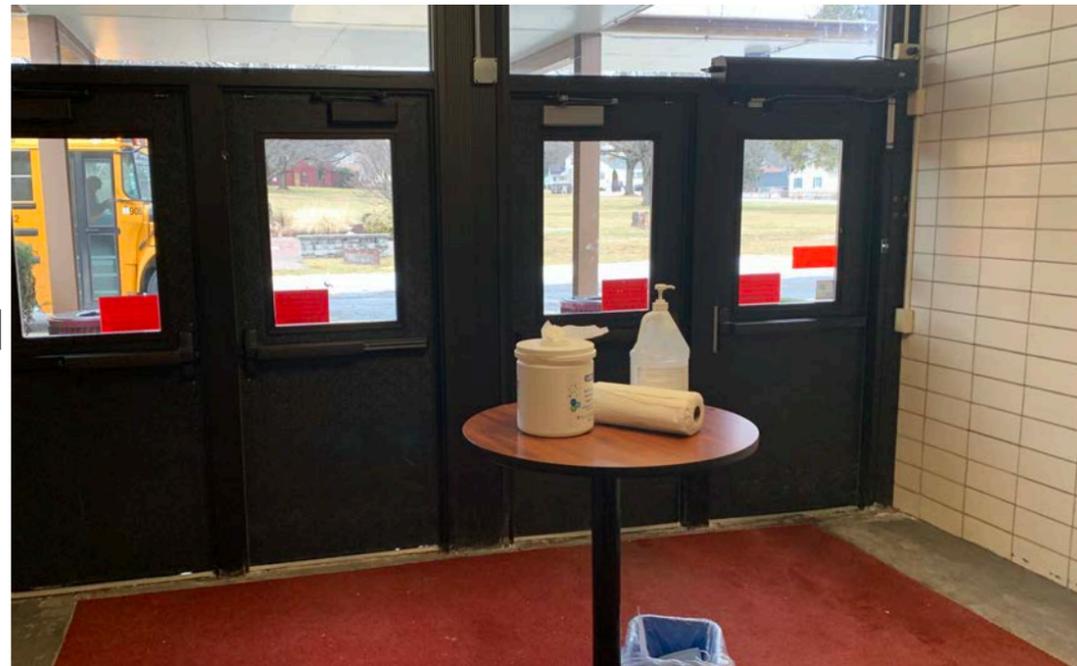
(2) First impressions of the school are vibrant and caring, but layout and materials send a different message.

(2) Entry/Security Concern/Lack of Welcome

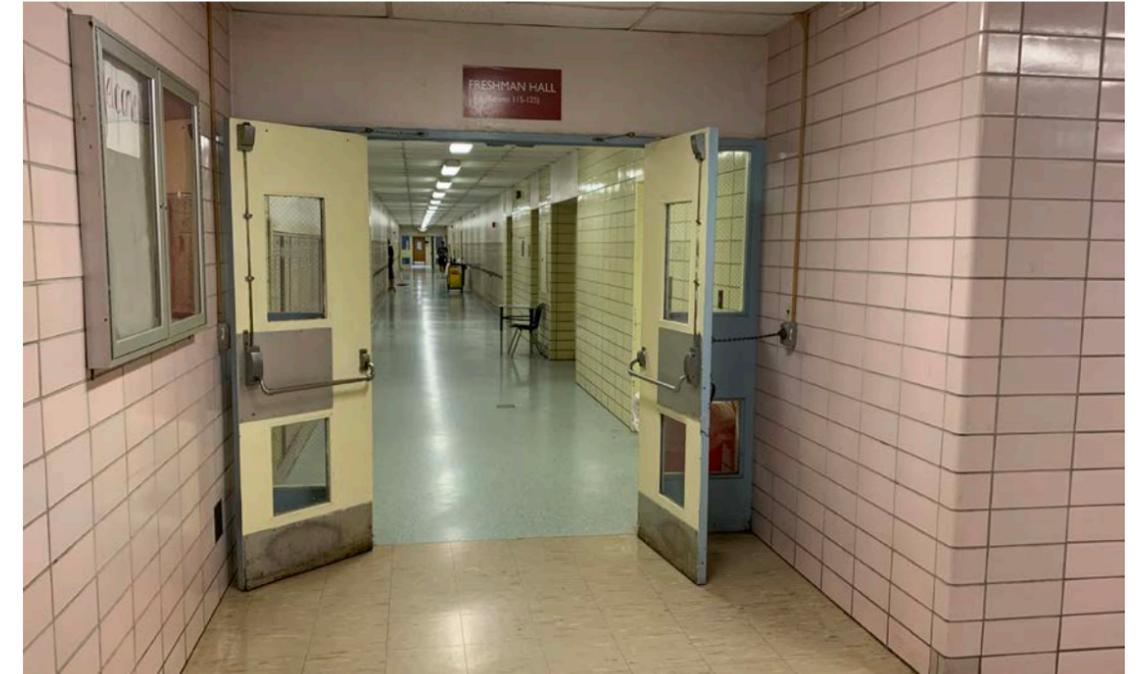
(3) Hard surfaces, grid ceilings, dated tile reinforce 1950s institutional feel of school.

(3) Dated, institutional corridor, lacks student space

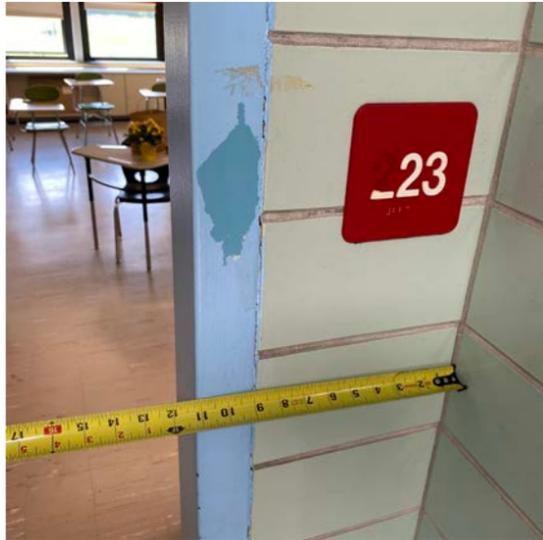
Lack of compliance with MAAB / ADA in numerous locations

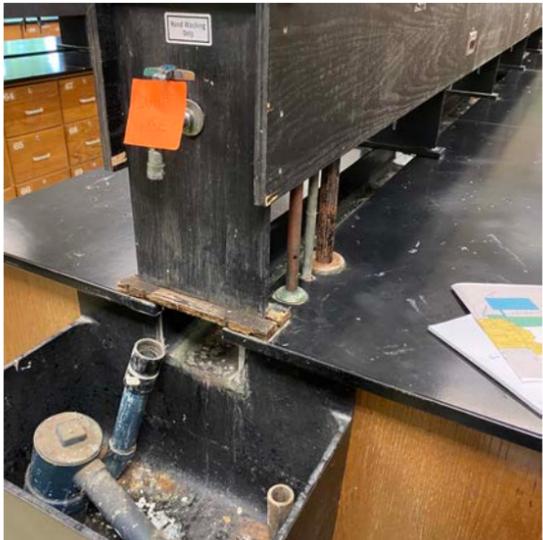
Science facilities outdated and lack necessary infrastructure

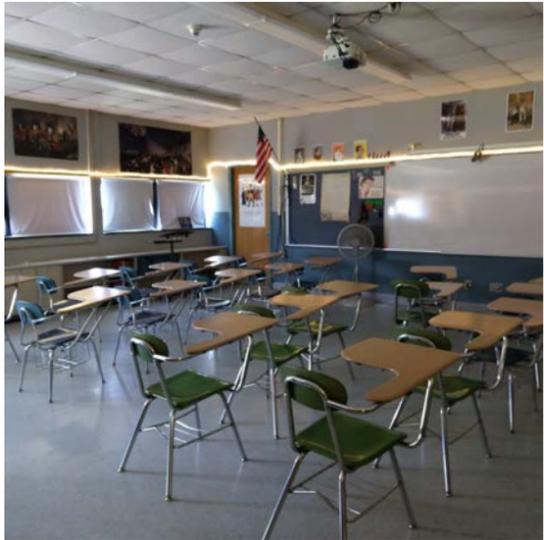
Blinds pulled permanently - to try to help control glare and heat

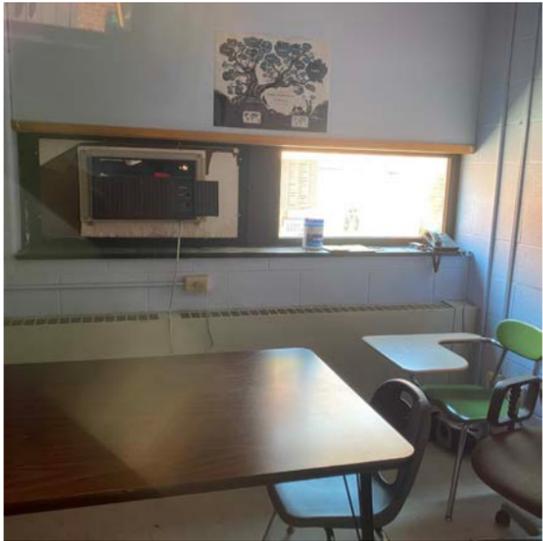
Small windows at perfectly wrong height

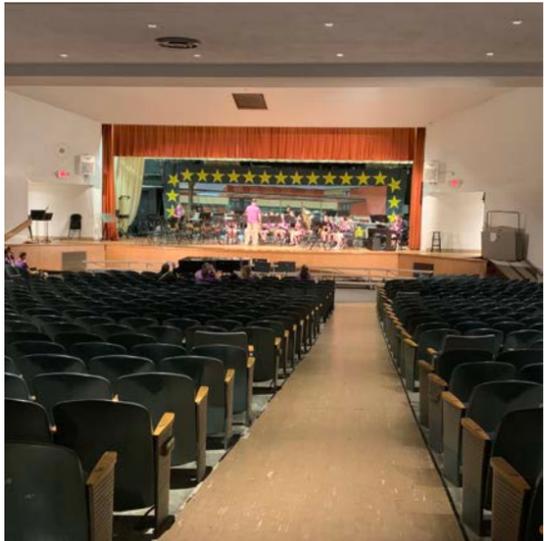
Major public spaces lack technology and updated finishes

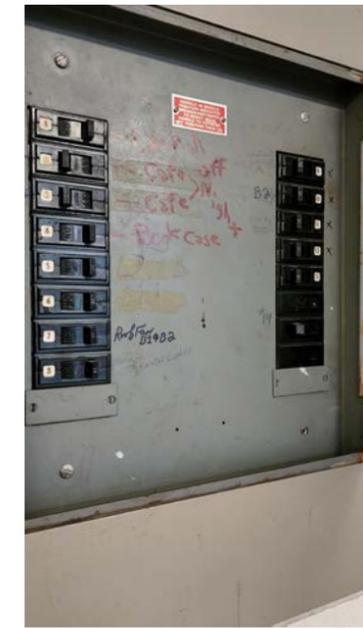
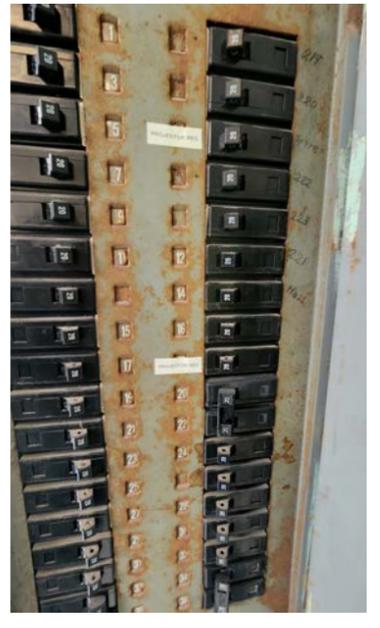
Utility Transformer, Main Distribution Panel, Typical Small Power Panels

- Existing outdoor utility transformer and the Main Distribution Panel, by Eaton, rated 1,200 Amp 277/480v 3ph 4w, were installed during 1975 school building addition. Although the Main Distribution panel is in good operational condition, it's reaching its 50-yr life expectancy.

- The Main Distribution Panel is feeding the Original 1965 Distribution panel, by General Electric, rated 120/208v 3ph 4w, via an indoor 500KVA stepdown transformer. The Original Distribution panel is in poor condition and beyond its life expectancy.

- The Main and Original Distribution Panels feed (37) branch panels, installed throughout the building. Majority of panels are in poor condition and beyond their life expectancy, except for a few "newer" ones, such as Gym panels and Kitchen panels. All downstream power feeders are old, except for a few ones associated with recent upgrades.

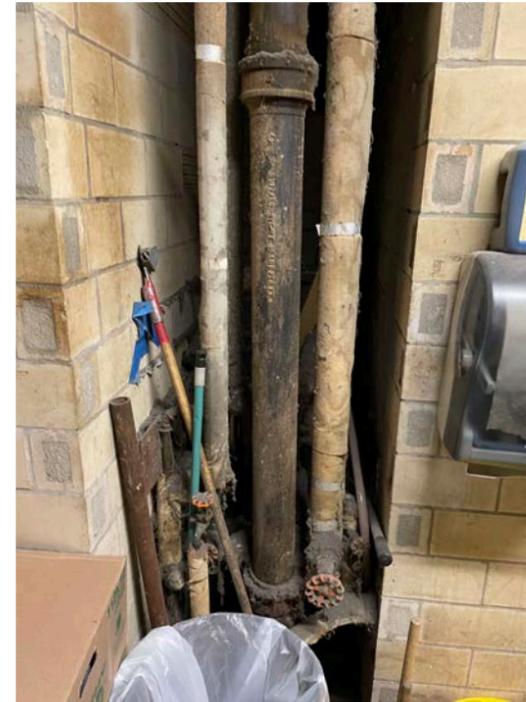
Waste and Domestic Water Piping

Sanitary and Vent piping, where visible, are beyond their lifespan.

Domestic water piping outdated, insulation intermitted, outdate where present.

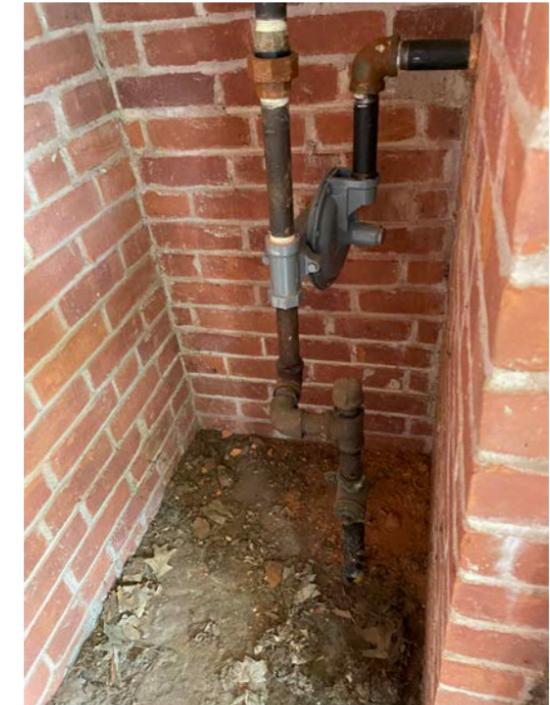
Low Pressure Natural Gas Entrance

(2) Natural Gas entrances and distributions, high and low pressure, in fair condition.

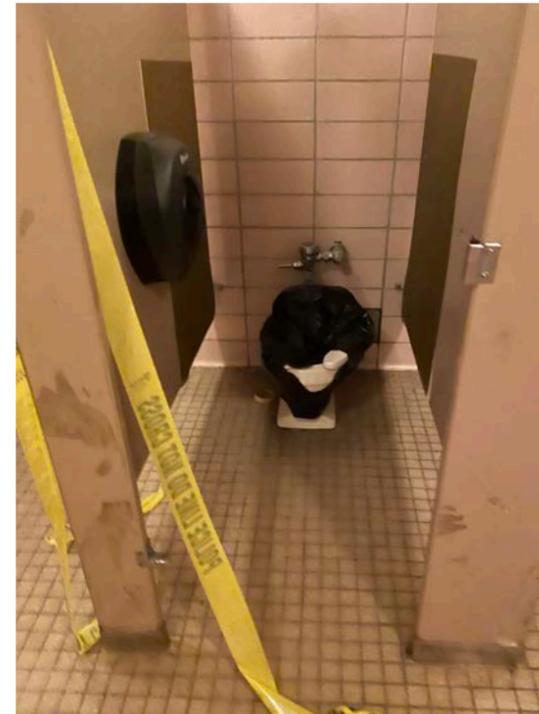
Domestic Hot Water Heaters in boiler room in fair condition. Heaters in several locations not operational. Hot water loops provide sporadic hot water to fixture locations.

Non-Operational Water Closet
