## 5.A

### SITE DEVELOPMENT NARRATIVE

#### Existing Conditions

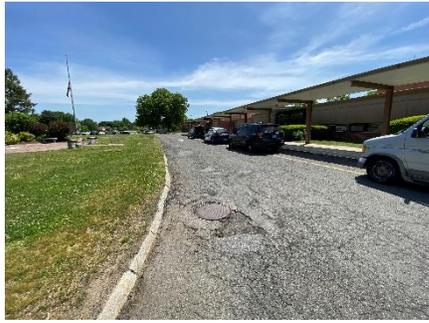
Front access drive

Sloped granite curbing exists along a majority of the front parking, the front access drive, and the west access drive off of Maple Street where it abuts lawn conditions. Vertical granite curb is present along the front drive at areas adjacent to sidewalks. The granite curbing is generally in fair to poor condition due to damage, settlement, and varying reveal that is less than standards in many areas. The low reveal heights may be a result of previous pavement overlays occurring without resetting of the curb. The majority of parking and access drive areas south of the building do not have perimeter curbing, with the exception of some bituminous curbing at areas directly adjacent to the building. This bituminous curbing is in overall fair condition due to average signs of wear and deterioration.

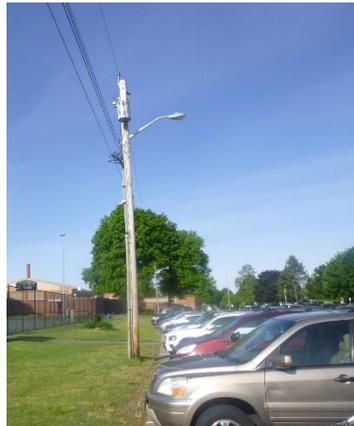
Pole-mounted fixtures are present along the front drive and the main parking lot northeast of the building. A majority of fixtures are mounted on compatible light-specific poles, while the remaining fixtures are cobra head style mounted to wood utility poles. Fixtures do not appear to be LED. School administration has indicated that lighting levels are poor in some portions of the parking lot and at the front of the building. There is no dedicated lighting present along the Norden Street access and south parking areas, with the exception of minimal coverage in some areas provided by building mounted lights. Building egress areas generally appear to have dedicated building mounted fixtures. Refer to the Electrical Summary for additional information on building mounted exterior lights.

Fixture on utility pole at northeast parking lot

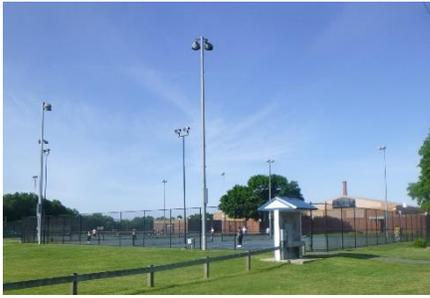
The tennis courts have a dedicated pole mounted lighting system that appears to function adequately. Similarly, there is dedicated stadium lighting for the track and synthetic field area that also appears adequate.

Tennis court lighting

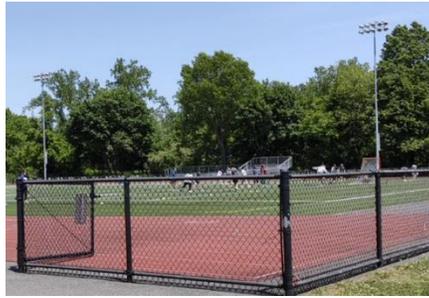
Track and synthetic field lighting

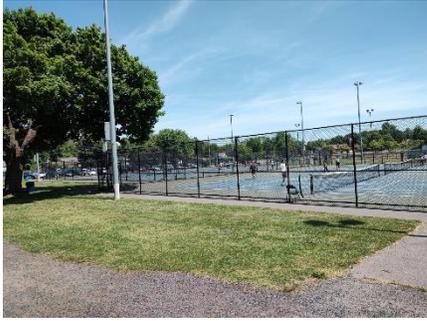
- Six tennis courts are located adjacent to the east side of the existing school building and just to the south of the main parking lot. The courts are arranged in two separate pods (three courts per pod) and share their northern/southern boundary. Each pod is surrounded by chain link fence and includes multiple entrances and lighting. The tennis courts have good, but not ideal orientation for optimal performance. Surface conditions are good, with the only visible cracks being at the expansion joints between courts. The district indicated a potential resurfacing to occur in the near future.

Tennis courts

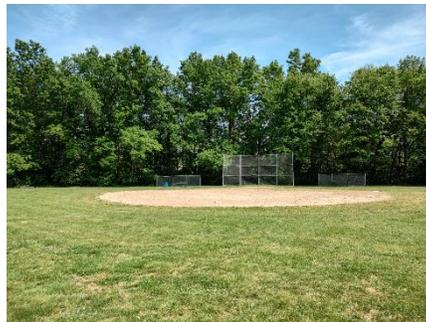
- A tee-ball field (not used for high school athletics) is located at the southern tip of the property. The outfield is also utilized as a practice field. The tee-ball field consists of a dirt infield, small portable steel and plastic team benches located in unenclosed grass team areas, a chain link backstop, and associated chain link fencing limited to the area immediately between the playfield and the team benches. No permanent chain link fencing is provided down the left or right field lines. The infield, backstop, chain link fencing, and team areas are in poor condition, and the tee-ball field is not properly oriented for optimal performance.

Tee-ball field
