Birchland Park Middle School

Town of East Longmeadow ADA Transition Plan

October 2025

Institute for Human Centered Design

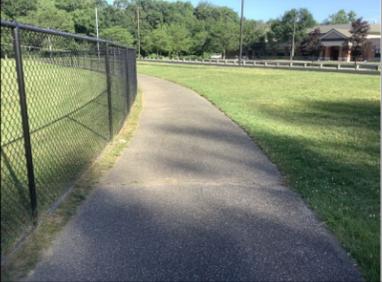
Surface openings > 1/2"	1.5"	Ensure that the surface opening is no greater than 1/2" max.	1	-	-
3	Along Elmcrest Street	Ext.	-	Exterior Access Route	Sidewalk

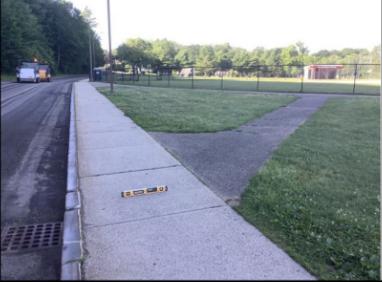
Cross slope > 1:50 (2.00%) Level changes > 1/4"	2.8% 1"	Reduce cross slope to be no steeper than 1:50 (2.00%). Alter change in level to be 1/4" high max.	1	-	-
4	Along Elmcrest Street/ Parking Lot South of Building	Ext.	-	Exterior Access Route	Sidewalk

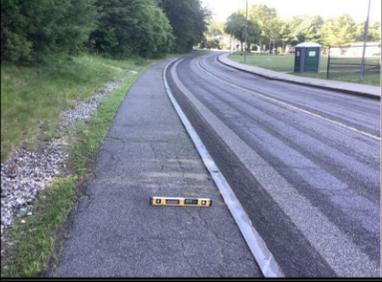
Cross slope > 1:50 (2.00%)	10.7%	Reduce cross slope to be no steeper than 1:50 (2.00%).	1	-	-

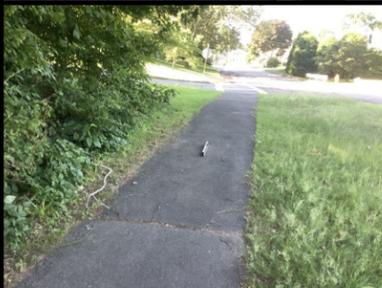
Surface openings > 1/2"	1.25"	Ensure that the surface opening is no greater than 1/2" max.	1	-	-
8	Along Elmcrest Street/By Hanward Hill	Ext.	-	Exterior Access Route	Sidewalk

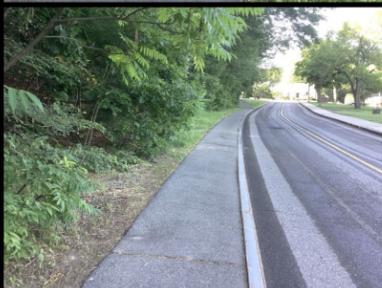
Surface openings > 1/2" Vertical clearance < 80" above ground	2.25" 56"	Ensure that the surface opening is no greater than 1/2" max. Trim and maintain low hanging tree branches so they are 80" min. above the ground.	1	-	-
9	Along Elmcrest Street/By Hanward Hill	Ext.	-	Exterior Access Route	Sidewalk

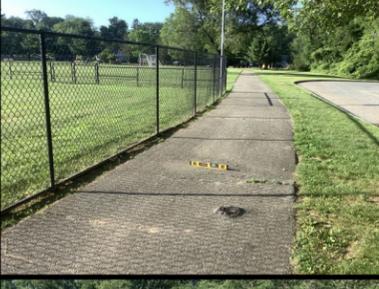
Cross slope > 1:50 (2.00%)	3.2%	Reduce cross slope to be no steeper than 1:50 (2.00%).	1	-	-

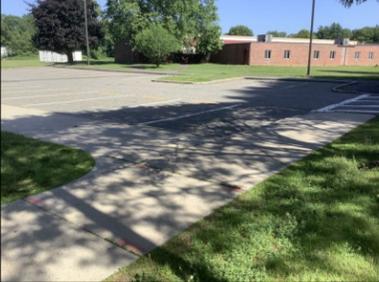
Level changes > 1/4"	0.75"	Alter change in level to be 1/4" high max.	1	-	-
28	By Northeast Corner of Building	Ext.	-	Exterior Access Route	Sidewalk

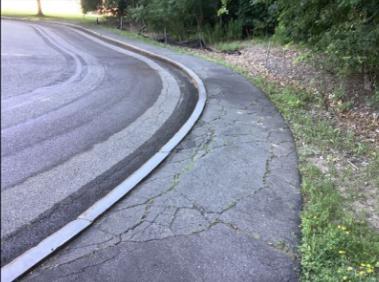
Level changes > 1/4" Route not maintained in operable working condition	1" -	Alter change in level to be 1/4" high max. Repair cracked openings in the surface to ensure the accessible route is maintained in operable working condition.	1	-	-
29	By Northeast Corner of Building	Ext.	-	Exterior Access Route	Sidewalk

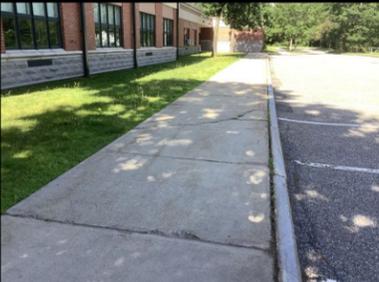
30	By Northeast Corner of Building/To Secondary Entrance (North Side)	Ext.	-	Exterior Access Route	Sidewalk

Surface openings > 1/2" Level changes > 1/4"	3" 1"	Ensure that the surface opening is no greater than 1/2" max. Alter change in level to be 1/4" high max.	1	-	-

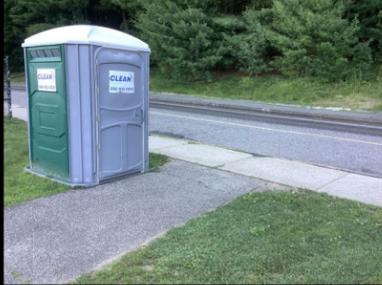
34	By Portable Toilet by Northeast Corner of Soccer Field	Ext.	-	Exterior Access Route	Walkway

Level changes > 1/4"	1"	Alter change in level to be 1/4" high max.	1	-	-
35	By Southwest Corner of Building	Ext.	-	Exterior Access Route	Sidewalk

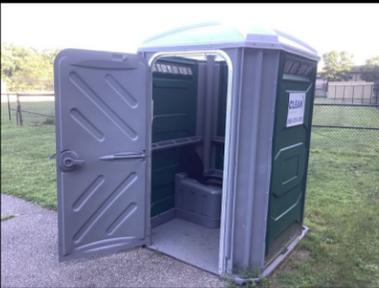
Vertical clearance < 80" above ground	74"	When an accessible portable toilet is provided, ensure the the bottom edge of the door frame is located 80" min. high.	1	-	-
48	Secondary Entrance - West Side by Girls' Multi-User Toilet Room 151	Ext.	-	Exterior Access Route	Walkway

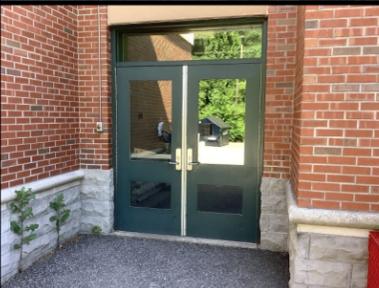
Level changes > 1/4"	1"	Alter change in level to be 1/4" high max.	1	-	-
49	To East Softball Field First Base Dugout	Ext.	-	Exterior Access Route	Walkway

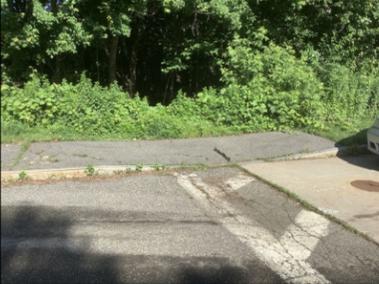
Running slope is > 1:12 (8.33%) Curb ramp flares > 1:12 (8.33%) (if no landing)	12.4% 9%	Reduce running slope to be no steeper than 1:12 (8.33%). Reduce slope at curb ramp flares to be no steeper than 1:12 (8.33%)	1	-	-
58	By Parking Lot North of Building	Ext.	-	Curb Ramp	Blended Transition

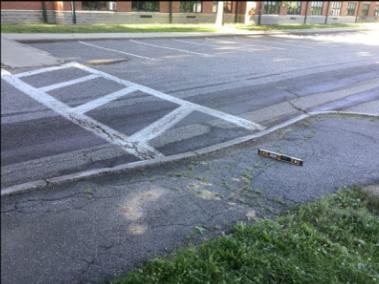
Running slope is > 1:12 (8.33%) Curb ramp flares > 1:12 (8.33%) (if no landing)	9.9% 10.6%	Reduce running slope to be no steeper than 1:12 (8.33%). Reduce slope at curb ramp flares to be no steeper than 1:12 (8.33%).	1	-	-

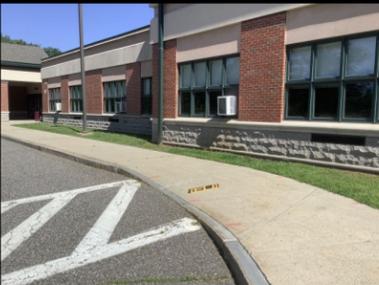
59	By Secondary Entrance - South Side/ Bus Drop-Off	Ext.	-	Curb Ramp	Blended Transition

Running slope is > 1:12 (8.33%) Curb ramp flares > 1:12 (8.33%) (if no landing)	9.8% 9.9%	Reduce running slope to be no steeper than 1:12 (8.33%). Reduce slope at curb ramp flares to be no steeper than 1:12 (8.33%).	1	-	-
60	By Southeast Corner of Building	Ext.	-	Curb Ramp	Blended Transition

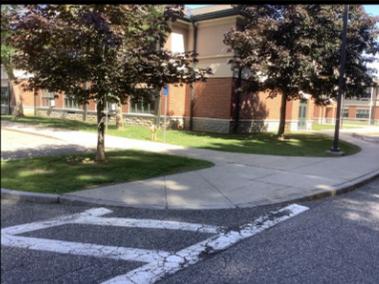
Curb ramp flares > 1:12 (8.33%) (if no landing)	8.9%	Reduce slope at curb ramp flares to be no steeper than 1:12 (8.33%).	1	-	-

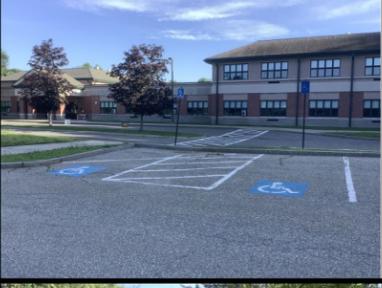
78	Parking Lot South of Building/East Accessible Spaces	Ext.	-	Off-Street Parking Lot or Garage	Visitor

Running or cross slope at access aisle > 1:50 (2.00%) Sign bottom < 60" above finished grade	3.9% 84"	Reduce running or cross slope to be no steeper than 1:50 (2.00%). Locate both signs with the bottom of the sign 60" above the ground. Locate sign with the top of the sign 96" above the ground.	1	-	-
79	Parking Lot South of Building/West Accessible Spaces	Ext.	-	Off-Street Parking Lot or Garage	Visitor

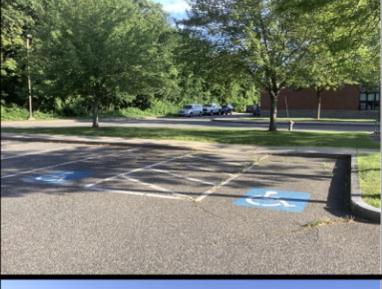
Sign with the International Symbol of Acc. not provided	-	Provide a sign with the International Symbol of Accessibility (ISA) with the bottom of the sign 60" min. above the ground and the top 96" max. above the ground. (Cost estimate is for signage.)	2	1650	\$1K - \$5K
											3300	
80	Parking Lot South of Building/West Accessible Spaces Facing Fields	Ext.	-	Off-Street Parking Lot or Garage	Visitor

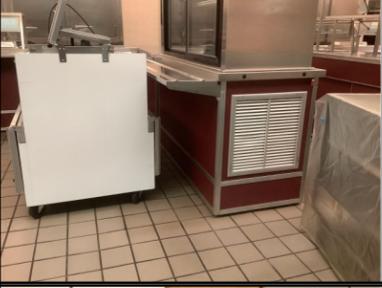
Obstructed by protruding objects	12.5"	Provide a cane-detectable barrier at each open end of the service counter, located 27" max. above the finished floor. Note: Unit cost is provided for one instance of this repetitive item.	1	657	\$500 - \$1K

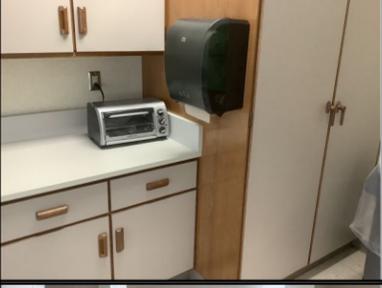
89	Community Room	1	129	Interior Access Route	N/A

Obstructed by protruding objects	9.5"	Relocate the paper towel dispenser out of the circulation path, or provide a cane-detectable barrier such as a railing located 27" max. above the finished floor. Note: Cost provided is to relocate the paper towel dispenser.	1	825	\$500 - \$1K
90	Girls' Locker Room	1	-	Interior Access Route	N/A

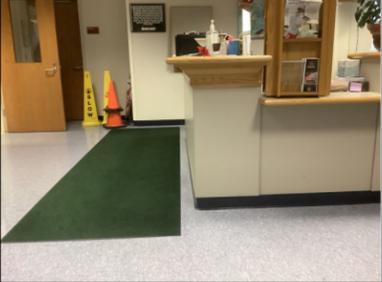
Obstructed by protruding objects	7"	Provide a cane detectable barrier underneath each open end of the service counter located 27" max. above the finished floor. Note: Unit cost is provided for one instance of this repetitive item.	1	657	\$500 - \$1K
											657	
Doors, Doorways, & Gates												
93	All-Gender Single-User Toilet Room by Science Lab 103	1	-	Doors, Doorways, & Gates	Toilet Room

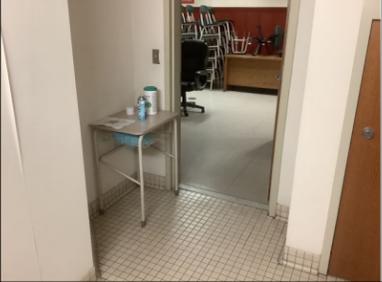
Maneuvering clearance(s) not provided	40"	Provide an automatic door opener.	1	9900	\$5K - \$10K
											9900	
94	Art Storage	1	124	Doors, Doorways, & Gates	Classroom

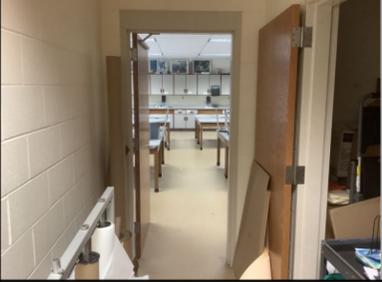
Maneuvering clearance(s) not provided Maneuvering clearance(s) not maintained	10.25" -	Provide an automatic door opener. Ensure that maintenance staff is aware that the maneuvering clearance at doors should be kept clear at all times.	1	9900 Labor	\$5K - \$10K

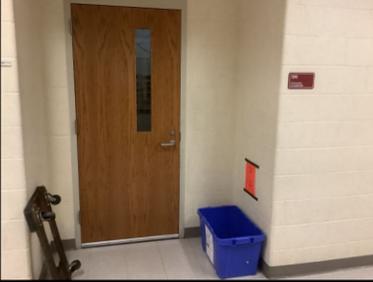
Raised characters < 48" or > 60" above ground Location of tactile sign not compliant	62.25" -	Mount the sign so that the baseline of the lowest tactile character is 48" min. above finished floor and the baseline of the highest tactile character is 60" max. above the finished floor. Locate sign alongside the door on the latch side.	1	Labor	Labor
112	Library Media Center	2	-	Signage	Designation

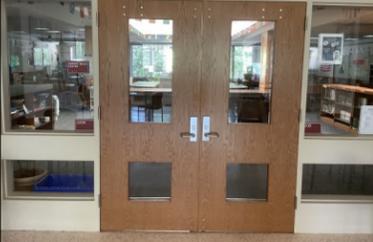
Location of tactile sign not compliant		Where a tactile sign is provided at double door with two active leafs, locate the sign to the right of the right-hand door. Recommendation applies to all double doors in a similar condition.	1	Labor	Labor
Service Counter												
113	Main Office	1	-	Service Counter	N/A

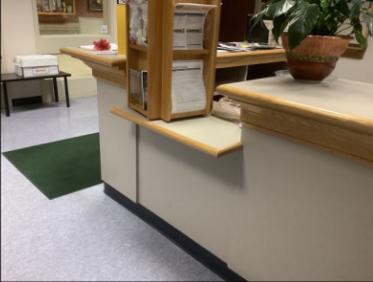
Parallel approach w/ part of counter surface < 36" long Accessible service counter is not maintained	32" -	Provide a portion of the counter surface that is 36" long min. and 36" high max. above the finished floor. Ensure that the accessible service counter is kept clear and that objects are not stored in the 30" by 48" clear floor space.	1	1888 Labor	\$1K - \$5K

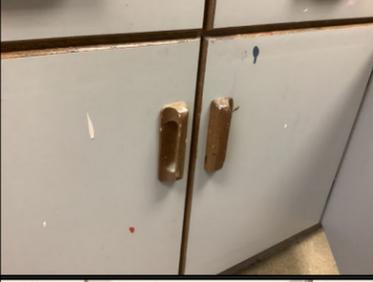
Not compliant	-	Provide cabinet hardware that can be operable with one hand and not require tight grasping, pinching, or twisting of the wrist. Recommendation applies to all cabinet hardware with a similar issue. Note: Unit cost is provided for one instance of this repetitive item.	1	116	\$1 - \$500
											116	
115	Band Room	1	128	Operable Parts / Reach Range	Storage Cabinet

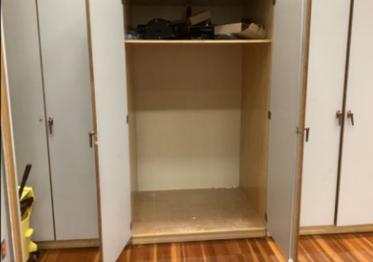
Reach < 15" or > 48"(forward/side approach)	68.5"	Provide at least one storage cabinet with shelves located between 15" min. and 48" max. above the finished floor.	1	825	\$500 - \$1K
											825

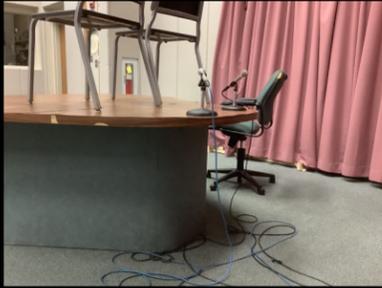
Knee clearance less than 19" deep	11.5"	Provide at least one work surface with knee clearance that is 19" deep min.	1	1155	\$1K - \$5K
											1155	
128	By Elevator	2	-	Dining or Work Surfaces	Work Surface

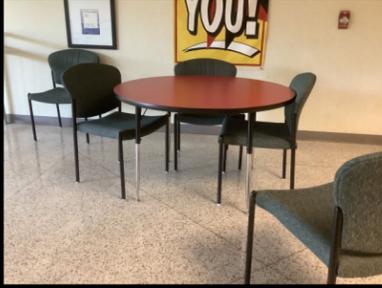
Knee or toe clearance not provided	26.5"	Provide at least one work surface with 30" min. wide knee and toe clearance.	1	1155	\$1K - \$5K
											1155	
129	Library Media Center	2	-	Dining or Work Surfaces	Work Surface

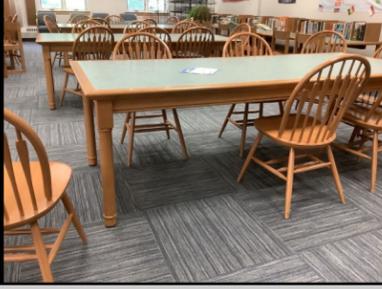
Knee or toe clearance not provided	24.25"	Provide at least one work surface with 27" min. high knee and toe clearance.	1	1155	\$1K - \$5K

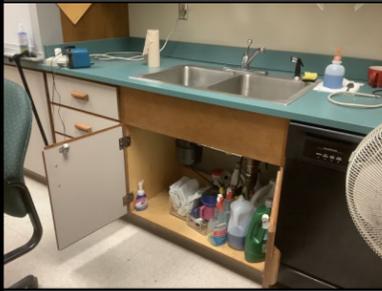
Knee/toe clearance not provided at sink Sink > 34" high	- 36"	Provide a sink with knee and toe clearance positioned for a forward approach, with a counter located 34" max. above the finished floor, positioned for a forward approach.	1	5106	\$5K - \$10K

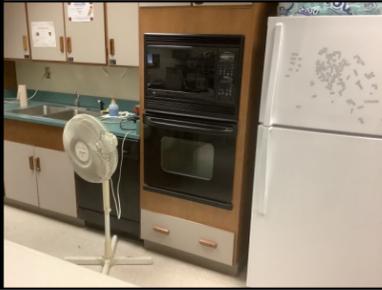
5106	
143	Family and Consumer Science	1	114	Kitchens and Kitchenettes	N/A

Bottom of oven doors > 30" high	18.5"	Locate oven so the bottom of the door is located 30" above the finished floor.	1	3630	\$1K - \$5K
											3630	
Toilet & Bathing Rooms												
Overall Access												
144	Boys' Locker Room/Multi-User Toilet Room	1	-	Overall Access	Toilet Room

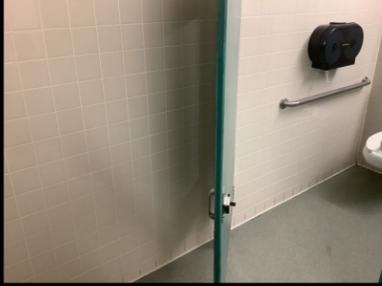
2145	
Toilet Compartment												
147	Faculty Men's Multi-User Toilet Room by Cafetorium	1	-	Toilet Compartment	Accessible Compartment

Door has malfunctioning self-closing hinge Door pull not provided	- -	Repair hinge. Provide a door pull on each side of the door between 34" to 48" above the finished floor that does not require tight grasping, pinching or twisting of the wrist. Recommendation applies to all accessible toilet compartments with a similar issue. Note: Unit cost is provided for one instance of this repetitive item.	1	Labor 116	\$1 - \$500
											116	
148	Faculty Men's Multi-User Toilet Room by Cafetorium	1	-	Toilet Compartment	Accessible Compartment

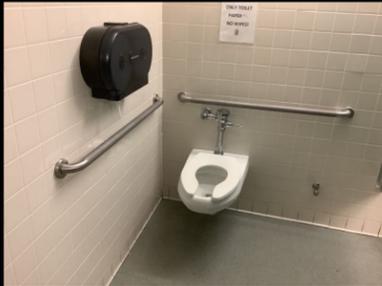
Noncompliant toilet paper dispenser Side grab bar < 54" from back wall	- 48"	Relocate toilet paper so that it is 24" min high, located under the grab bar, and between 7" and 9" from the front of the toilet. Relocate the side wall grab bar to ensure it is located 12" max. from the rear wall. Recommendation applies to all accessible toilet compartments with a similar issue. Note: Unit cost is provided for one instance of this repetitive item.	1	1320 1320	\$1K - \$5K

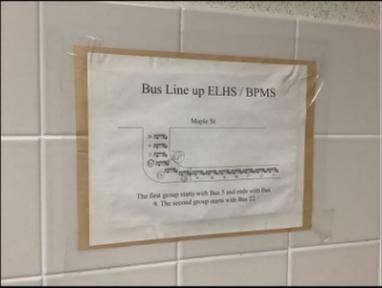
ID	Location	Floor	Room	Element	Type	Photo	Issues	Current Measure	Recommendations	Quantity	Price	Cost Estimation
Bus Line-Up Map												
166	Stair 2	2	-	Bus Line-Up Map	N/A

Recommend providing a bus line-up map with the street names at Birchland Park Middle School, rather than the street names by East Longmeadow High School.	1	-	-
Crosswalk												
167	Parking Lot South of Building/By West Accessible Spaces	Ext.	-	Crosswalk	N/A

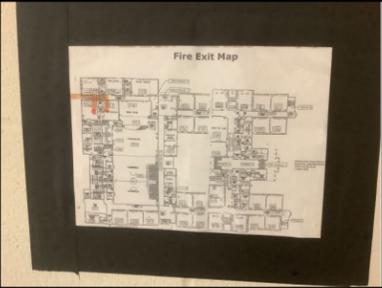
Recommend providing egress maps that use dashed lines to identify egress routes rather than highlighted pathways, and recommend identifying a secondary egress route on the egress maps. Recommendation applies to all similar egress maps.	1	-	-
Handrails												
169	Cafetorium - To Stage	1	-	Handrails	N/A

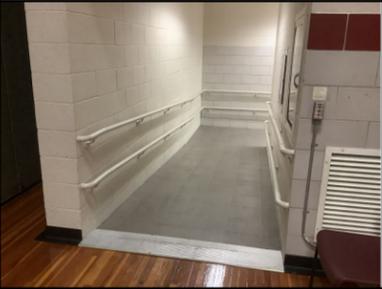
Recommend providing handrails that contrast with the color of the walls.	1	-	-

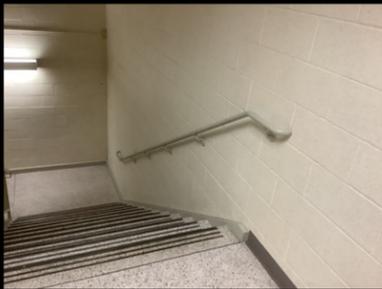
ID	Location	Floor	Room	Element	Type	Photo	Issues	Current Measure	Recommendations	Quantity	Price	Cost Estimation
170	Stair 1	2	-	Handrails	N/A

Recommend providing handrails that contrast with the color of the walls.	1	-	-
Parking												
171	Accessible Parking by Secondary Entrance - South Side/ Bus Drop-Off	Ext.	-	Parking	N/A

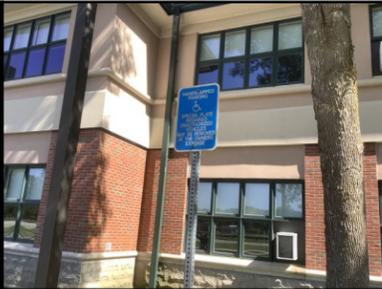
Recommend using the term "accessible" rather than "handicapped" on all accessible parking signage.	1	-	-
172	Parking Lot North of Building	Ext.	-	Parking	Visitor

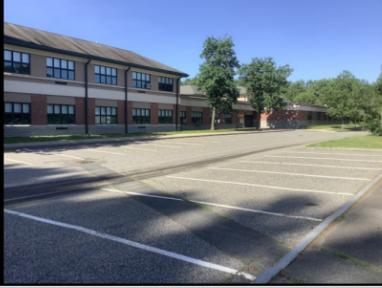
Recommend, because of the presence of the accessible drop-off area, providing at least one accessible parking space in this area.	1	-	-
Podium												
173	By 7th Grade Health 116	1	-	Podium	N/A

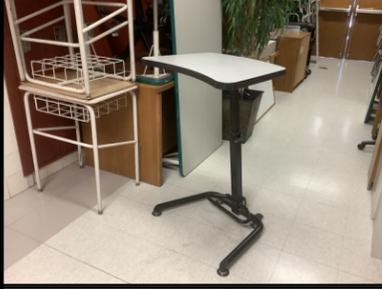
Recommend providing a height-adjustable podium in with compliant knee and toe clearance in classrooms.	1	-	-
174	Cafetorium Stage	1	-	Podium	N/A

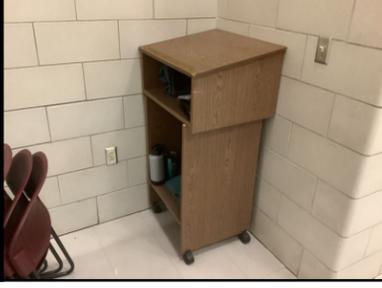
Recommend providing a height-adjustable podium with knee and toe clearance.	1	-	-

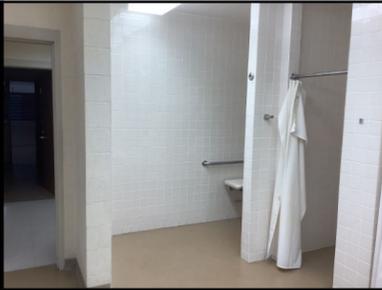
ID	Location	Floor	Room	Element	Type	Photo	Issues	Current Measure	Recommendations	Quantity	Price	Cost Estimation
Shower												
175	Boys' Locker Room	1	-	Shower	N/A

Recommend ensuring a privacy curtain is always provided at the transfer shower.	1	-	-
Signage												
176	Stair 2	1	-	Signage	Floor-Level Designation

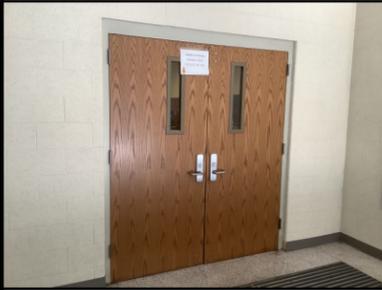
Recommend providing floor-level designation signage with raised characters duplicated in braille.	1	-	-
177	Television Studio	1	127	Signage	Designation

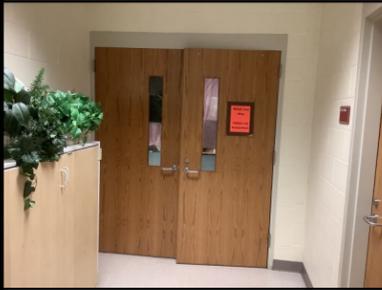
Recommend providing a compliant designation sign with raised characters and braille. Recommendation applies to all doors that lack a designation sign.	1	-	-
178	West Courtyard Entrance	1	-	Signage	Designation

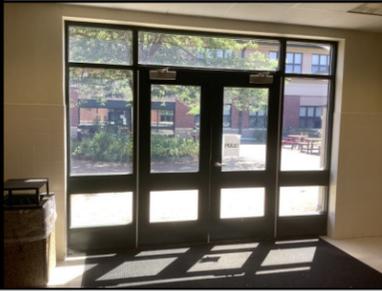
Recommend providing a compliant designation sign with raised characters and braille, located at both entrances to the courtyard.	2	-	-
Stairs												
179	To Secondary Entrance - West Side to Classroom 171	Ext.	-	Stairs	N/A

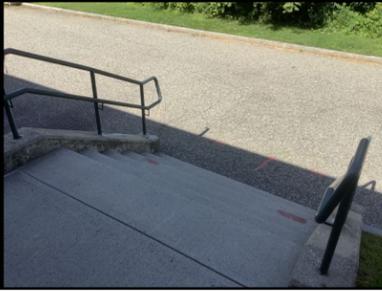
Recommend providing a solid and continuous stripe applied to the horizontal leading edge of each exterior stair tread so that each tread is readily apparent when viewed in descent at this exterior stair. Recommendation applies to all interior and exterior stairs that lack visual contrast on the stair nosings.	1	-	-
