Mapleshade Elementary School

Town of East Longmeadow ADA Transition Plan

October 2025

Institute for Human Centered Design

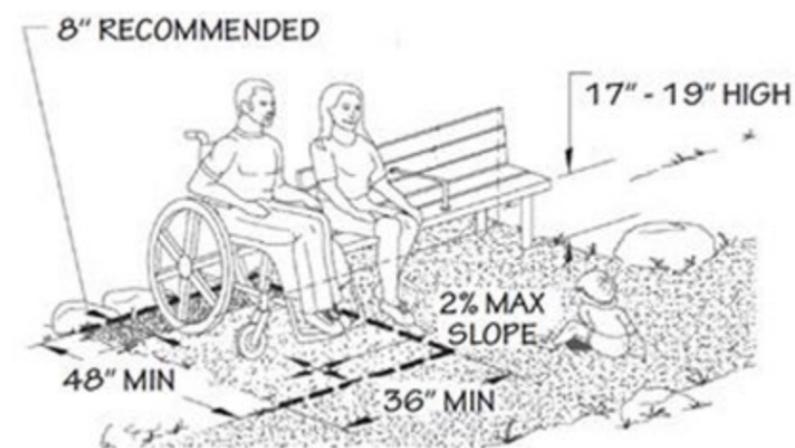
- Recommend providing a 36" min. by 48" min. stable, firm and slip-resistant surface adjacent to at least one bench in each area where benches are provided positioned to allow a person in a wheeled mobility device and a person sitting on the bench to have their shoulders aligned.

The following illustration demonstrates how to incorporate a 36" min. by 48" min. stable, firm and slip-resistant surface adjacent to a positioned to allow a person in a wheeled mobility device and a person sitting on the bench to have their shoulders aligned.
