Meadow Brook Elementary School

Town of East Longmeadow

ADA Transition Plan

September 2025

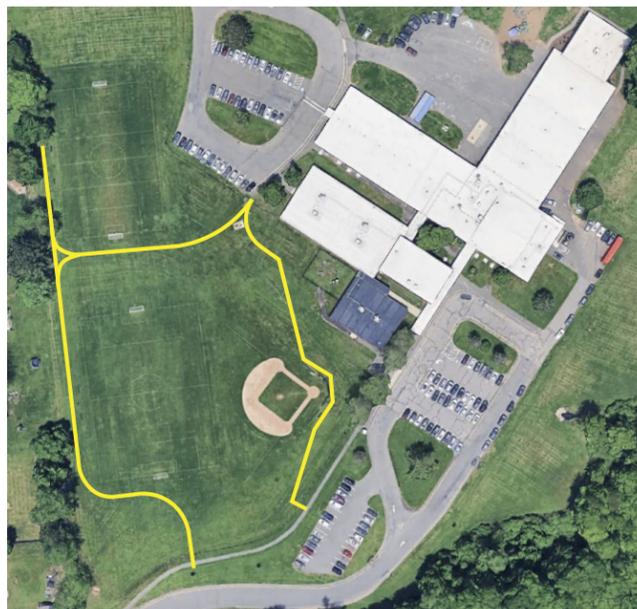
Accessibility issues include a lack of an accessible route to the baseball and soccer fields.

Figure 1: In the following image, the yellow lines show approximate routes to connect the baseball and soccer fields, along with the team seating areas associated with each field, to the nearest accessible routes from each parking lot.

Additional accessibility issues at the baseball and soccer fields include lack of accessible team seating spaces.

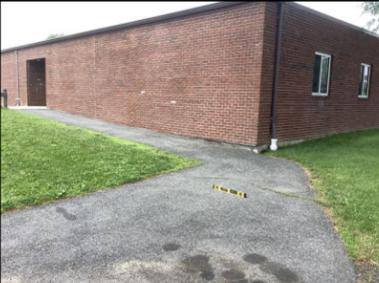
Level changes > 1/4"	1"	Alter change in level to be 1/4" high max.	1	-	-
14	From Southwest Egress by Library 39	Ext.	-	Exterior Access Route	Walkway

Cross slope > 1:50 (2.00%) Running slope > 1:20 (5.00%)	3.7% 6.6%	Reduce cross slope to be no steeper than 1:50 (2.00%). Reduce running slope to be no steeper than 1:20 (5.00%).	1	-	-

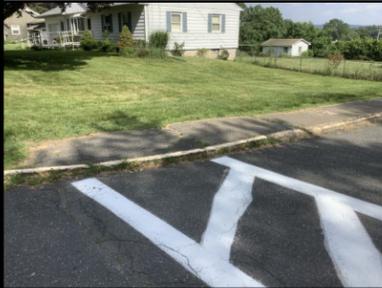
Level changes > 1/4"	4.5"	Alter change in level to be 1/4" high max.	1	-	-
Curb Ramp												
29	Access Road at Porter Road	Ext.	-	Curb Ramp	Blended Transition

Curb ramp not provided	-	Provide a curb ramp at intersection of the sidewalk and crosswalk.	1	-	-

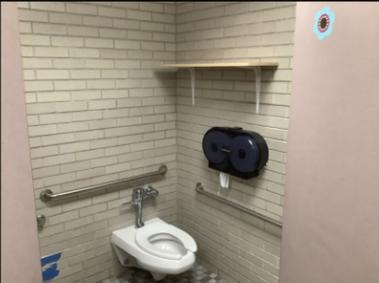
49	Girls' Multi-User Toilet Room - Grade 2 Wing	1	-	Interior Access Route	N/A

Obstructed by protruding objects	10"	Relocate the shelf out of the toilet compartment. Ensure that maintenance staff is aware every object that they mount in the circulation path that is greater than 4" deep, located between 27" and 80" above the finished floor is considered a protruding object.	1	825	\$500 - \$1K
											825	
50	Library and Museum	1	-	Interior Access Route	N/A

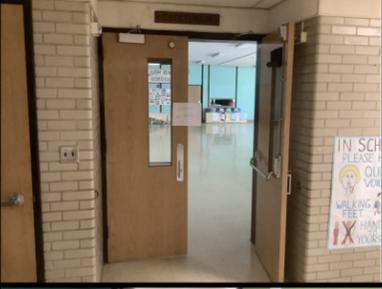
1650	
59	Cafetorium	1	-	Doors, Doorways, & Gates	Circulation

If double-leaf door, neither compliant	28.5"	Provide an automatic door opener that opens both doors.	1	9900	\$5K - \$10K
											9900	
60	Girls' Multi-User Toilet Room - Grade 2 Wing	1	-	Doors, Doorways, & Gates	Toilet Room

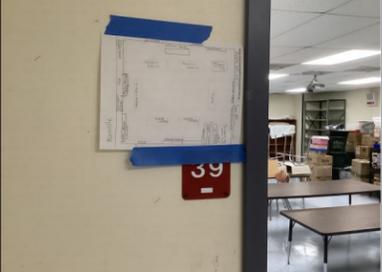
Not in operable working condition	-	Remove paper blocking raised characters/braille.	1	Labor	Labor
Service Counter												
73	Library and Museum	1	-	Service Counter	N/A

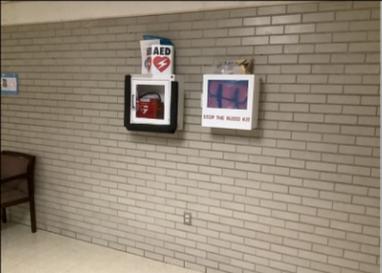
Operable Parts / Reach Range												
74	By School Counselor Office 14	1	-	Operable Parts / Reach Range	Defibrillator

Reach < 15" or > 48"(forward/side approach)	58.5"	Relocate the defibrillator and bleed control kit so that controls are located 48" max. above the finished floor. Recommendation applies to all defibrillators and bleed control kits with a similar issue. Note: Unit cost is provided for one instance of this repetitive item.	1	825	\$500 - \$1K
75	Library and Museum	1	-	Operable Parts / Reach Range	Book Shelves

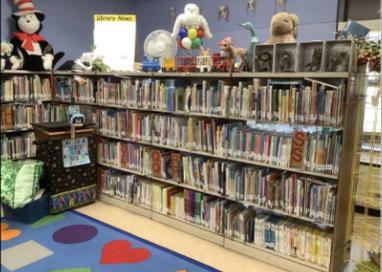
Reach < 15" or > 48"(forward/side approach)	4.5"	Ensure that staff is available to assist visitors who need assistance.	1	Labor	Labor

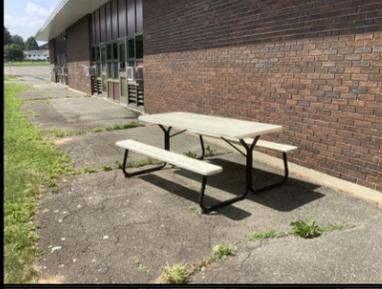
84	By Grade 2 Classroom 20	Ext.	-	Picnic Tables	N/A

Knee clearance less than 19" deep	6"	Provide at least one picnic table with knee clearance that is 19" deep min.	1	2310	\$1K - \$5K
85	By Secondary Entrance - Northwest Side by Kindergarten Classroom 34	Ext.	-	Picnic Tables	N/A

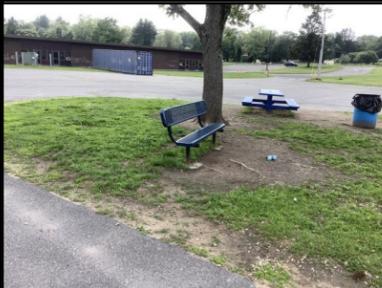
No accessible route to one bench in area	-	Provide an accessible route to one bench in this area.	1	-	-
88	North Playground	Ext.	-	Exterior Benches	N/A

No accessible route to one bench in area	-	Provide an accessible route to one bench in this area.	1	-	-
Toilet & Bathing Rooms												
Overall Access												
89	Nurse's Office - Single-User Toilet Room	1	-	Overall Access	Toilet Room

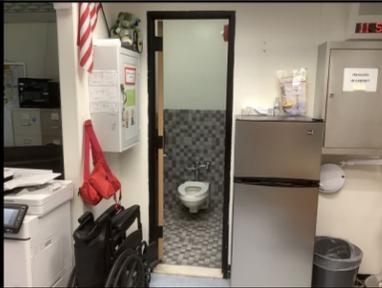
Clear width at door < 32" Accessible plumbing fixtures or stalls not provided	- -	Widen the door so that there is 32" min. clear width. Provide an accessible single-user toilet room.	1	52776	\$50K - \$100K

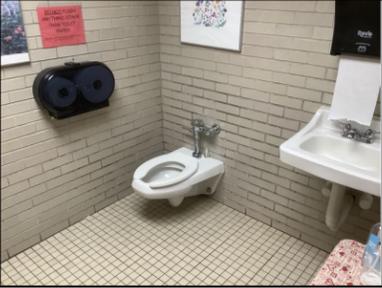
Flush control not on open side Grab bar not provided Toilet paper dispenser is not compliant	- - -	Relocate the flush control to the open side. Provide one grab bar on the side wall of the toilet and one on the rear wall. Relocate toilet paper so that it is 24" min. high, located under the grab bar, and between 7" and 9" from the front of the toilet.	1	1650 2476 825	\$1K - \$5K

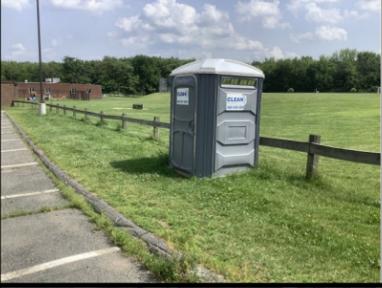
4951	
Portable Toilet												
93	Porter Road Lot - Portable Toilet	Ext.	-	Portable Toilet	N/A

Not located on an accessible route	-	When a new accessible portable toilet is provided, ensure the portable toilet is located on an accessible route.	1	Labor	Labor
94	Porter Road Lot - Portable Toilet	Ext.	-	Portable Toilet	N/A

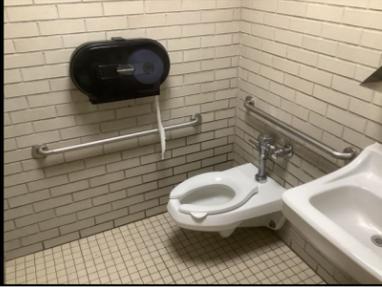
Clearance at toilet < 72" clear deep Flush control not on open side Centerline < 12" or > 15" (K - 3) Side or rear grab bar < 42" long Side or rear grab bar < 20" or > 25" high (K - 3)	60.25" - 16.5" 36.5" -	Renovate one of the single-user toilet rooms into an accessible single-user toilet room, with a clear depth of 72" min. Note: When renovations occur, a directional sign to the accessible toilet room must be provide at the inaccessible toilet room, and a sign with the International Symbol of Accessibility (ISA) must be provided at all accessible toilet rooms.	1	52776	\$50K - \$100K

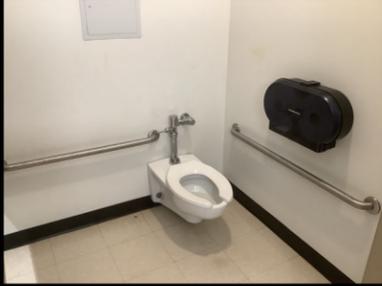
52776	
Toilet Compartment (Children)												
97	Boys' and Girls' Multi-User Toilet Rooms - Grade 1 Wing	1	-	Toilet Compartment (Children)	Accessible Compartment

Toilet seat < 12" or > 15" high (Ages 5 - 8) Side or rear grab bar < 42" long Centerline < 12" or > 15" (Ages 5 - 8) Noncompliant toilet paper dispenser	16" 37.5" 17.25" -	Relocate toilet so that the centerline is between 12" and 15" from the side wall and so that the seat is between 12"- 15" high above the finished floor. Provide a rear wall grab bar that is 42" long. Relocate toilet paper dispenser so that it is between 14"- 19" above the finished floor and between 7"- 9" in front of the toilet. Ensure dispensers and other devices are not mounted above grab bars.	2	- 1238 6066 825	\$10K - \$50K
											16258	
98	Boys' and Girls' Multi-User Toilet Rooms - Grade 2 Wing	1	-	Toilet Compartment (Children)	Accessible Compartment

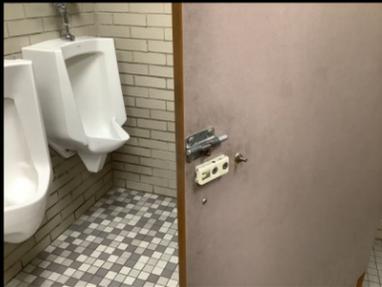
Door with noncompliant hardware	-	Provide a door lock that can be operable with one hand and not require tight grasping, pinching, or twisting of the wrist.	2	116	\$1 - \$500

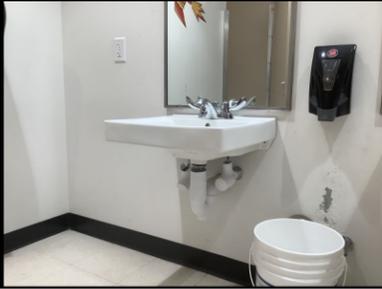
Toe or knee clearances not provided	23.5"	Provide at least one lavatory with 25" min. knee clearance positioned for a forward approach. Ensure toe clearance is also provided.	2	5106	\$10K - \$50K

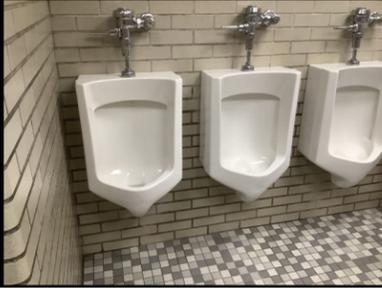
Rim > 15" high (MAAB)	22.5"	Provide at least one urinal with the rim no higher than 15" above the finished floor.	1	6967	\$5K - \$10K
Additional Access

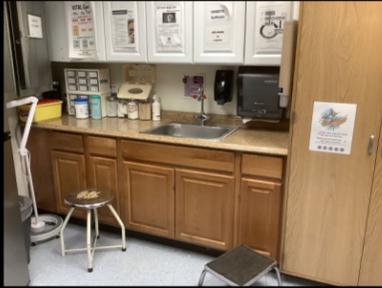
ID	Location	Floor	Room	Element	Type	Photo	Issues	Current Measure	Recommendations	Quantity	Price	Cost Estimation
Sink												
113	Nurse Office	1	-	Sink	N/A

Toe and knee clearances not provided Rim or counter > 34"	- 35.5"	If sink is used by students or the public, ensure there is a 27" min. knee clearance positioned for a forward approach. Relocate sink with the front of the rim or counter no higher than 34" above the finished floor.	1	5106	\$5K - \$10K
											5106	
114	Pre-K Classroom	1	12	Sink	N/A

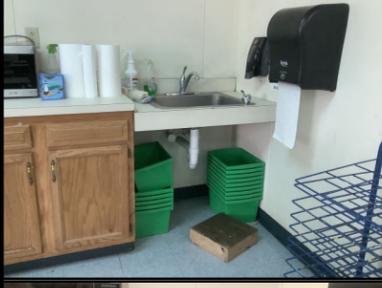
6733	
115	Kindergarten Classroom	1	30	Sink	N/A

Clear floor space not provided at sink	-	Relocate the paper towel dispenser and stored items to maintain the required 30" by 48" clear floor space positioned for a forward approach (Note: When the paper towel dispenser is relocated, ensure it does not act as a protruding object. Cost is to relocate the paper towel dispenser). Recommendation applies to all sinks with a similar issue. Note: Unit cost is provided for one instance of this repetitive item.	1	825	\$500 - \$1K
											825	
116	OT/PT	1	37	Sink	N/A

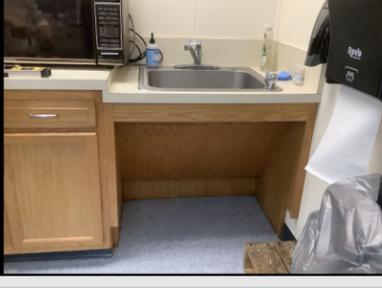
Toe and knee clearances not provided	4.5"	Reconfigure panels at the knee and toe clearance to ensure there is 8" min. of depth at 27" min. above the finished floor. Recommendation applies to all sinks with a similar issue. Note: Unit cost is provided for one instance of this repetitive item.	1	1320	\$1K - \$5K
											1320

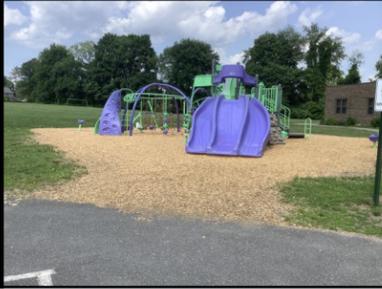
Recreation Facilities												
Play Areas												
117	North Playground	Ext.	-	Play Areas	N/A

Accessible route not provided around playground Accessible route not provided to play components	- -	Provide an accessible route around the play area. Provide a compliant impact-attenuating surface to and around the play components.	1	-	-

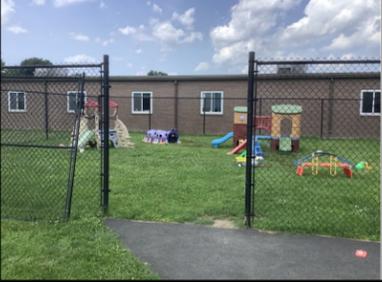
ID	Location	Floor	Room	Element	Type	Photo	Issues	Current Measure	Recommendations	Quantity	Price	Cost Estimation
118	Playground by Baseball Field	Ext.	-	Play Areas	N/A

Accessible route not provided around playground Accessible route not provided to play components	- -	Provide an accessible route around the play area. Provide a compliant impact-attenuating surface to and around the play components.	1	-	-
Field												
119	Baseball Field	Ext.	-	Field	Baseball

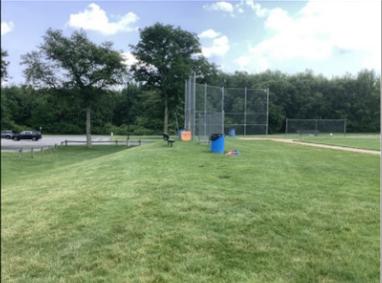
Field not connected to an accessible route	-	Provide an accessible route to the field.	1	-	-
120	Baseball Field - First and Third Base Dugouts	Ext.	-	Field	Baseball

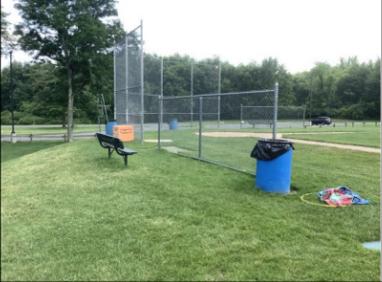
Accessible spaces not provided at team seating	-	Provide a 36" x 48" firm, stable, and slip-resistant clear floor space at team seating. Provide an accessible route to this space.	2	-	-
121	North and South Soccer Fields	Ext.	-	Field	Soccer

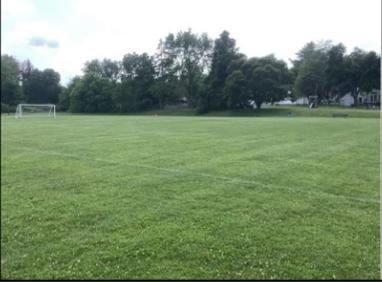
Accessible spaces not provided at team seating Field not connected to an accessible route	- -	Provide a 36" x 48" firm, stable, and slip-resistant clear floor space at team seating. Provide an accessible route to this space. Provide an accessible route to the field.	2	-	-

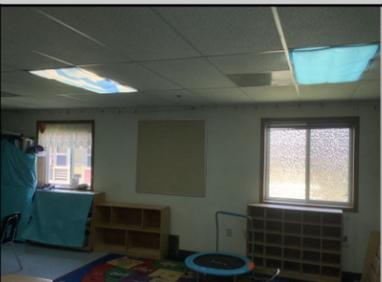
Best Practice												
Curtains												
122	Kindergarten Classroom	1	30	Curtains	N/A

Recommend providing blinds or curtains that can be adjusted to prevent glare during the daytime. Recommendation applies to all classrooms.	1	-	-

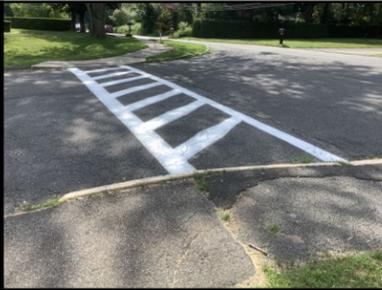
ID	Location	Floor	Room	Element	Type	Photo	Issues	Current Measure	Recommendations	Quantity	Price	Cost Estimation
Detectable Warning Platform												
123	Access Road at Porter Road	Ext.	-	Detectable Warning Platform	N/A

Recommend, when a curb ramp is provided, providing a detectable warning so that they are provided on both sides of the crosswalk.	1	-	-
Exterior Benches												
124	By Sidewalk to Parker Street/South Soccer Field and by North Playground	Ext.	-	Exterior Benches	N/A

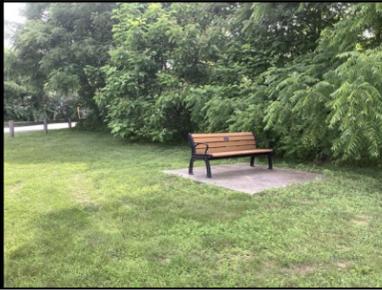
Recommend providing a 36" min. by 48" min. stable, firm and slip-resistant surface adjacent to at least one bench in each area where benches are provided positioned to allow a person in a wheeled mobility device and a person sitting on the bench to have their shoulders aligned.	1	-	-
Signage												
125	Nurse/ABA Classroom		7	Signage	Blade Sign

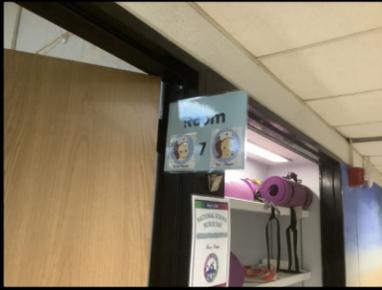
Recommend providing blade signage with a non-glare finish, with characters that have a high contrast to the background.	1	-	-

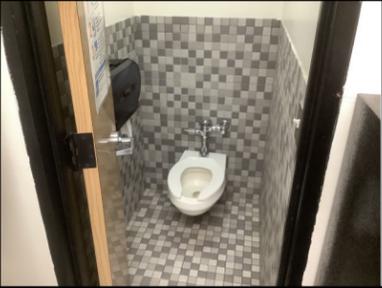
ID	Location	Floor	Room	Element	Type	Photo	Issues	Current Measure	Recommendations	Quantity	Price	Cost Estimation
Tiles												
127	Nurse's Office - Single-User Toilet Room	1	-	Tiles	N/A

Recommend providing color contrast between the wall and floor tiles when the toilet room is renovated.	1	-	-
