Mountain View Elementary School

Town of East Longmeadow ADA Transition Plan

October 2025

Background

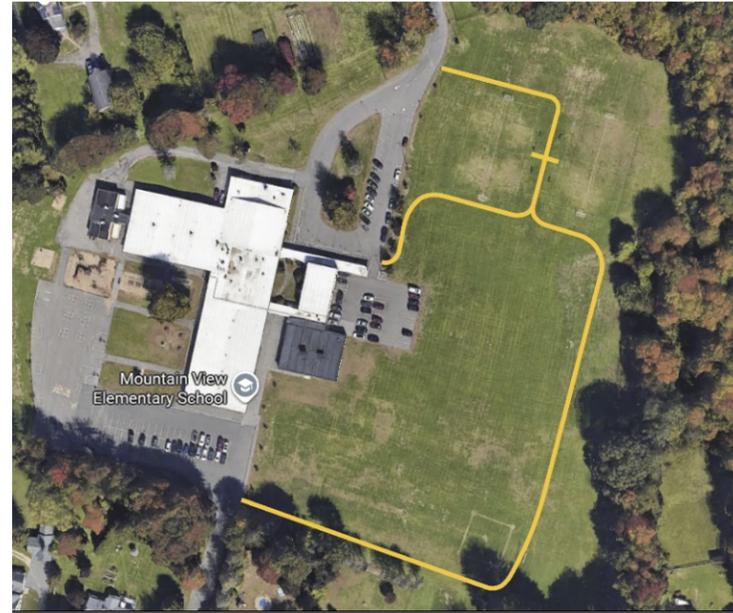
Figure 1: In the following image, the yellow lines show approximate routes to connect the softball and soccer fields, along with the team seating areas associated with each field, to the nearest accessible routes from each parking lot.

Accessibility issues include a lack of an accessible route to the softball and soccer fields, a lack of an accessible route to team seating area, and lack of accessible spaces at team seating areas.

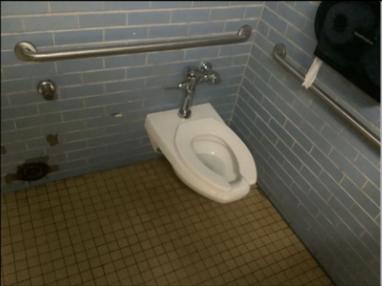
ID	Location	Floor	Room	Element	Type	Photo	Issues	Current Measure	Recommendations	Quantity	Price	Cost Estimation
Lighting												
118	Girls' Multi-User Toilet Room by Main Office	1	-	Lighting	N/A

<p>Recommend providing at least 10 foot candles of light in the toilet compartment. The light measurement was 1.9 foot candles.</p> <p>Recommendation also applies to all toilet compartments with a similar issue.</p>	1	-	-
