EVALUATION OF EXISTING CONDITIONS - SITE

East Longmeadow High School

Location: 180 Maple Street, East Longmeadow

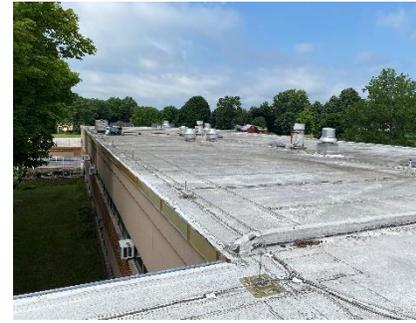
Classroom wing showing low slope, fascia and minimal roof drains.

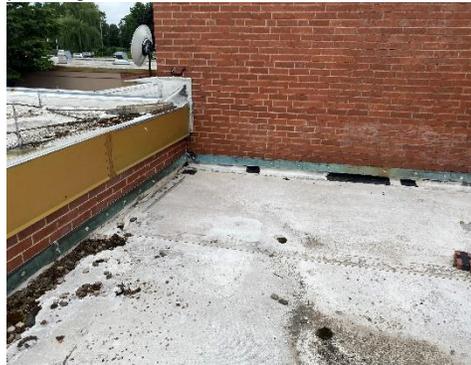
Flashing at wall beneath required height. Debris pooled by wind and water.

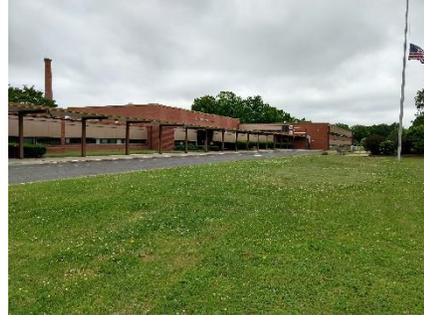
North elevation (Entry). All window systems infilled from original size with EIFS. Canopy metal in need of repainting.

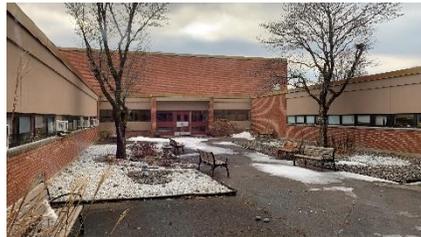
Typical interior courtyard showing revised windows with EIFS coverings

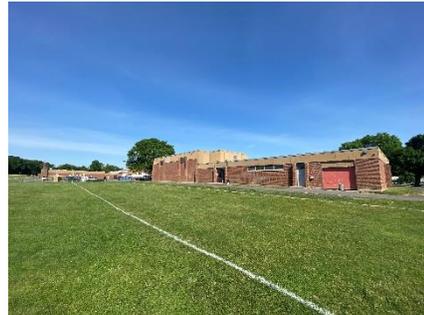
Exterior cladding at 1973 addition to rear of school. Upper locations are ACM containing sheet product.

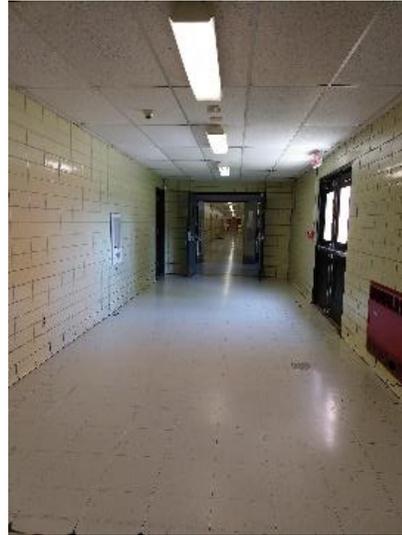
New ceiling in classroom wing in select areas where lighting has been replaced / upgraded.

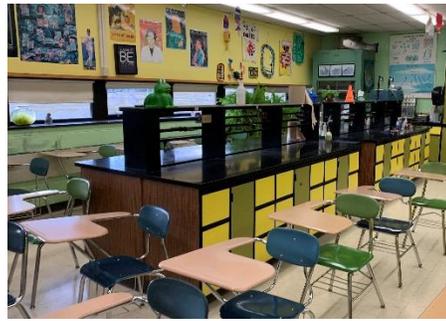
Built-in casework throughout the building is in worn condition, and at the end of its useful life. Labs are undersized. Labs lack safety equipment. Art spaces are former vocational spaces, with limited daylight and dated fixtures, finishes and equipment. Engineering, graphic design and culinary and early childhood education spaces lack required teaching equipment, storage, casework and furniture to support vocation needs.

Typical science lab casework

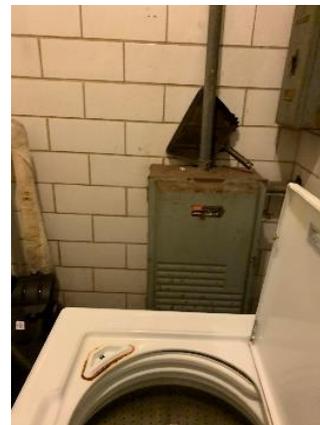
Exposed piping and conduit collect dust and are unsanitary.

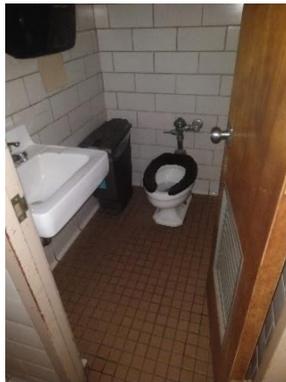
Toilet facility is not A.D.A. compliant.

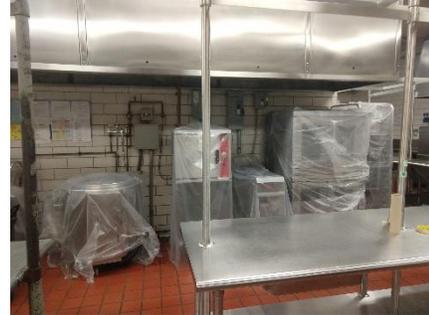
No water capture at wet cooking.

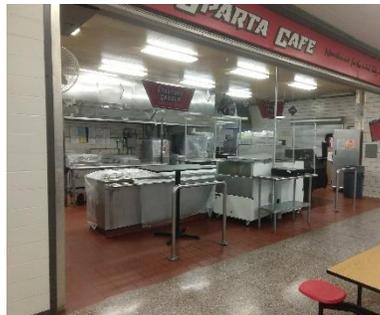
Serving lines lack food protectors. Equipment and arrangement are antiquated and congested.

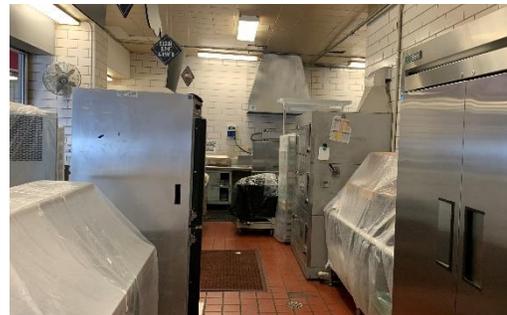
Back serving lines are congested and lack adequate temperature maintenance equipment.

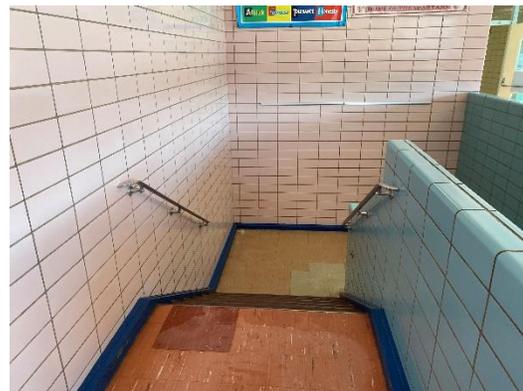
Typical Existing Stairs

Means of egress conforming to the requirements of the building code under which the building was constructed shall be considered compliant means of egress if, in the opinion of the code official, they do not constitute a distinct hazard to life (IEBC 805.2). The existing stairs are fairly modern exit stairs, no hazardous conditions were noted during the site visit. If the cost of renovation triggers full compliance with 521 CMR, new handrails would be required throughout however (see accessibility section of report).

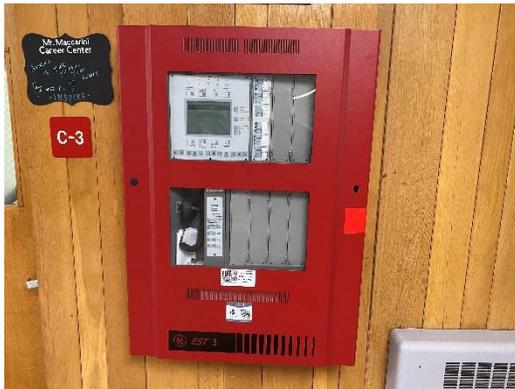
- Fire Alarm System – for a Level 2 Alteration existing previously approved fire alarm systems are permitted to remain (IEBC 804.4.1 Exception 1). A Level 3 Alteration requires a fire alarm system that complies with the code requirements for new construction (IEBC 904.2). The building includes an existing relatively modern voice/alarm signaling system that appears capable of being maintained and modified as necessary to accommodate any future alterations. Although not required by the IBC for a new Use Group E occupancy, smoke detection is also required throughout the building.

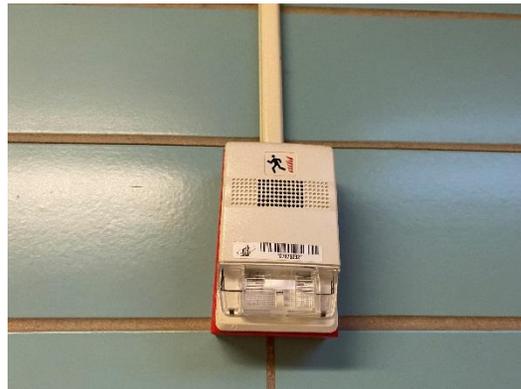
Existing Voice Alarm System

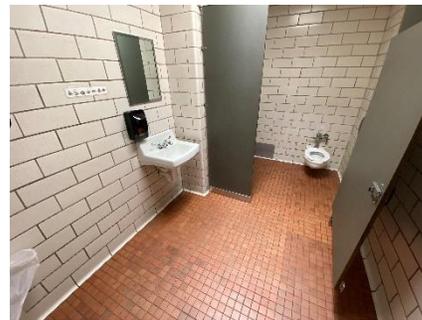
1. Toilet Rooms – none of the existing toilet rooms appear to be fully compliant, although some are semi-accessible. Each toilet room location would require accessible fixtures or a unisex accessible toilet room in each toilet room location (521 CMR 30.1).

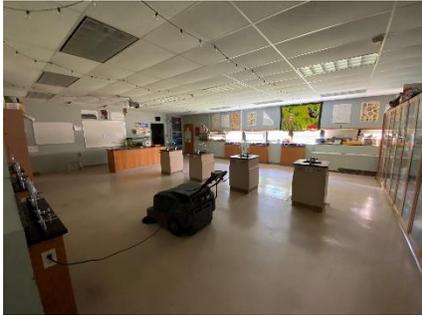
<p>2. Classroom Sinks & Counters – none of the art or science classrooms with sinks and built-in counters include accessible elements, at least one of each must be accessible (521 CMR 12.4).</p>

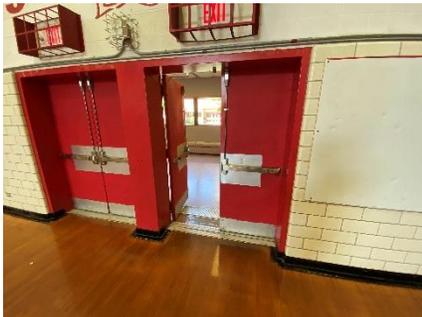
<p>3. Double Doors – the building include many double doors in corridors, at stair enclosures, at the gym entries, etc. where each leaf provides a clear width of less than 32 inches (521 CMR 26.4).</p>

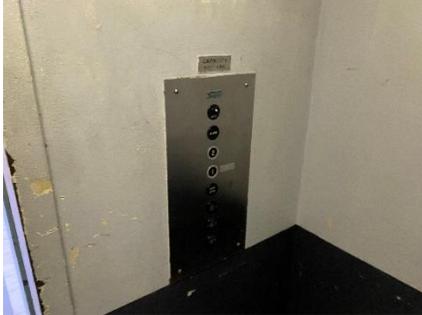
<p>4. Elevator – the existing elevator car is 61" wide and 53" deep (wall-to-door), which exceeds the minimum 48" x 48" required by 521 CMR Section 28.7 and includes a 32" wide door opening which complies with 521 CMR Section 28.6.1. The controls are not compliant however (i.e. no Braille or raised characters (521 CMR 28.8.4).</p>

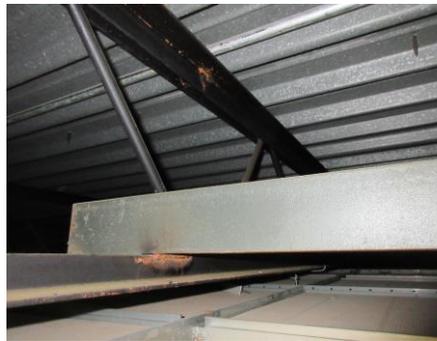
Both the 1959 & 1973 existing structural drawings are fairly complete, providing a clear picture of the building structure. The original 1959 building is supported by shallow foundations – concrete spread footings at columns and continuous concrete footings at perimeter walls. Ground floors consist of 4" concrete slab on grade. Elevated floors are structured with slab on metal deck, typically 3" of concrete of 1.5" deck. Slab on deck is supported by open web steel joists, which are supported by steel beams & steel columns. In the classroom wings, joists are oriented perpendicular to the corridors with the bearing lines of steel beams running along corridors and the perimeter. Roofs are structured with metal roof deck and open web joists (Photo 1) also supported by steel beams and steel columns.

Photo 1 – Typical Roof Structure
Open Web Steel Joists & Metal Roof Deck

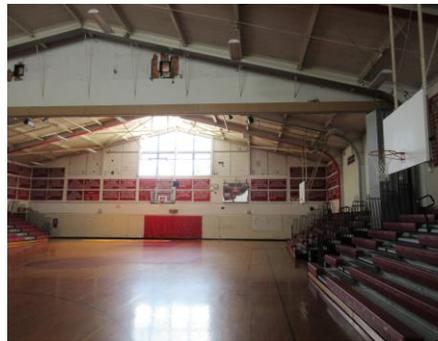
The gymnasium roof is structured with six clear spanning steel bents with steel beam purlins spanning to them (Photo 2). The auditorium roof is supported by long span, 8ft deep steel trusses. The trusses support open web steel joists and metal roof deck.

Photo 2 – Gymnasium Roof Structure
Steel bents with steel purlin beams

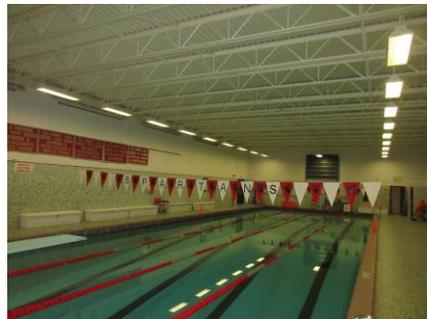
The 1973 addition involved three distinct single story wings – a new gymnasium wing, new industrial arts wing, and a new science wing. The science wing matched the classroom wing structure of the 1959 building with shallow foundations and roof framing comprised of open web steel joists, steel beams, steel columns. The roof has 2.5” concrete slab on form-deck with the intent of being able to use the roof as a future floor. The industrial arts and new gym wings are structured similarly to each other. They use shallow foundations and the roofs are comprised of triangle shaped steel space trusses, beam trusses and metal roof deck (Photo 3). The pool building roof is structured with open web steel joists and metal roof deck (Photo 4)

Photo 4 – Pool Roof Structure
Open Web Steel Joists & Metal Roof Deck

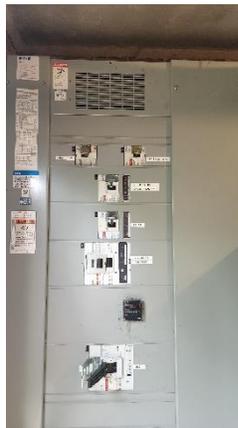
The transformer's secondary feeder enters the school building underground. It terminates in the "newer" electric room at 1,200 Amp 277/480V 3 phase 4 wire Main Switchboard, year 1973, manufactured by Eaton. The Main Switchboard appears to be in good operational condition; however, it reached or exceeded its useful life expectancy (usually about 30-40 years).

1,200 Amp 277/480V Main Switchboard

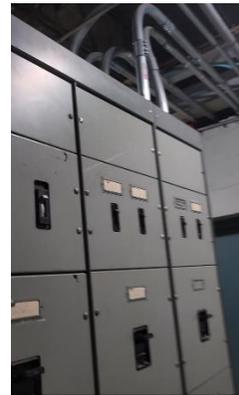
The Main Switchboard back-feeds via an indoor 500 kVA transformer the "old" (year 1959/1964) 800 Amp 120/208V 3 phase 4 wire Distribution Panel "DP-1" located in "older" electric room. Panel "DP-1" is manufactured by General Electric. It appears to be in poor condition, its installation does not meet the current Electrical Code requirements, and it significantly exceeds its useful life expectancy.

800 Amp 120/208V Distribution Panel "DP-1"

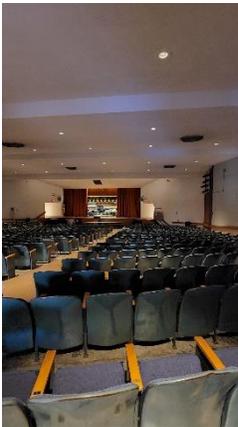
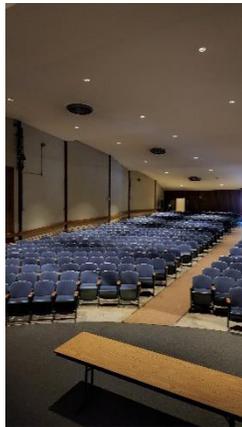
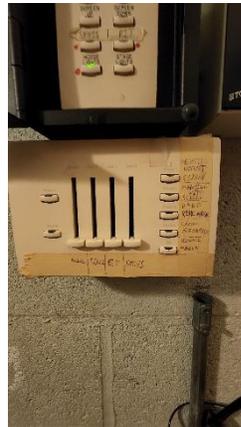
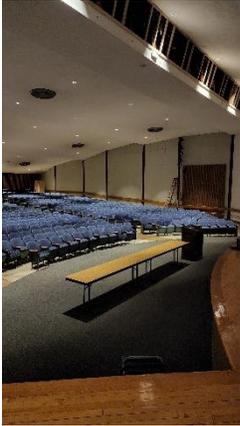
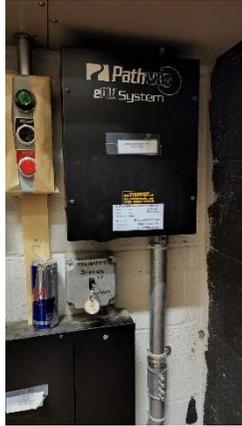
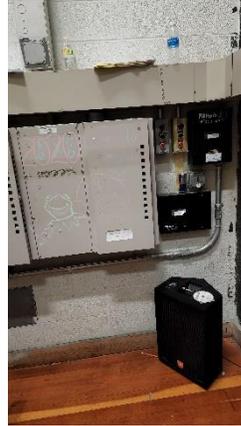
Auditorium “Stage” and “House” lights appear to be in good operational condition, however, not of an energy-efficient LED source, which would not meet the current Energy Code requirements. The “House” lights consist of incandescent type recessed downlights, controlled/dimmed in by0zone basis. The “Stage” lighting is a full “performance” lighting package with front, side and back flood and spot lights, controlled by console and entrance light stations. Seat lights are provided at every third row. The Auditorium Lighting system is dated, but operational.

Examples of Auditorium Lighting

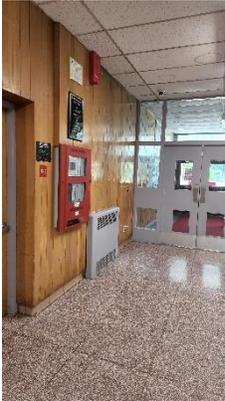
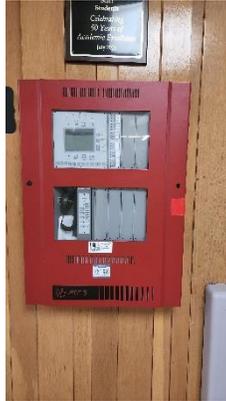
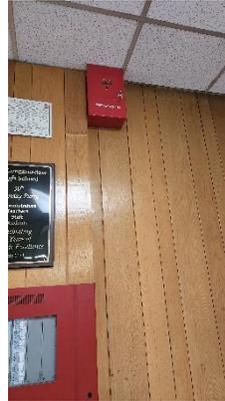
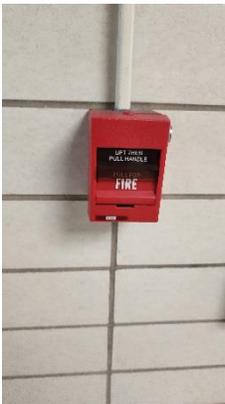
Existing addressable Fire Alarm system EST-3 is about 20 years old. It appears to be in good operational condition with full smoke detection coverage. The system consists of manual double action pull stations, speaker/strobes and strobe units, area smoke detectors, and radio antenna communicator for transmitting alarm and trouble conditions to Fire Department. A few corridors and larger classrooms looked as if they would benefit from additional smoke detectors and/or speaker/strobes, but otherwise the existing fire alarm system appears to be adequate.

Examples of addressable Fire Alarm system

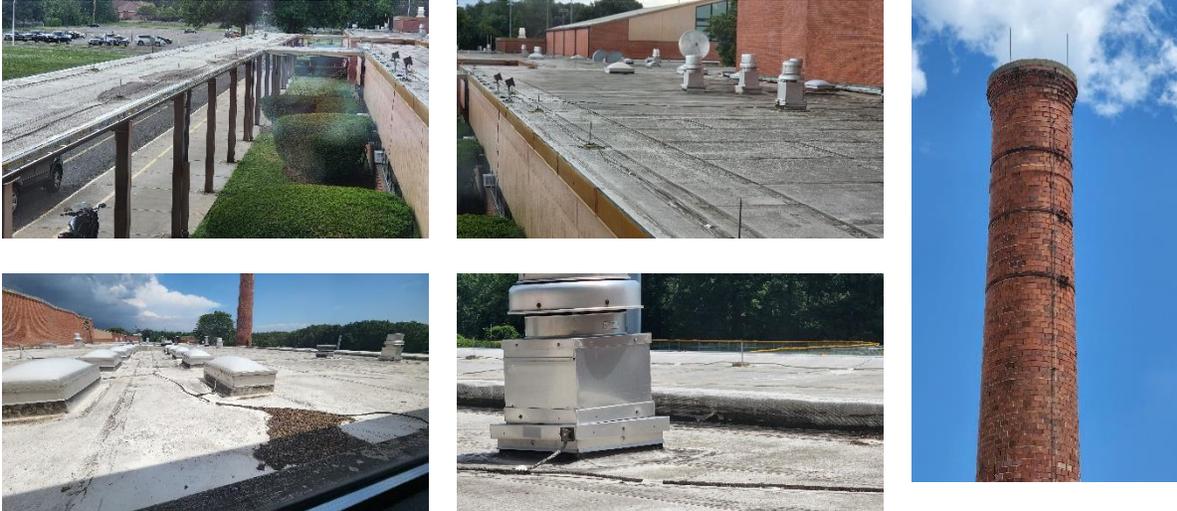
Aluminum air terminals and aluminum stranded interconnecting conductors are installed on roof perimeter, canopies, extended to roof-mounted equipment and up along chimney. The installation looks a bit dated. Assumption is that it's periodically tested for LPI re-certification.

Examples of Lightning Protection system installations.

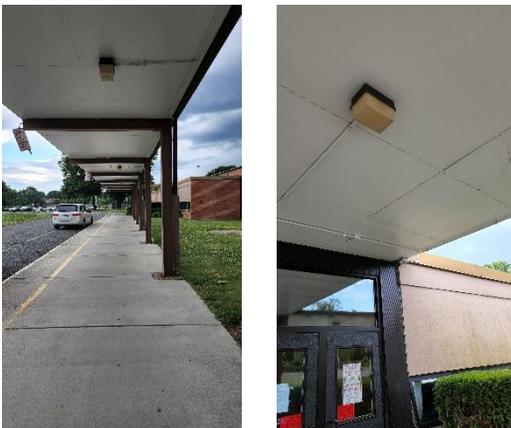
Building-mounted lights were observed to be dated and appeared not to be an energy-efficient LED source. As well they seem to be manually switched "on/off", with no programmable schedule, which would not comply with the current Energy Code.

Examples of exterior building-mounted lights

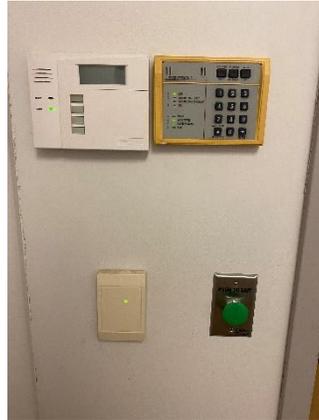
Honeywell and Sonitrol intrusion keypad.

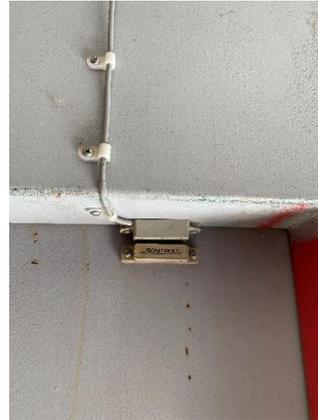
Door position switch on exterior door in men's swim lockers storage room.

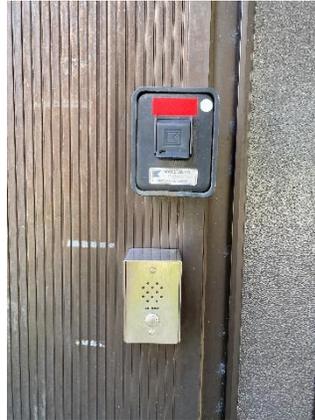
Audio intercom at main entrance.

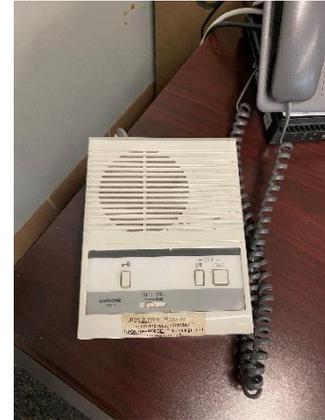
Master intercom at main office desk.

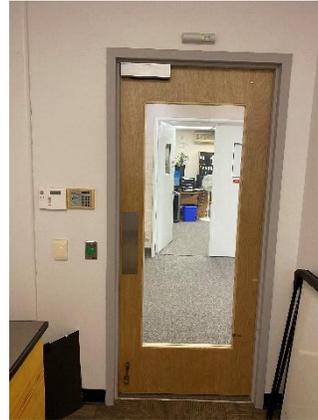
There is one door, the entrance door into the cable television area, that is equipped with a magnetic lock and push to exit button.

Door with magnetic lock.

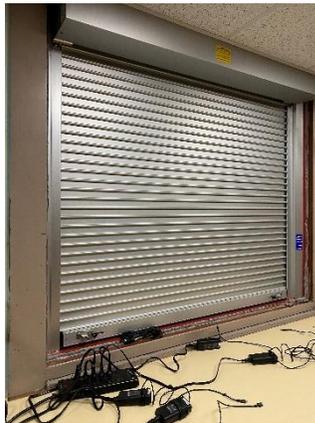
There is a rollup window located in the IT closet next to the cafeteria. It is unclear if this window is used.

Rollup window located in the IT closet next to the cafeteria.

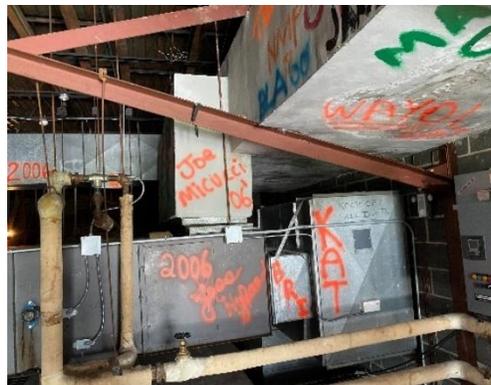
The auditorium is heated and ventilated only and is served by a Trane H&V unit located in the penthouse, which is original to the 1959 building. The unit is beyond its useful life and should be replaced.

Auditorium H&V unit

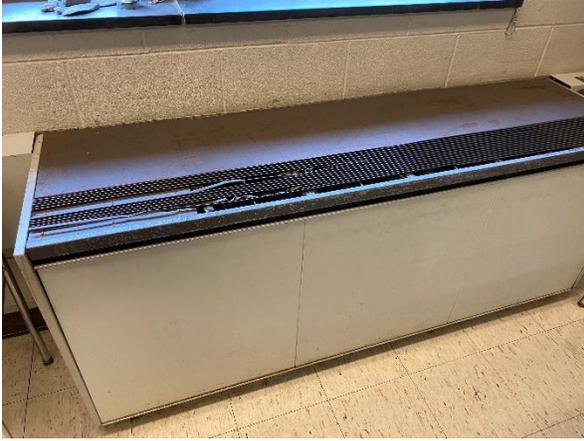
The classrooms are served by unit ventilators with hot water heating coils. The unit ventilators are original to the building (1959 original building, 1964 addition and 1973 addition). The unit ventilators are in poor condition. The unit ventilator cabinets and interior components show corrosion and many of the air grilles are damaged. The amount of fresh air being introduced to the classrooms through the unit ventilators may not be in accordance with the current codes as the ventilation dampers are controlled to limit outside air in the colder months. All unit ventilators are beyond their useful life and require replacement. Hot water piping and associated valves are antiquated, piping insulation is damaged in many areas, and both require replacement. Temperature controls are the original pneumatic system, may not all be operational, and a number of valves are replaced each heating season to keep the system running – all require replacement.

Classroom Unit Ventilator

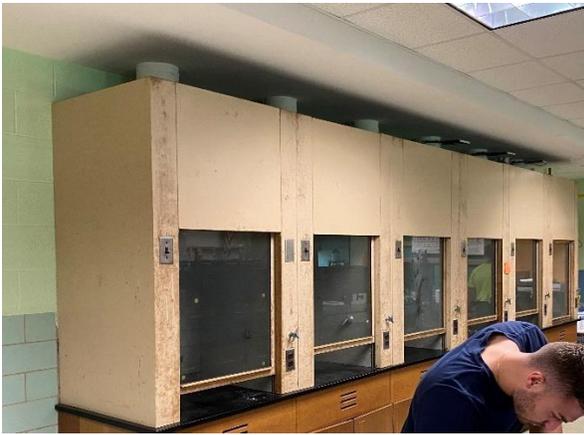
The Chemistry classroom has a six-section fume hood which is antiquated and not currently in use. There are blast gates in the fume hood exhaust ductwork, the fume hood lacks flow alarms to alert users of unsafe conditions, and the makeup air unit has been abandoned on the roof. The fume hood and associated HVAC equipment are not compliant with current code and should be replaced.

Chemistry classroom fume hood

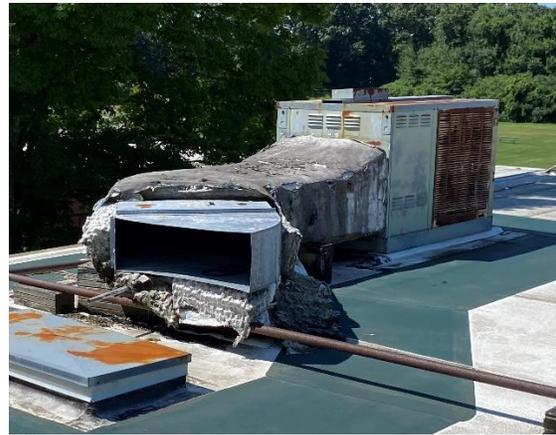
Abandoned makeup air unit on roof

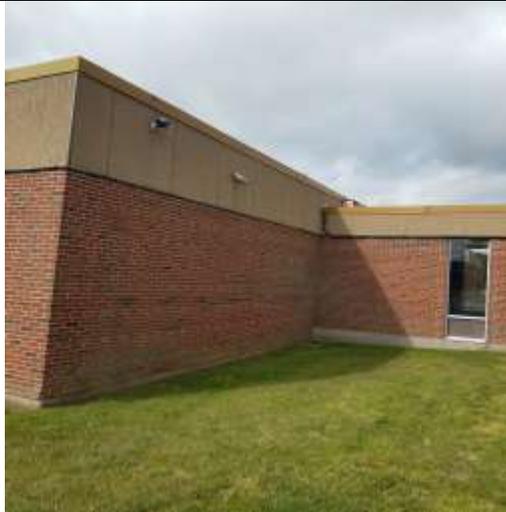
Bldg. C asbestos upper panel walls

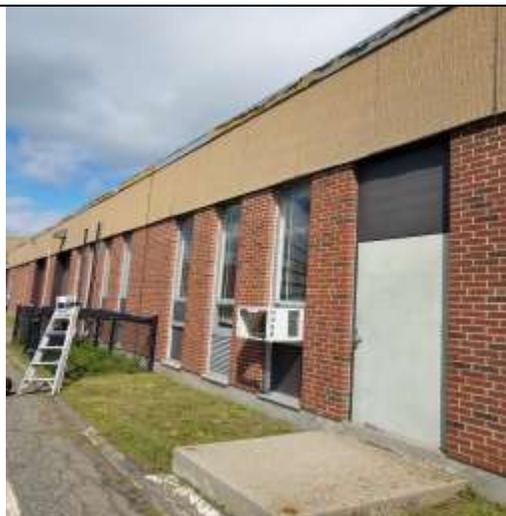
Bldg. C asbestos panel walls & window panel

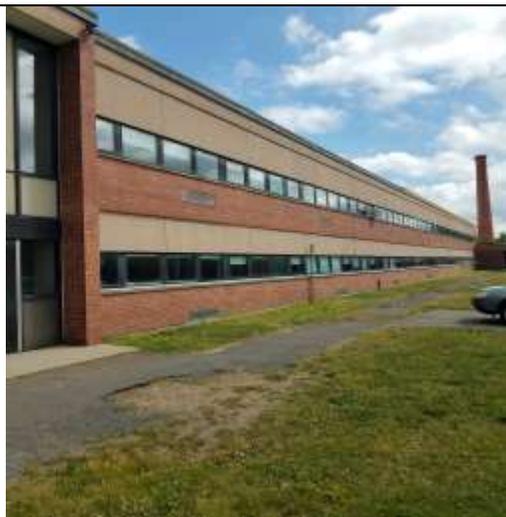
Bldg. B, asbestos black glazing

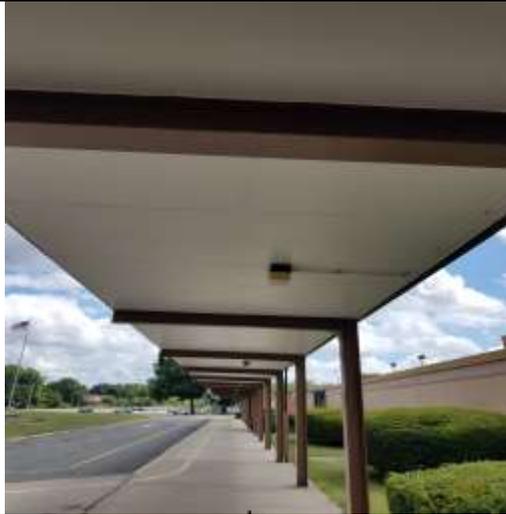
Front asbestos canopy

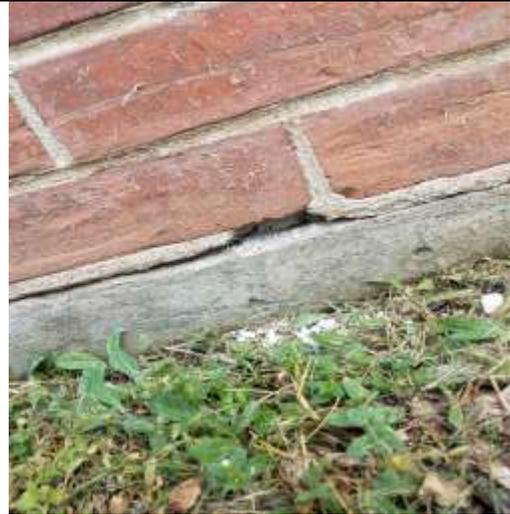
Front asbestos vapor barrier

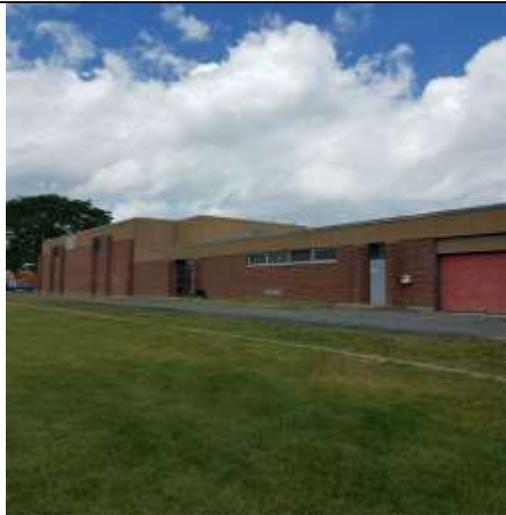
Rear of building, asbestos upper panels

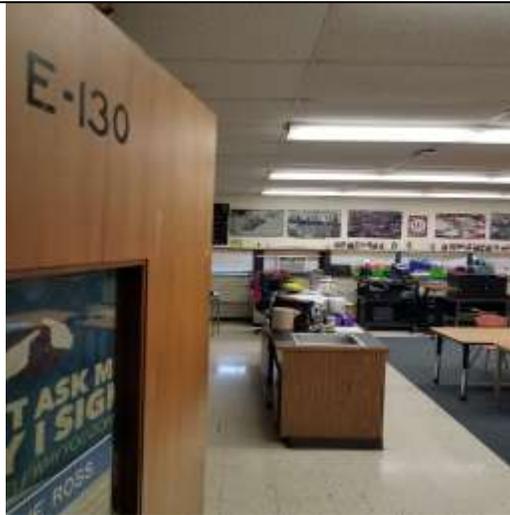
E-130 asbestos floor tile/mastic

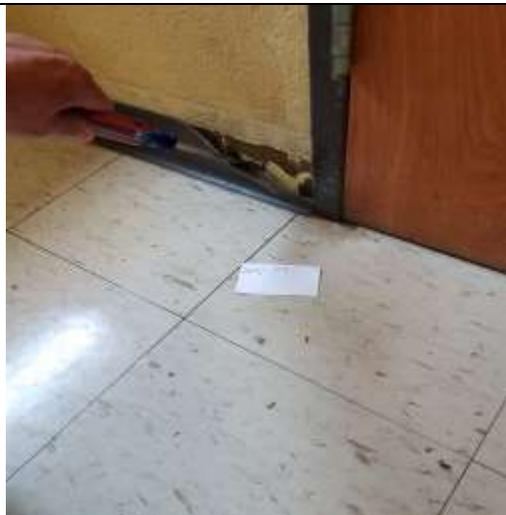
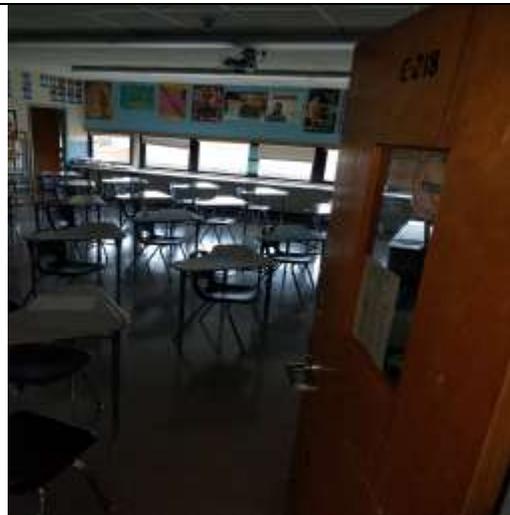
E-130 asbestos floor tile/mastic	Wood door with assumed insulation
----------------------------------	-----------------------------------

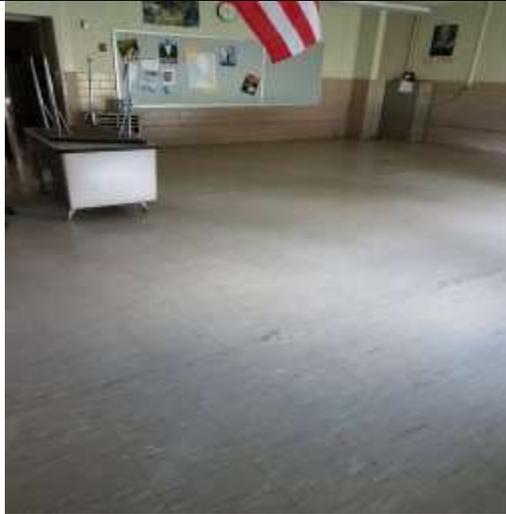
Asbestos floor tile in class

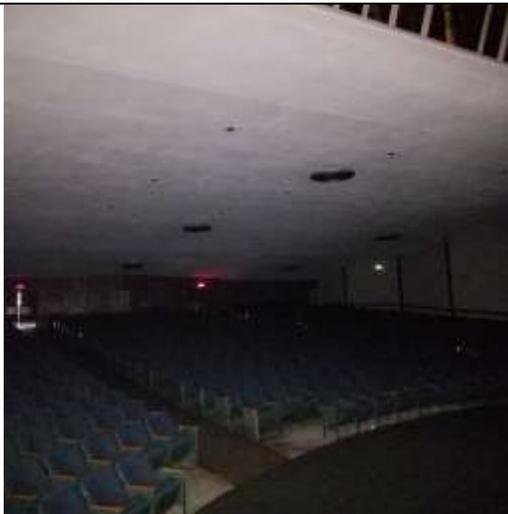
9" floor tile in auditorium

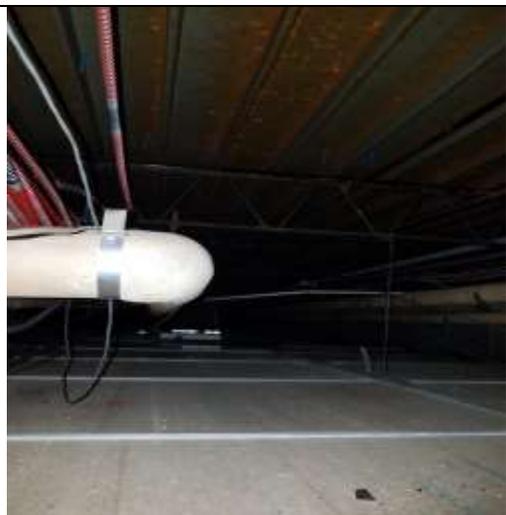
<p>Pipe fitting in plenum hall at auditorium</p>	<p>Old floor tile below & newer in hall</p>

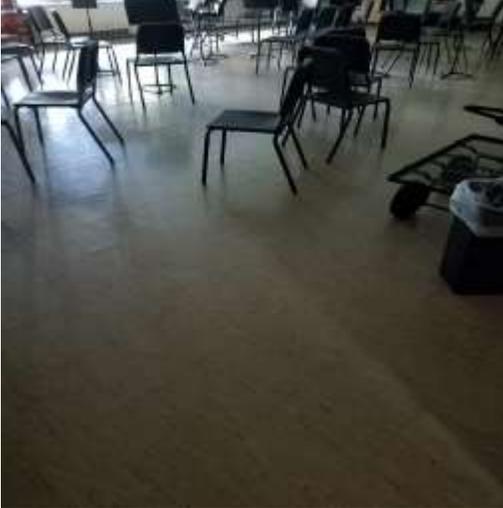
<p>Music room floor tile, asbestos</p>	<p>Fittings in plenum</p>

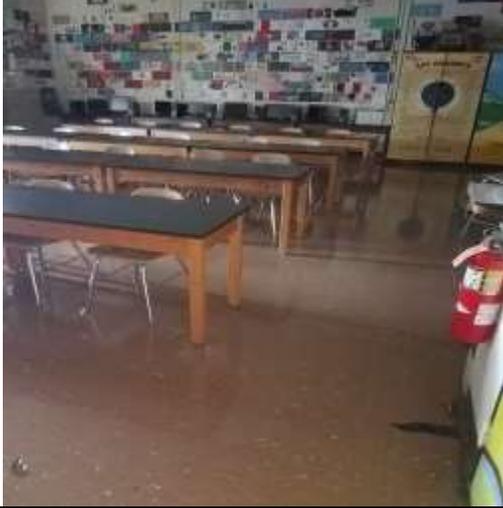
<p>Graphics, older 12" floor tile</p>	<p>Newer boilers</p>

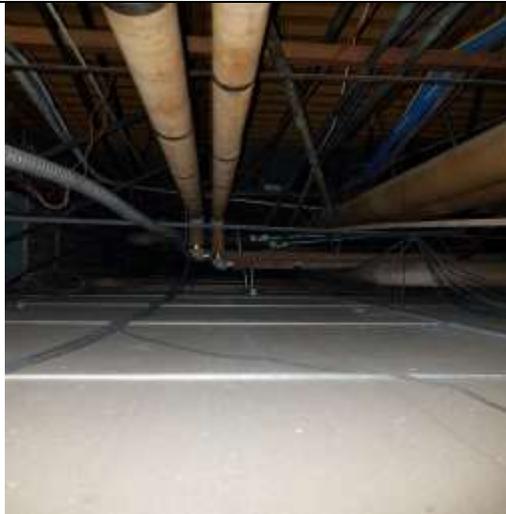
Fittings in plenum in cafeteria

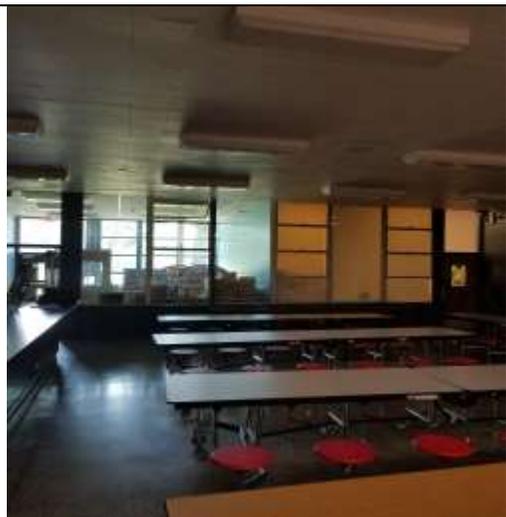
Original windows in small cafeteria
